The Nautical Institute Marine Accident Reporting Scheme

MARS Report No 178 August 2007

This edition highlights the causes and consequences of some recent hand injuries and poor onboard and onshore practices in carrying out hot-work operations.

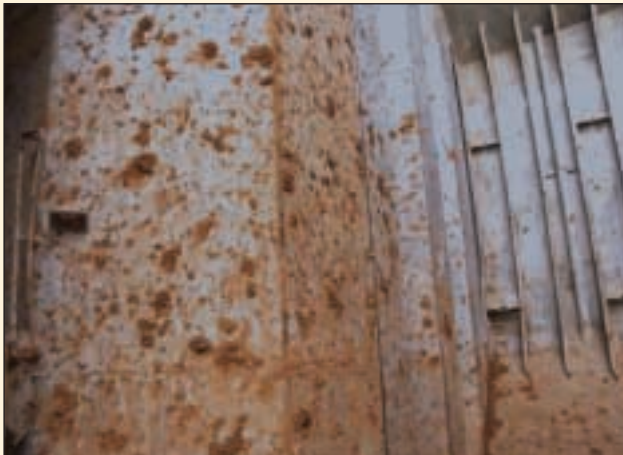
▲ 1. Warning signs: such heavy splattering on the hold bulkhead during loading is an indication that at least some of the cargo has experienced 'flow state' due to impact.

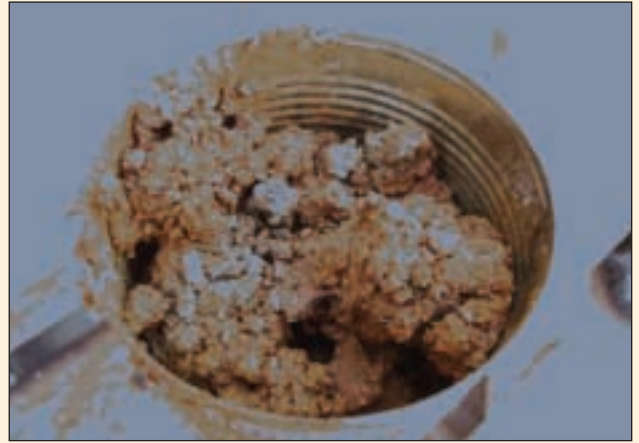
▲ 2. Nickel ore sample taken from a grab during loading from a barge prior to a shipboard can test.

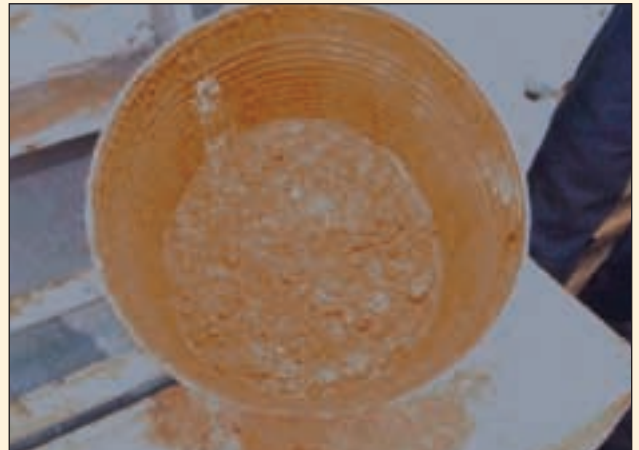
▲ 3. Showing the same sample but after 25 strikes of the can on a hard metal surface. Note the flat surface and free moisture visible in the surface layer, indicating that the sample has liquefied.
