Mariners' Alerting and Reporting Scheme

MARS Report No. 255 January 2014

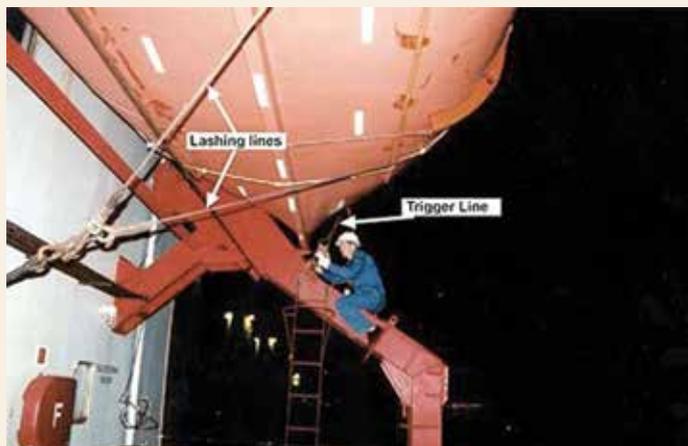
→ While underway but not yet in open sea, the bosun was instructed to properly secure the port lifeboat for sea. He called on a seaman to help him with the work. By the time the seaman arrived at the lifeboat station the bosun had already begun the task. The bosun was sitting astride the forward davit cradle, close to the underside of the lifeboat, trying to secure the forward trigger line to the trigger mechanism on the cradle (see photo). The seaman climbed the aft cradle ladder and attempted to do the same with the aft trigger line. When the seaman realised there was not enough slack in the line to permit the connection, he descended the ladder with the intention of lengthening the turnbuckle at the other end. Shortly after reaching the deck he heard a noise; he then saw the lifeboat sliding down the cradle of the roller gravity davits.

The noise also alerted the ship's electrician who was nearby. Both the electrician and the seaman rushed to the lifeboat davit winch and applied the brake. The lifeboat stopped descending but not before hitting the bosun, sending him backwards. He clung to the trigger line momentarily, but lost his grip and fell overboard into the water 15 metres below. 'Man overboard' was quickly communicated to the bridge where the OOW, a helmsman and a pilot were navigating the vessel. The pilot immediately put the engine to dead slow ahead, but the confined area of the channel prevented a turning or full astern manoeuvre. The pilot also released the port smoke buoy, but this fell into the partially deployed port lifeboat. The Master arrived on the bridge and released the starboard smoke buoy. Another life ring was also thrown into the water, and persons on deck could see the bosun apparently swimming some 20 metres from one of the buoys; however, they lost sight of him within minutes. Five days later, the bosun's body was recovered approximately 10 miles from the site of the accident.

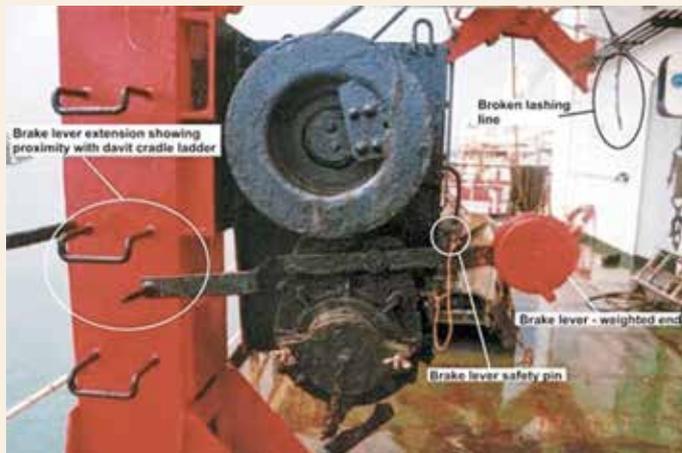
It was observed during the course of the investigation that the outboard end of the brake lever (opposite the weighted end) was

extended such that the handle was near the vessel's side to enable the person who controlled the brake, by pushing down, to view the lowering of the lifeboat. The handle was in very close proximity to the second rung of the aft cradle ladder (6 cm below and 5 cm away, see photo above).

- 1 The 12 mm gap between the safety pin and its brake release lever, and the less-than-adequate maintenance on the brake-lever mechanism, contributed to the unexpected release of the lifeboat down the davit cradle.

- 2 The wire rope used as the lashing line was in a severe state of corrosion and well beyond a serviceable state.
- 3 The davit cradle ladder rungs were located in very close proximity to the faulty winch brake lever, and as the seaman descended the aft davit cradle, he probably stepped on the winch brake lever extension, instead of the ladder rung, and released the lifeboat.

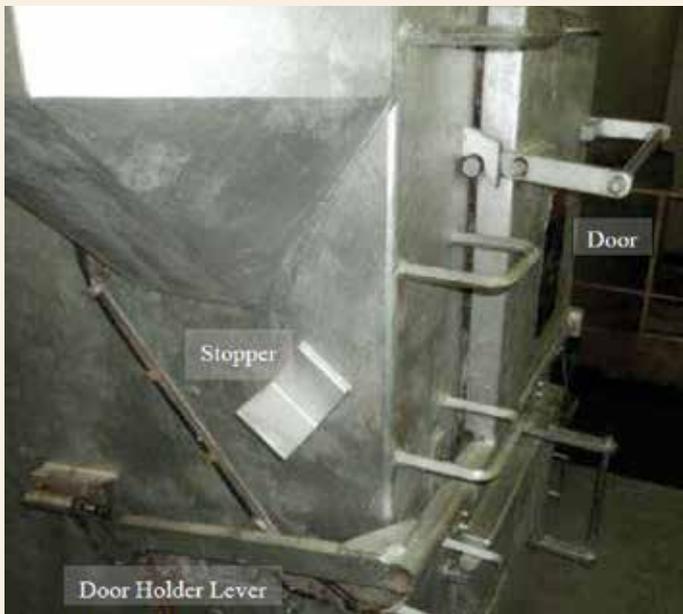
Incinerator with door closed

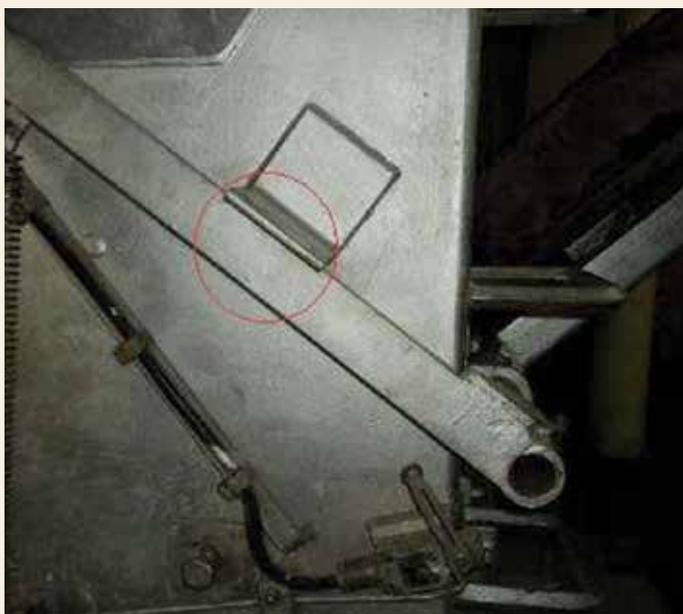
→ An engineer attempted to open the incinerator door while underway. His thumb was trapped and crushed between the door holder lever and the stopper plate (see photo). He was quickly transferred to the ship's hospital and first aid was administered. The victim was disembarked and at the hospital a fracture of the thumb was diagnosed and orthopaedic surgery was necessary.

With door open, red circle indicates where crushing ensued

- 1 Inappropriate handling of the equipment.
- 2 Improper decision-making and lack of judgement.
- 3 Fatigue due to violation of resting hours the previous day without adequate compensatory rest.

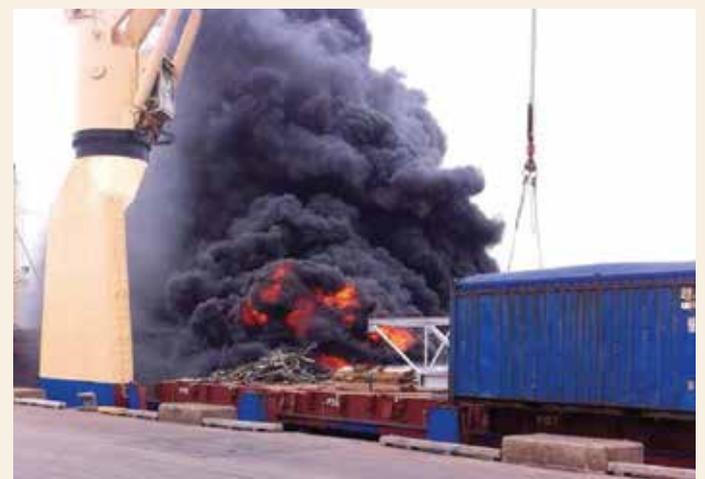
→ In preparation for hot work by shore workers the crew placed three fire hoses, two dry-powder fire extinguishers and a number of fire blankets in the hold. As gas-cutting began no fire watch had been established at the hot work site(s) inside the cargo hold. A tarpaulin cover caught fire, and the shore workers raised the alarm. None of the ship's crew were in the hold and there was no attempt to use a fire extinguisher or the other fire-fighting equipment that had been prepared. The chief mate saw smoke coming from number one cargo

In carrying out the hot work on board the vessel, neither the ship's crew nor the shore personnel properly considered or mitigated the risk of fire. Not all of the precautions listed on the ship's hot work permit were taken, nor was the permit completed properly. Similarly, not all of the measures listed on the shore gang's job safety analysis were taken.

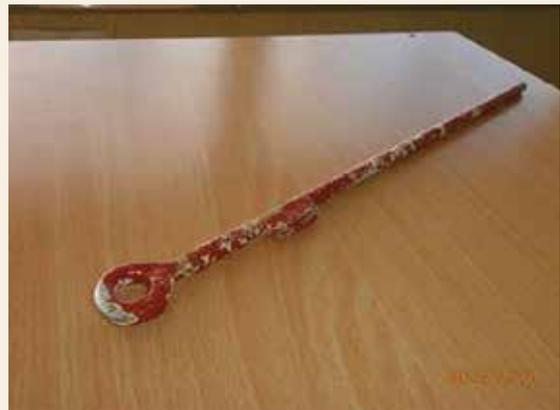
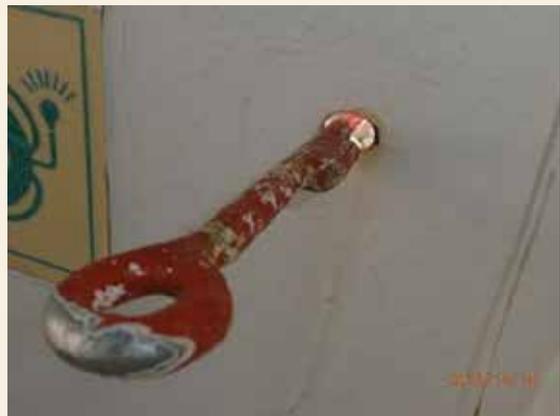
Before

→ After a rough sea passage the vessel entered harbour and dropped anchor. As this manoeuvre was being completed it was noticed that the starboard man overboard (MOB) life ring had fallen into the sea thus bringing with it the MOB smoke float.

It was found that the securing pin of the life-ring was able to loosen on its own and back off from the as-installed condition. It would appear that the rather light construction of the pin allowed it, through vibration and vessel movement, to move to a point where it self-released.
