Seaways

Mariners' Alerting and Reporting Scheme

MARS Report No. 268 February 2015

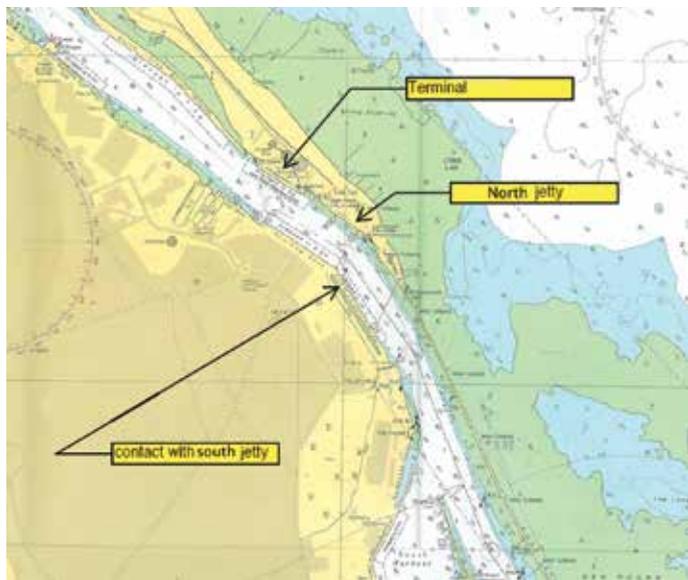
→ On a clear night, a small feeder ship with controllable pitch power (CP) was brought out of a restricted port in order to shift berth from port to starboard side. It was to be turned around and brought back in. A passage plan was presented and discussed during the Pilot/Master exchange prior to leaving the berth. The passage down river to the sea was uneventful. The vessel turned outside the port and began the approach to re-enter.

While passing the breakwaters the vessel's speed was approximately 8.5 knots (40% pitch). As they progressed in the gyro was checked against leading lights and found to be out by up to 8°. The pilot suggested that another bearing be taken on the inner harbour leading line. During this phase of the transit, verifying the gyro occupied the bridge team to a great extent.

On approaching the jetty, the pilot ordered a reduction of speed to minimal ahead. The pitch was subsequently reduced from 40% to 10% but this sudden reduction caused a large swing to port. The pilot ordered starboard helm and more propeller pitch to aid steerage. Now at about 2-3 cables from the terminal berth, the pitch was put to 0% and then full astern which swung the bow to starboard. This resulted in the vessel grounding south of the terminal berth at about 3 knots.

Coming full astern brought the vessel off the ground very quickly, but caused the stern to swing rapidly to port. The vessel then made heavy contact with the south jetty on the opposite side of the river. At this point, control of the vessel was regained and the vessel completed berthing starboard side to at the terminal berth.

- The gyro error distracted the bridge team during a critical period of the berth approach.

- Background lights and darkness made visual observation of the berth, and the closing distance, more difficult to judge.
- The Master was unaware of the pilot's contingency plan, which was to overshoot the berth (go further up-river). This was not communicated during the Master/Pilot exchange.
- As is common with CP power vessels, the abrupt decrease of speed caused the vessel to lose steering and take a shear.
- The Master played a passive role during the manoeuvres and could have been more aware and involved in the handling of the ship and its movements.

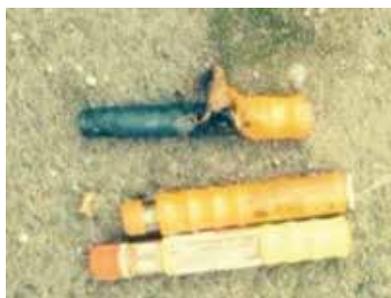
→ A discarded marine flare ignited on the picking line at a depot where ship's garbage is sorted. Fortunately there was no injury to personnel but some damage was done to the conveyor belt.

Flares and other special wastes should not be disposed of within the waste receptacles provided by the port for the use of ships. Disposal of expired ship's flares or any marine pyrotechnic should only be arranged through an approved provider for such services.

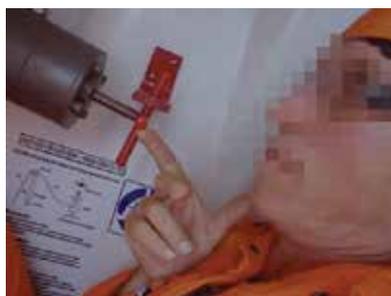
→ There are concerns that freefall lifeboats being installed in vessels currently under construction may not be compliant with the Life Saving Appliance (LSA) Code. Despite type-approval and acceptance by a major classification society the design does not comply with LSA Code

(Chapter IV 4.7.2.2), which calls for at least 650mm free clearance in front of the backrest. In this design the distance is only about 150mm. Under certain circumstances such a limited distance can be dangerous or even fatal to any person sitting in that seat. In addition to the personal injury hazard the non-compliance could put the vessel at risk of detention in the event of a port state control inspection.

1. Even classification societies and the class inspector on board during the vessel construction can make mistakes or miss something. Mariners should remain vigilant as ultimately they will be the ones using the equipment.
2. Shipowners, Masters and mates should ensure that lifeboats aboard their vessels are compliant with the LSA Code and, in event of non-compliance, advise their owners and class society.

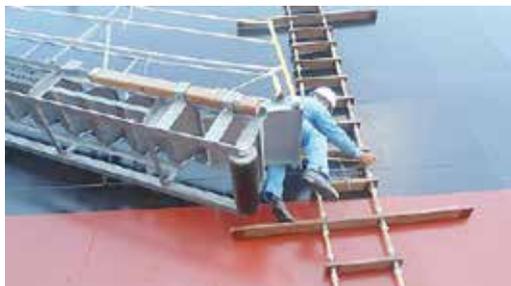
No lifejacket or safety harness

1. Crew should always wear a safety harness and lifejacket while rigging a gangway. Even though installing a safety harness line can sometimes be difficult and movement restricted by the length of the harness line, a life saved is well worth the effort. Gangways should be inspected regularly. Particular attention should be paid to areas where there are aluminium alloy to steel connections. The absence or deterioration of the insulating gasket can lead to electrolytic corrosion, which will cause wastage and hence weakening.

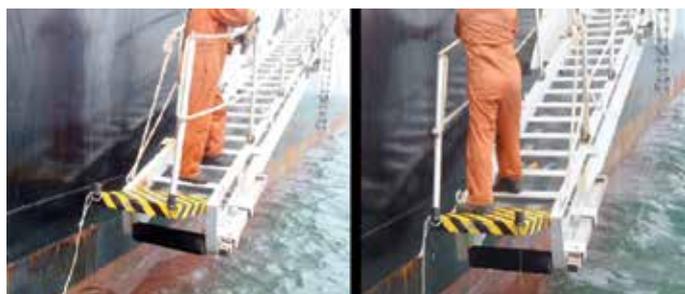
Consider how best to rig stanchions and safety chains. In the photo below on the left, it is clearly difficult to step onto the bottom platform from the bow of the launch, while on the right access from a launch to the gangway or vice versa is much easier.

Wrong

Correct

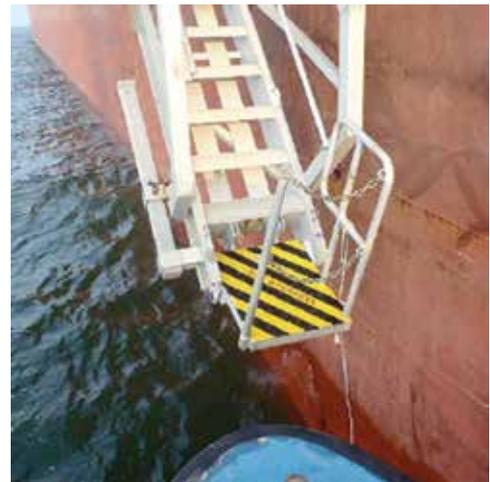
Sometimes the bottom platform has not been adjusted to suit the ship's draught. The bottom platform should be as close to the horizontal as possible to ease access and increase safety.

Bottom platform not horizontal

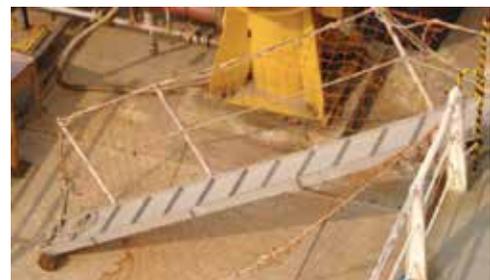
Other common faults with gangways include incorrectly rigged safety nets, slack sidelines, slippery steps and loose or missing stanchions.

Missing stanchions

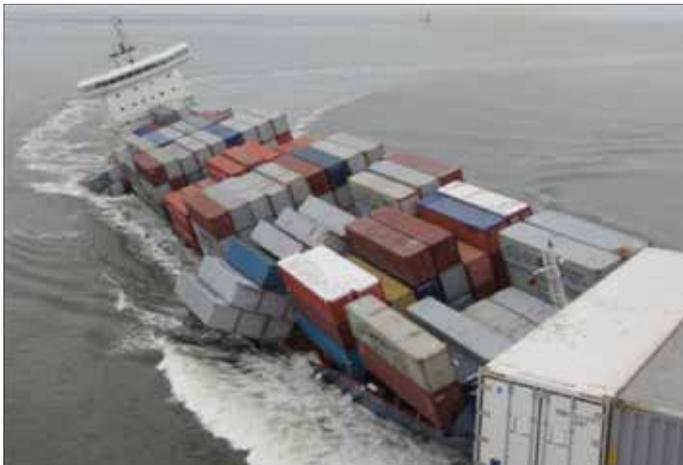
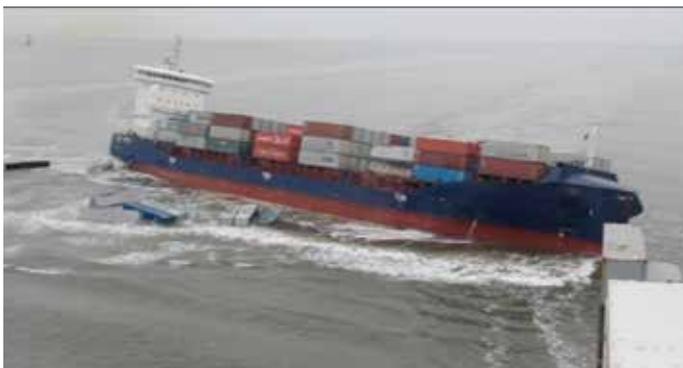
The vessel decided to overtake a much larger container vessel. As it was overtaking, the lubricating oil problem occurred again, and main propulsion on the small container vessel automatically shut down. Hard starboard rudder was quickly applied, but the vessel became unmanoeuvrable and was drawn to port towards the larger vessel due to hydrodynamic interactions. The forecastle of the smaller ship rammed into the starboard side of the larger vessel's aft section at an angle of about 60°. The force of the collision caused 15 containers on the smaller vessel to fall overboard. Due to the ebb current and the loss of manoeuvrability, the smaller vessel then ran aground outside the fairway. Both ships sustained material damage above the waterline and the fairway had to be temporarily closed to transiting shipping.

1. The loss of main propulsion on the smaller container vessel caused a reduction in speed, among other things, and made the vessel unmanoeuvrable. Hydrodynamic effects then took over and caused the smaller vessel to move unavoidably towards the larger.
2. Even after extensive investigations it was not possible to conclude, with absolute certainty, the cause of the oil pressure drop of the main engine. However, seizure marks were found on the discharge piston of the pressure control valve of the lubricating oil system. The most probable theory is that this valve became blocked in the fully open condition from time to time enabling a disproportionately large amount of lubricating oil to flow back into the retention tank.

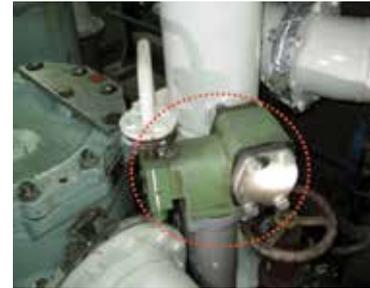
Pressure control valve as installed
