Mariners' Alerting and Reporting Scheme

MARS Report No. 276 October 2015

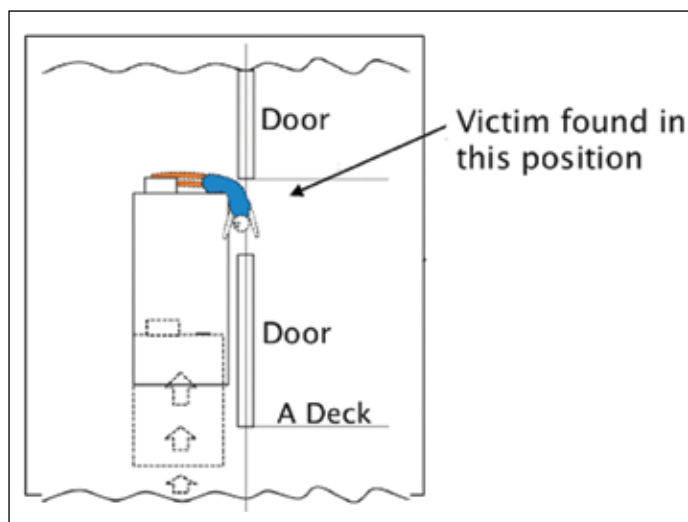
MARS 201555

Elevator fatality

The two men then proceeded to other duties, but the AEO returned alone to the elevator. Shortly thereafter, loud screaming was heard coming from the elevator location. Crew quickly came to the elevator and found the AEO trapped in the space between the elevator cage and the shaft.

The company investigation found it probable that the switch on the control panel at the time of the accident was set to AUTO. Other safety devices were most probably bypassed; as such, any calls from decks above B-deck would cause the elevator to move up automatically at a speed of 30 metres per minute, which is the nominal speed of the machine.

The investigation into the accident revealed that the main contributing factor to the accident was that the elevator safety procedures issued by the company were not closely followed by the personnel. Additionally, the work was prepared without sufficiently appraising the associated risks.

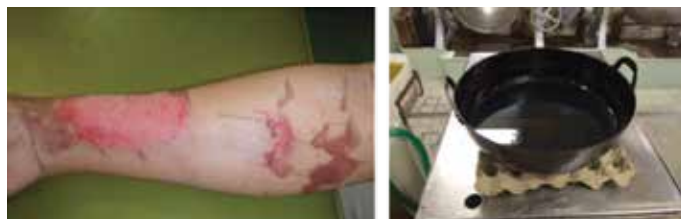
MARS 201556

Hot oil splatter danger

→ The vessel was at sea in good weather with no rolling. The galley crew members were going about their regular duties, preparing for lunch. The second cook lifted a pan containing approximately four litres of hot oil from the stove and walked towards a nearby rack to store it out of the way. As he tried to place the pan on the rack his right hand lost its grip on the pan handle; in a failed attempt to regain grip, the pan, now being held only by the left hand, tilted heavily to the right and the oil spilled out of the pan. Some of the spilled oil made contact with a significant area on his right arm, causing second degree burns.

- The small, all metal handle of the pan did not provide a good grip and had no thermal insulation areas.
- The selected location for placing the oil was inconvenient as it involved bending down and reaching into the rack to place the pan.
- The oil was not allowed to sufficiently cool down before being picked up to move.
- Wearing a full sleeved cook's shirt could have greatly reduced the consequence of the burn.

- Intensify behaviour-based safety observations in the galley
- Revise the company SMS to prohibit shifting of hot oil in pans until sufficiently cooled.

- Revise the SMS to clearly indicate the appropriate clothing for certain tasks. Long sleeves to be used during frying, handling of hot objects otherwise, and cutting. Short sleeves may be used during washing, with other appropriate PPE.
- Revise the SMS to ensure all frying pans and boiling pots ordered in the future have handles that are either insulated or large enough to be used with gloves.

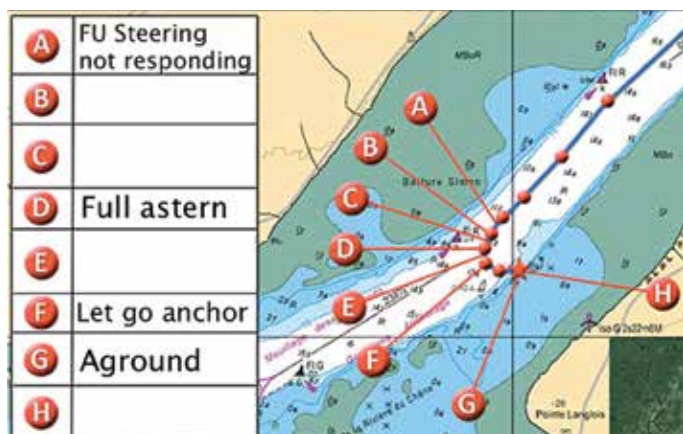
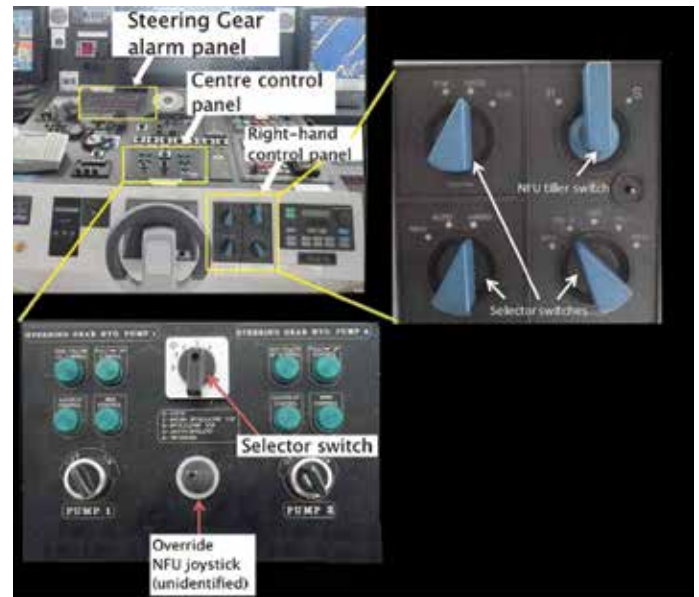
MARS 201557

On the centre console panel there is also a short black 'override' joystick that can be used to steer the vessel (NFU mode); however, on this vessel, it was not the practice to use this joystick. The joystick does not have an identification label, nor does it have a protective covering or any other locking feature to prevent accidental activation. Only a light touch of this override joystick is necessary to activate it and give steering control to the joystick while disabling all other means of steering in use. To reactivate the other means of steering after the override joystick has been activated, an operator must press the override reset button on the steering gear alarm panel, which resets the steering control system to its initial condition.

- Steering control from the steering wheel was likely disabled when the unprotected override joystick was inadvertently touched.
- The bridge crew was not adequately familiarised with the vessel's steering control system and did not know how to regain steering control after the override alarm activated.

■ **Editor's note:** In many accident reports where FU steering is lost, crew are not familiar enough with their steering systems and NFU is left untried. In this instance, the bridge team had the right reflex to try the NFU – but not the correct joystick. The only NFU that could have saved them was the override joystick on the centre panel – the one they didn't try. Unfamiliarity with the equipment and lack of identification were the primary contributing factors. The fact that the override joystick was unprotected could also be viewed as an unsafe condition.

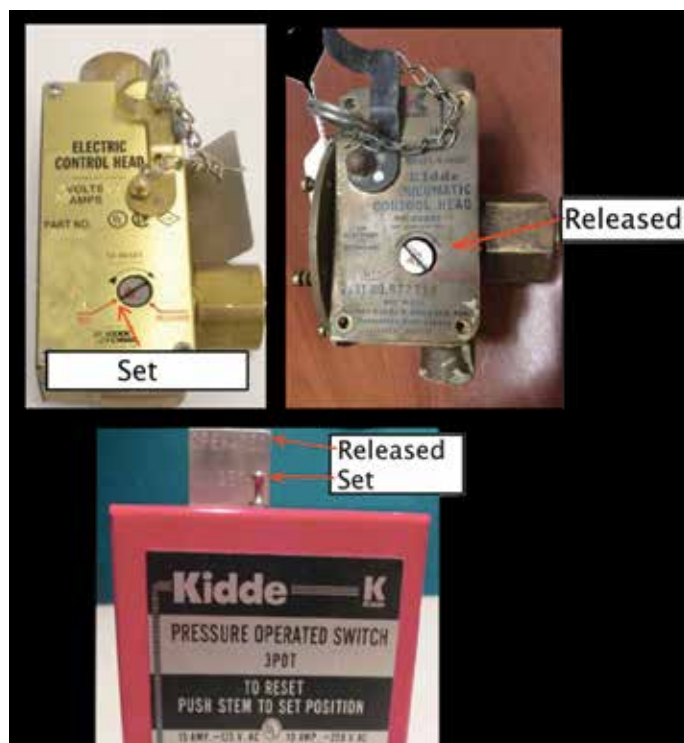
MARS 201558

➔ During the annual servicing of a KIDDE CO2 system on a passenger ferry, it was discovered that an undetected discharge of the CO2 system within the emergency generator room had taken place. Although the time of the inadvertent discharge could not be determined, the cause was a worn internal mechanism within the control head.

The crew was unaware of the discharge in the emergency generator room because the space did not require any indicators (eg alarm, smoke/heat detection) to alert them of the discharge and was unoccupied during discharge. This circumstance presented three latent unsafe conditions:

Identifying the status of a fixed CO₂ system can easily be done by eye. The control head of the valve has a slot that lines up with either the 'set' or the 'released' position and the indicators are the same whether the control head is electrically operated (left photograph) or pneumatically operated (right photograph). The bottom photo is an example of a second visual indicator for checking system status. It indicates the pressure switch position for the CO₂ system. If the indicator is in the down 'set' position, no CO₂ has been released and the system is ready for operation. If the indicator is in the up position, it indicates that the system has been 'operated' (released) and that the proper servicing company should be contacted immediately to bring the system back to readiness.

- Receive adequate training to perform routine inspections of their vessel's fixed CO₂ systems and fully understand their operation, particularly those protecting large spaces or multiple areas.
- Frequently review and update operating manuals, checklists, and safety management systems associated with vessel extinguishing systems onboard.
- Post clear instructions for fixed CO₂ system emergency operation.

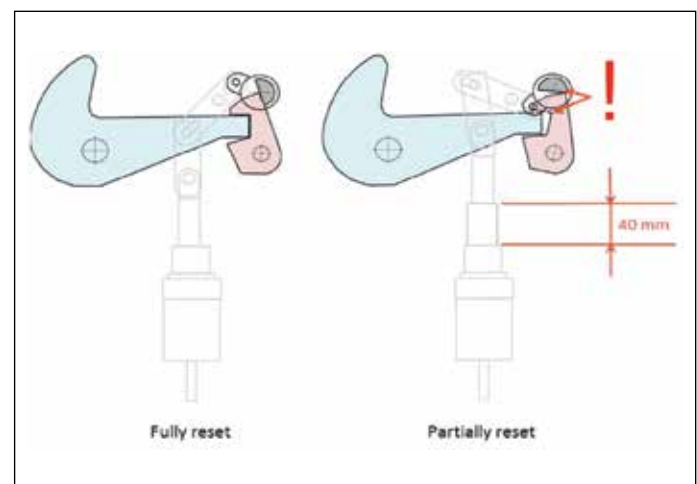
MARS 201559

During the investigation it was discovered that the oil level was not actually low; oil had remained in the ram and had not returned to the pump reservoir. Additionally, it was found that the reset alignment arrows could indicate that the hook was in the correct reset position, even if it was actually only in a partially reset position. This condition was not apparent because of a cover fitted over the release mechanism and the lack of an indicator for the release linkage to indicate if the ram had fully retracted (or not). Thus, the on-load release was unintentionally tripped after only four operations of the hand pump, because it was only partially reset.

- There was no equivalent, alternative arrangement to the safety pin to prevent inadvertent tripping of the free-fall lifeboat's on-load release during routine operations, such as inspections and maintenance.
- The simulation wires were longer than required and had not been installed as per the manufacturer's design guidance. Therefore, once the on-load release was tripped, the lifeboat travelled significantly further than it was designed to during a simulated release, with a proportional increase in the shock load placed on the wires.
- The manufacturer's calculations did not take into account the shock load imposed on the simulation wires or the lifeboat and launching frame mounting points.
- The Recognized Organisation's process for the approval of the simulation wires for 'maintenance and testing' had not taken into account the shock loading that would be experienced during testing.
