# Seaways

# Mariners' Alerting and Reporting Scheme

MARS Report No. 277 November 2015

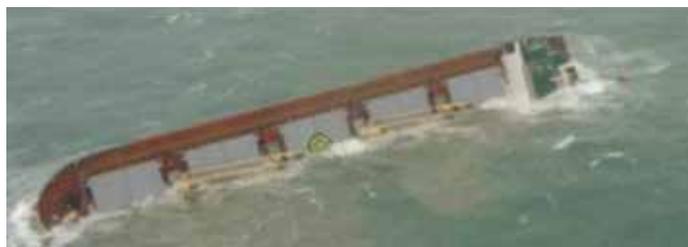
About a week after departure the Master had to divert due to a typhoon, eventually dropping anchor at a port of refuge that offered protection from wind and seas from the north. The vessel was yawing and rolling heavily and dredging her anchor at the anchorage due to strong winds and heavy sea, now coming from the southeast. The following day, the vessel encountered a strong wave causing her to heel to port about 20°. The vessel returned somewhat upright but was still listing about 10° to port. Within two hours the list to port increased to 45° and then 90°. Soon afterward the vessel capsized and sank.

Vessel at 45°

- Nickel ore was loaded despite a moisture content that exceeded its Transportable Moisture Limit, contrary to the requirements of the International Maritime Solid Bulk Cargoes Code (IMSBC Code).
- Several of the shipboard safety procedures for loading and carriage of nickel ore were not followed.
- Due to the heavy rolling at anchorage there was liquefaction of the ore cargo.

■ **Editor's note:** Although 'can tests' can be used by crew to validate suspicions\* that the moisture content of the ore may be above the certified TML, the oven drying test should be done in a laboratory. The Intercargo guide for transporting nickel ore, published in 2012, states: **Where there is doubt concerning any cargo declaration information, or suspicion that the cargo has been misrepresented, independent cargo testing to determine the FMP, TML and actual moisture content of the cargo to be loaded should be carried out.**

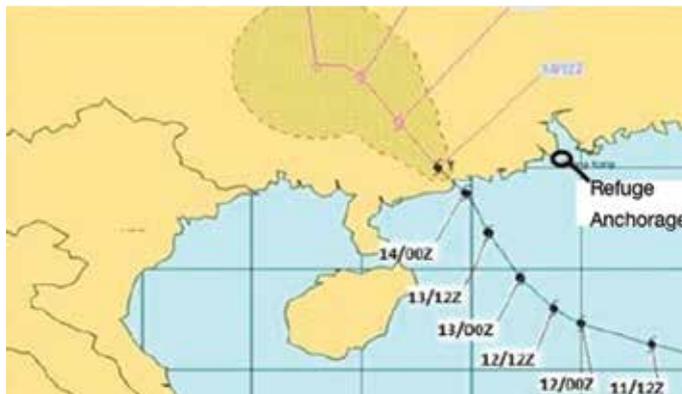
### Typhoon track and refuge anchorage

- The Master's selected refuge anchorage was not appropriate as the location could only shelter from northerly wind and waves. The vessel experienced strong southeasterly wind and waves when the typhoon, as predicted, passed south and southwest of the vessel's anchorage. The investigation also revealed the following safety issues:
- The moisture content certificate of the nickel ore was issued by the shipper instead of the local administration or independent organisation (or authorised organisation)
- The crew was not trained and therefore not competent to carry out the oven drying test to verify the moisture content of the cargo before loading.

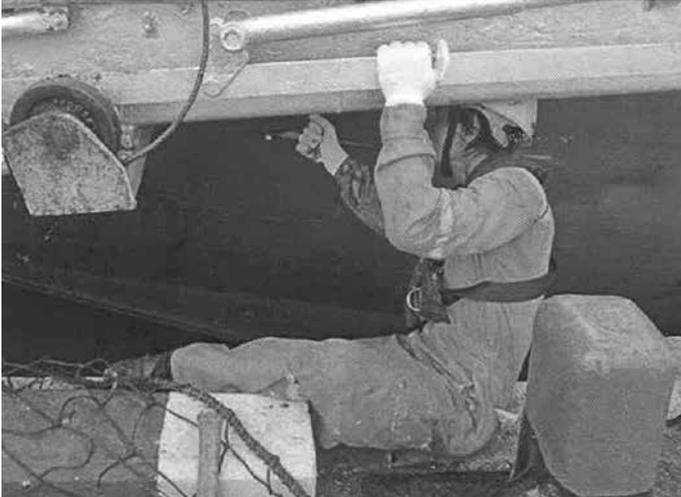
In this case, the gangway support wire had come out from its sheave and become jammed and a crew member was attempting to remove it. Thankfully, he did take some precautions, like wearing a life vest, helmet, and gloves but failed to realise that during the process of clearing the stuck gangway wire, the gangway could have moved or lowered onto him.

The superintendent stopped the work and ensured that concrete blocks were placed on the wharf so that the weight of the gangway could be landed on them. The wire clearing process was then resumed in relative safety.

■ **Editor's note:** In this instance, the person initiating the 'stop work' request was a port official. The lesson here is, even if you are not part of the team involved in the work, if you see a danger you should make it known.

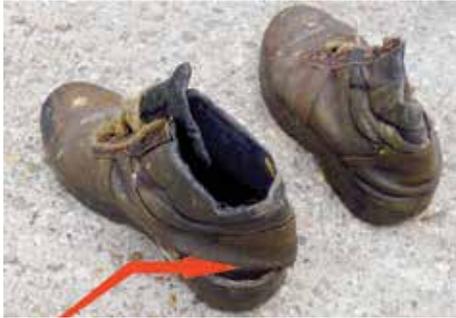
It is not known how the crew member lost his balance, but after the accident it was found that his shoes and coveralls were in very poor condition. At the time of the accident the victim was not wearing a safety harness, life vest or helmet.

Work boots in poor condition

- Personal protective equipment such as boots should always be in good order for proper support, protection and traction.
- When working on deck a safety helmet should always be worn.
- The crew considered moving the hatch covers a routine job. As such, they did not discuss arrangements and possible risks prior to moving the hatch cover on the morning of the accident.
- The spreader had an uneven surface and was without fall protection. It was probably slippery due to the morning dew; it had no anti-slip paint applied as it was not intended to be walked upon.

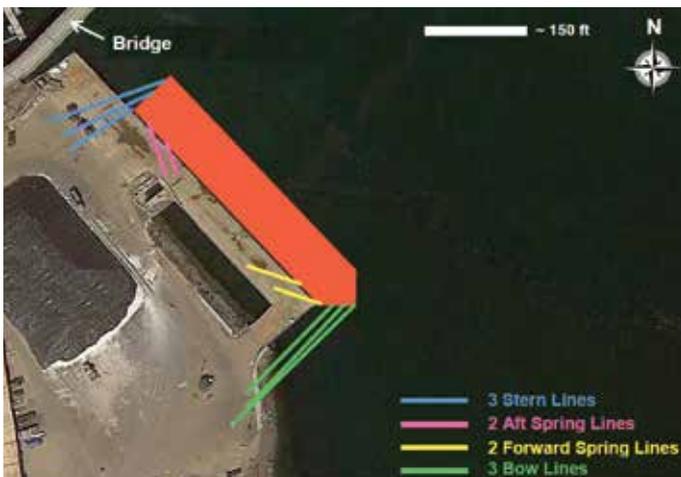
The next day after loading, and in order to refuel, the vessel was shifted about three miles downriver during slack water. This was accomplished by the same pilot from the previous day and the transit was uneventful. At the new berth, ten mooring lines were used as illustrated.

Because of draught considerations, the vessel was docked such that the ship's bow extended 30 feet beyond the east end of the wharf. After docking, a crew member conducting a patrol noticed dust and smoke coming from the brakes of the mooring line drums on the bow. The alert was given and the bridge team tried using the ship's bow thrusters to push the vessel toward the dock but to no avail.

As the vessel's bow was pushed into the river, the three mooring lines that were on bitts parted (both forward springs and one aft spring). The remaining mooring lines were on winches; the winch brakes began slipping and the lines quickly ran free off the drums and fell into the water. Within about 10 minutes of the initial warning, the ship was adrift in the river. Anchors were dropped but they only slowed the drift. A few minutes later the vessel struck a bridge, which sustained approximately \$2.5 million in damage, while damages to the vessel were estimated at \$1 million.

- All mooring lines should be equally tensioned so as to share the load.
- Never underestimate the force a current can exert on the vessel and carefully evaluate the vessel's mooring situation with respect to possible current interactions.
- Mooring winch brakes should always be in top condition and properly adjusted.
- Given the vessel's bow was exposed to the flood tide current, several bow lines should have been on bitts as opposed to on mooring winches.

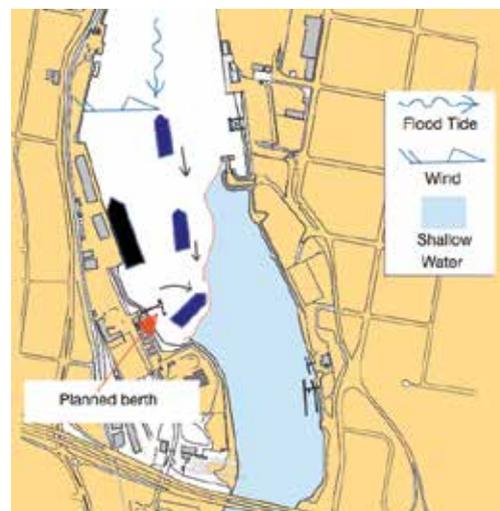
→ Our tanker arrived in port and was to go to berth at the southern extremity of the port. The manoeuvre required swinging the vessel 180 degrees and then backing astern to berth port-side to. Another tanker was moored just to the north of the intended berth which restricted the manoeuvring room somewhat. The berthing plan was discussed between the pilot and the Master but the pilot had not mentioned the restricted room due to the other berthed tanker. Although there was a flood tide and the westerly wind was blowing at 15 knots, a tug was not considered necessary. Once turned successfully, the pilot began backing

When our vessel was approximately 15-20 metres from the berth, an aft spring line was sent ashore by heaving line and secured. The forward mooring station lowered the headlines to the mooring boat but they could not be made secure in good time. The vessel was now swinging to starboard even though the bow thruster was full to port. Since the headlines were not secured at the designated bollards, and in an attempt to reduce the vessel's swing to starboard, the headlines were sent for securing at the designated bollards for the springs, but still to no effect.

team ordered the port anchor dropped but the headlines were now obstructing the anchor's release. By the time the anchor was finally released, the vessel was already aground; the vessel's position almost perpendicular to the berth. A tug was promptly called and with the rising tide the vessel was quickly re-floated and properly berthed.

- The angle of approach to the berth was more open than 'usual' due to another tanker alongside the adjacent berth. This placed the vessel in a more vulnerable position, especially considering the effect of the wind and current.
- When manoeuvring a vessel in a confined waterway where the margin for error is small, a tug is always a good investment.
