# Seaways

# Mariners' Alerting and Reporting Scheme

MARS Report No. 280 February 2016

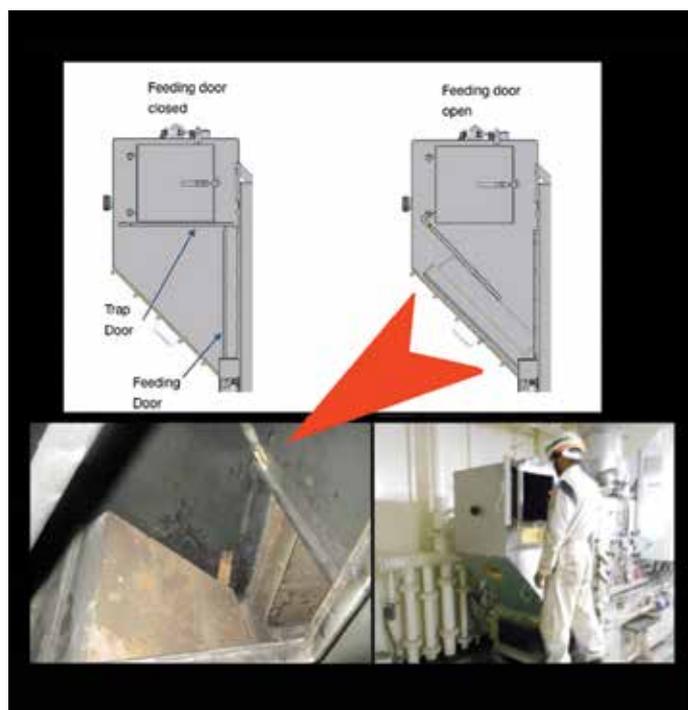
→ The vessel was underway when the incinerator alarm sounded, indicating the inside sluice gate was open. The incinerator was stopped and allowed to cool. A few hours later, the 4th engineer went to the incinerator room to investigate.

Standing on a small step, he opened the garbage loading door and also the sluice gate. (The incinerator feed system is such that when one door is open, the other must be closed and vice versa. Two different safety devices near the feed door ensure this operation; these must be overridden in order to look into the incinerator sluice chamber.) When the sluice gate was opened, he saw a piece of wood at the opposite end of the garbage loading door. While checking, he accidentally dropped his torch inside the incinerator door. While trying to recover the torch, the automatic sluice began to close and trapped his arm.

In the hospital, no fracture was apparent but a total obstruction of all blood vessels to the hand and forearm was confirmed. Surgery was performed immediately but to no avail and amputation of the forearm was unavoidable.

- Never bypass the safety features of an installation and always follow the procedures.
- The amount of waste fed at any one time should be in quantities that do not tend to block the incinerator doors.
- Working alone in isolated areas has increased risks and should be the subject of a risk analysis.
- Apparently, objects blocking the incinerator doors was a fairly regular occurrence (once a month) on this ship. It is possible that this 'common occurrence' encouraged complacency and risky behaviour such as taking shortcuts and bypassing safety features on the equipment.

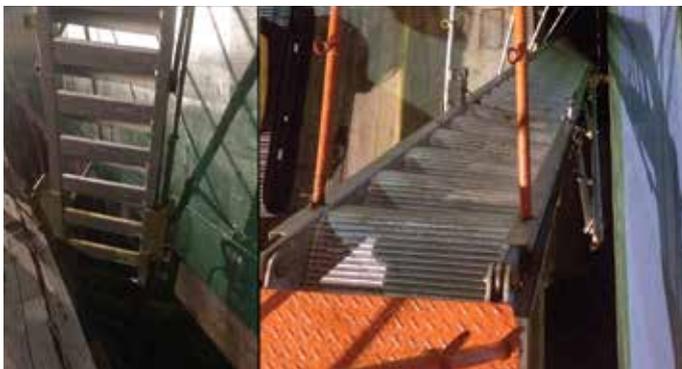
➔ The pure carrier was berthed starboard side to. A pilot boarded and was in the pre-departure briefing with the Master and bridge team when it was reported that the gangway had fallen. Although the wire had been replaced in the last six months, the gearbox had failed and the gangway had crashed to the berth below. Fortunately no one was on the gangway when it failed and the incident resulted only in equipment damage and a minor delay in departure.

- Never linger unnecessarily on a gangway.
- Although gangway wires are an obvious maintenance item, gangway gearboxes and motors should be inspected annually.

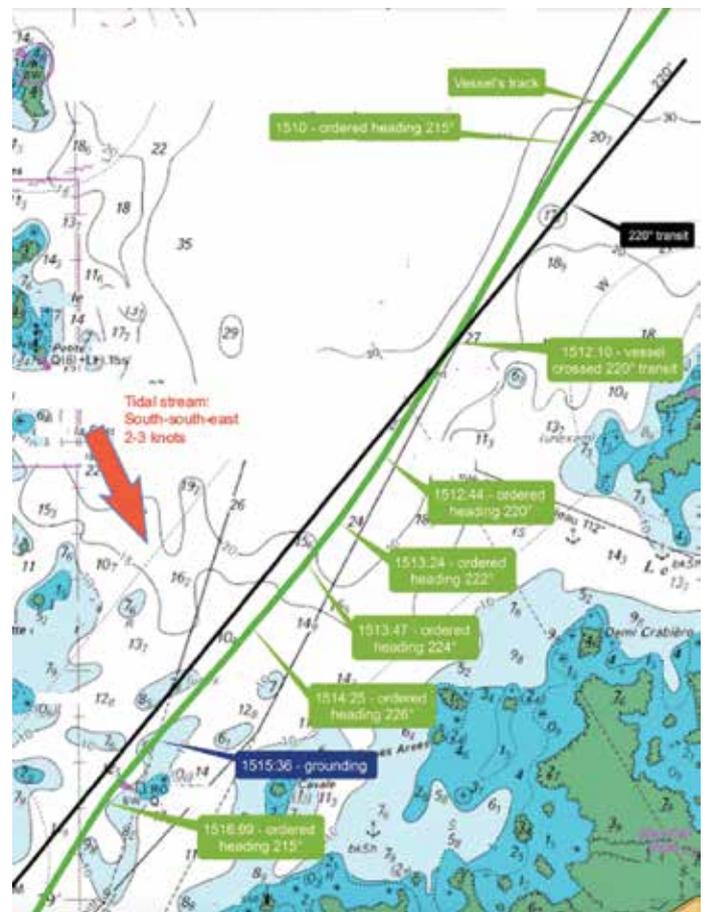
➔ A ro-ro ferry was inbound in a restricted waterway on a heading of 220° at full sea speed (18 knots OTG). The vessel was approximately one cable to starboard of the 220° transit line when the Master ordered an alteration to port to 215° in order to bring the vessel onto the 220° transit line (see figure).

Soon, the vessel crossed the transit and the Master ordered the helmsman to return to a heading of 220°. The vessel did not steady on this heading, as a further alteration to 222° was ordered. Two further alterations to starboard were made in quick succession; to 224° and then to 226°. As the Master ordered the successive alterations to starboard, the chief officer went to the centreline of the bridge to visually assess the vessel's position. While on the heading of 226°, a noisy shuddering vibration lasting about nine seconds was heard and felt throughout the vessel. The Master slowed the vessel but nothing unusual was seen astern nor were there any alarms. Steering and propulsion were also responding normally so the Master returned the vessel to full sea speed and continued the approach to the harbour.

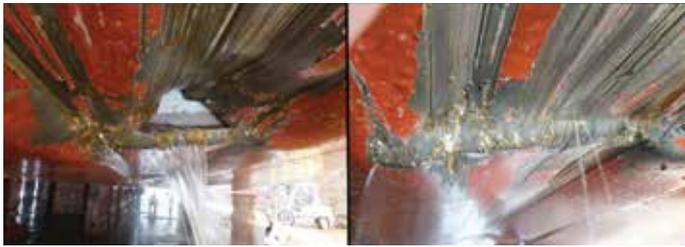
Once berthed in port, cargo discharge, reloading and a lifeboat drill went ahead as planned. A pre-planned divers' inspection of the hull also went ahead and divers soon discovered significant bottom damage; the vessel was thereafter withdrawn from service.

**Bottom damage**

- There had been insufficient passage planning for the voyage; in particular, for the transit through the restricted waterway of the port approaches. For example, the extremely low tide and effect of squat were not properly considered. This resulted in the bridge team being unaware of the limits of safe water available. Despite the bridge team's apparent good positional awareness, they headed into danger without appreciation of the risk.

- The highly repetitive nature of the ferry's schedule induced a degree of planning complacency.
- The ECDIS was not utilised effectively as a navigation aid. In particular, the safety contour value was inappropriate, the cross track error alarm was ignored, and the audible alarm was disabled.

- If you hear loud shuddering noises accompanied by vibrations throughout the ship, you should suspect you have touched bottom even if all else appears normal. Have all tanks sounded as a precaution.
- Beware of complacency – it can creep in when you are most sure of yourself.
- ECDIS is a wonderful tool if used effectively. In particular, learn how to appropriately set the safety contour and safety depth.

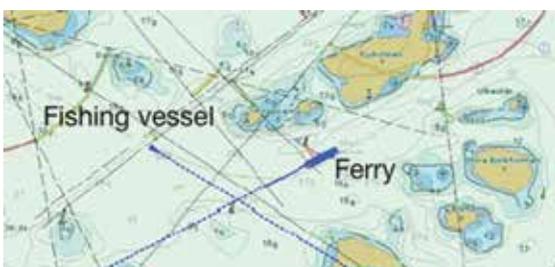
A few minutes before the close quarters situation

about 15 knots, an inbound fishing vessel was observed. The bridge team on the ferry deemed the fishing vessel to be on the wrong side of the fairway. Hence, the starboard turn was slowed and the ferry continued on the south side of the fairway to give some room for the fishing vessel; ostensibly dictating a green to green passing.

The fishing vessel's operator, who had heard the ferry's securité call, saw the ferry and instinctively turned to starboard, towards the south side of the fairway. The vessels were involved in a very close quarters situation but last minute manoeuvres avoided a collision.

- Inadequate positioning of both vessels.
- Lack of communication resulting in misunderstanding of intentions.

- If you intend a green to green encounter, best communicate with the other vessel to confirm their understanding of the situation.

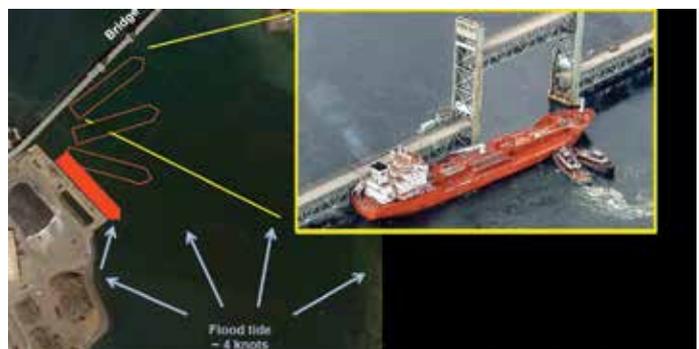
→ Readers may recall MARS 201564, where a vessel was secured in a river berth subject to strong tidal currents. Mooring lines failed and the vessel drifted and hit a nearby bridge. One of our readers and a member of The Nautical Institute, Mr Vilas Salukhe, wrote to express the following:

'The berth allotted for bunkering the vessel may not be suitable considering the length and draft of the vessel, particularly the angle at which the head lines were leading. Also, considering the strong river current, the location of the berth at less than 100 metres distance from the bridge would benefit from a risk evaluation review.'

- Review the suitability of the berth in view of its vicinity to the seemingly unprotected commuter bridge.
- Consider vessel's draft and length before allowing the berth for bunkering operations.
- Consider using vessel's anchor for berthing to provide additional holding power.

- Consider keeping engines on standby when faced with high river currents and tight berthing situations.
- Anticipate change in draft due to bunkering and suitably attend to mooring lines with sufficient manpower on deck.
- **Editor's comment:** We are always pleased to accept reader's thoughts and comments regarding reports published under the MARS banner. The more people are involved and thinking about risk reduction, the better.
