# The Nautical Institute Marine Accident Reporting Scheme

MARS Report No 186 April 2008

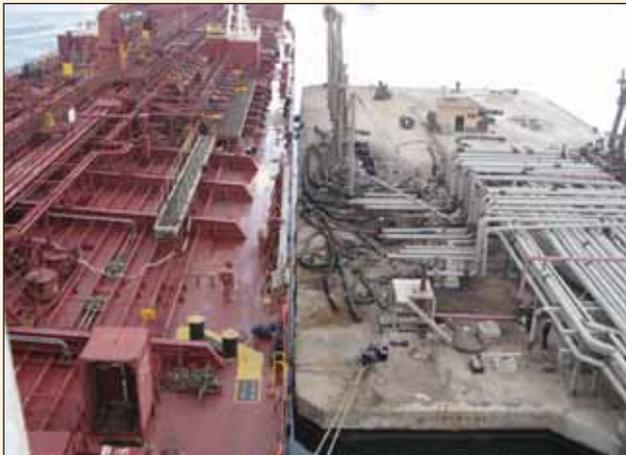
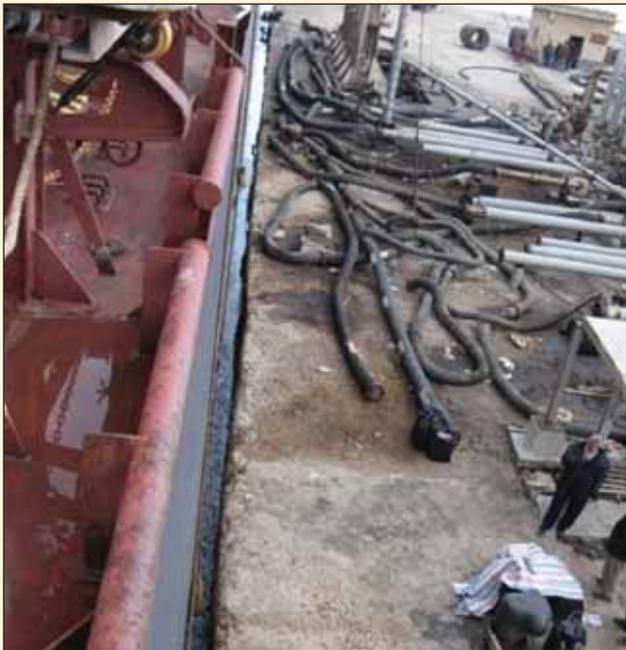
Our medium-sized tanker recently called at a well-known oil terminal, where we were to berth starboard side to a finger pier. Approaching the berth, I noticed that there appeared to be only three small fenders on the foremost part, and the remaining length of the concrete wall had no protection at all (see pictures). Moreover, the ship being longer than the pier, there would be a 30-40 m overhang forward, with no suitable bollards for the forward breastlines or headlines, which would, at best, lead astern. I considered it an unsafe berth and after verbally protesting to the pilot and the port authorities, I refused to berth there.

However, the local regulations required that the vessel be cleared inwards, for which my ship had to tie up temporarily at this berth. We put out the few small rope fenders that we had and went alongside – during our short stay, I managed to photograph the berth. After obtaining inward clearance, we unberthed and anchored in the waiting area. Both my owners and time-charterers fully supported my decision not to conduct operations at this unsafe berth.

If obliged to berth under such circumstances, masters, especially those on tankers, should take all seamanlike precautions and additionally preserve photographs and other evidence, note protest and inform owners, charterers and the local P&I correspondent.
