## Oily water separator – pipe removal

*Brazilian Port State Control Officers are becoming more vigilant*

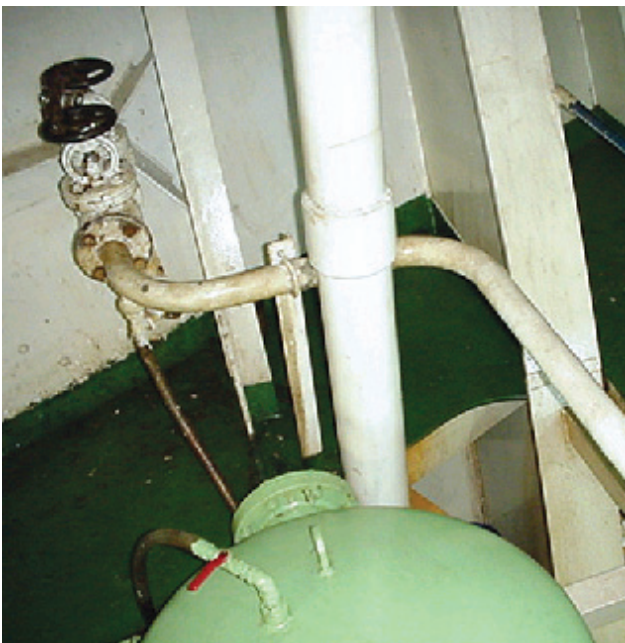
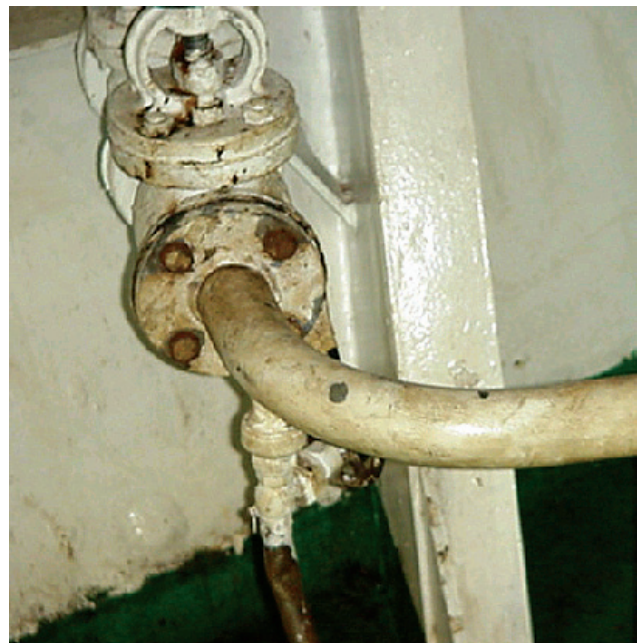
In a recent incident, the Port State Control Officers insisted that the pipe from the OWS to the overboard discharge valve was removed by ships staff for a closer inspection. Although nothing abnormal was found and the section of pipe was replaced, no written evidence was retained onboard clearly stating that the pipe had been removed under the instruction of the Port State Control.

In its present condition with indications of possible tampering, there is cause for concern that Port State Control Inspectors in other ports may wrongly assume that the ship has been pumping oil overboard and bypassing the OWS. It is suggested that if Port State Control insist on the removal of any section of pipe that is connected to the OWS or overboard valve then an official entry is made in the log book and preferably a comment made on the PSC inspection form by the attending Port State Control inspector. Photographic evidence with the attending Port State Control Inspector clearly in the picture will also help to defend the ship against any false accusations.
