# LP BULLETIN

## Bulletin 602 - 9/08 - Shipping nickel ore - Indonesia

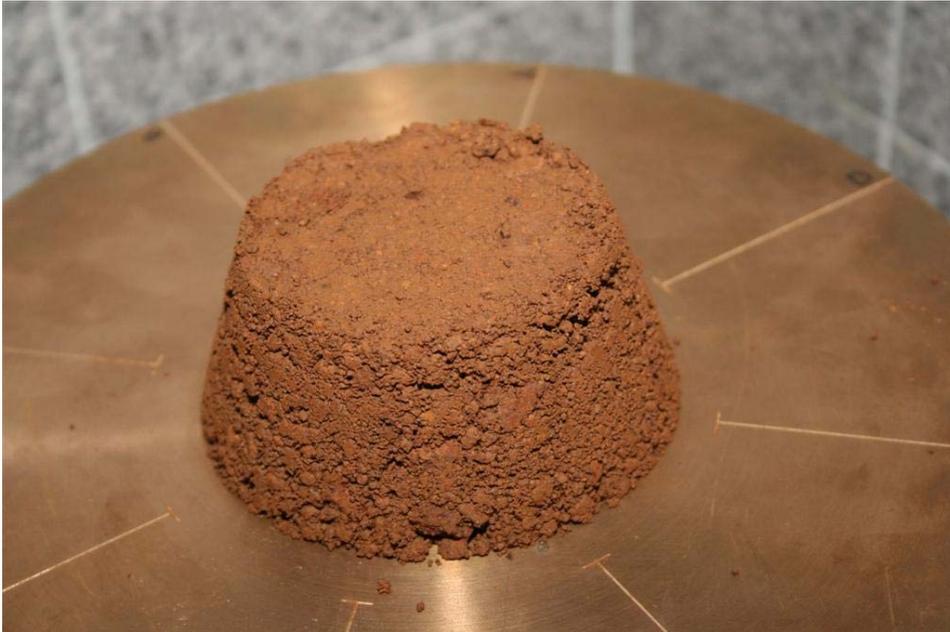
Appendix 2 of the BC Code states that when the FMP is passed “the moulded sides of the sample may deform”. Image 1 illustrates the shape of a sample cone for a sample below FMP, while image 2 shows the shape of a sample cone after recent testing at a mine in Halmahera. Despite the cone being deformed, with a recorded cone expansion >6mm, it was regarded as being below FMP. The sample was not failed until the cone had expanded by a massive 20mm, as shown in image 3, with a declared FMP of 33.8%. Previous criterion would have given a FMP <31%. The mine were unable to justify their change of methodology, which ignored all the key indicators of a flow state (see page 252 of BC Code – 2004 Ed.), and enabled them to ship wetter cargo at a greater risk to the carrier.

Image 1 - Typical shape of sample cone prior to testing

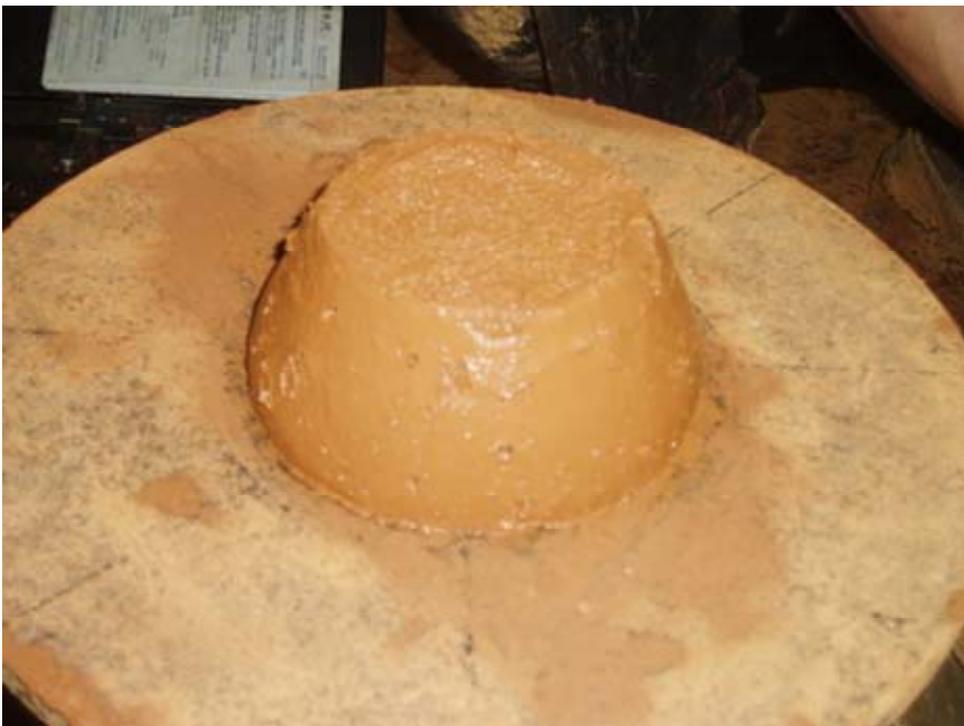
Image 2 - Change in shape of sample cone after testing, corresponding to a 6.5mm cone expansion

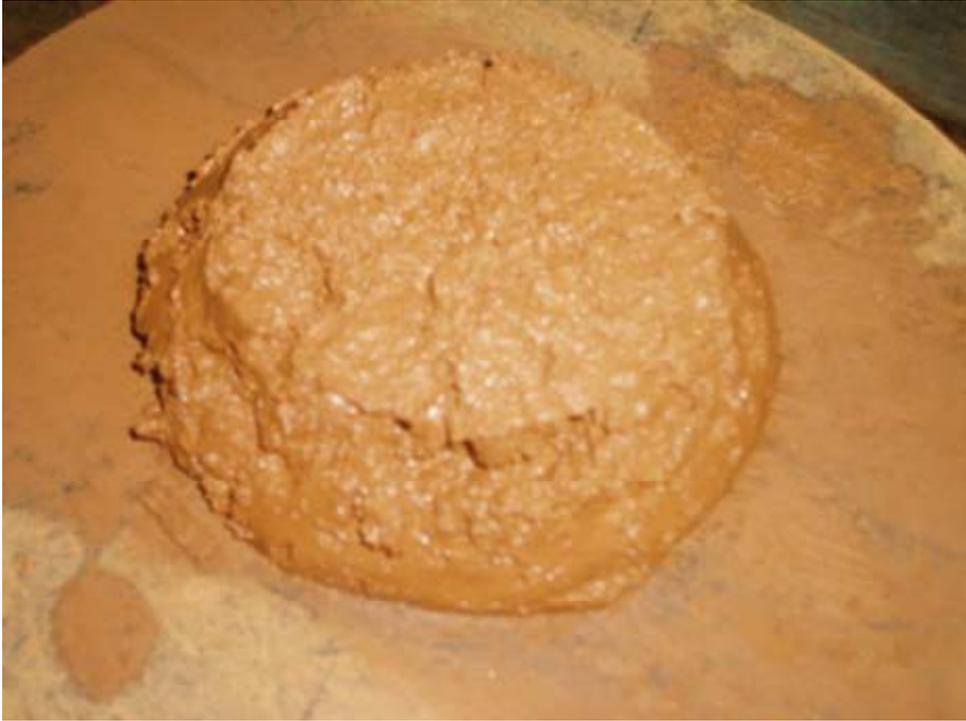
Image 3 - Sample cone after testing with 20mm expansion at base

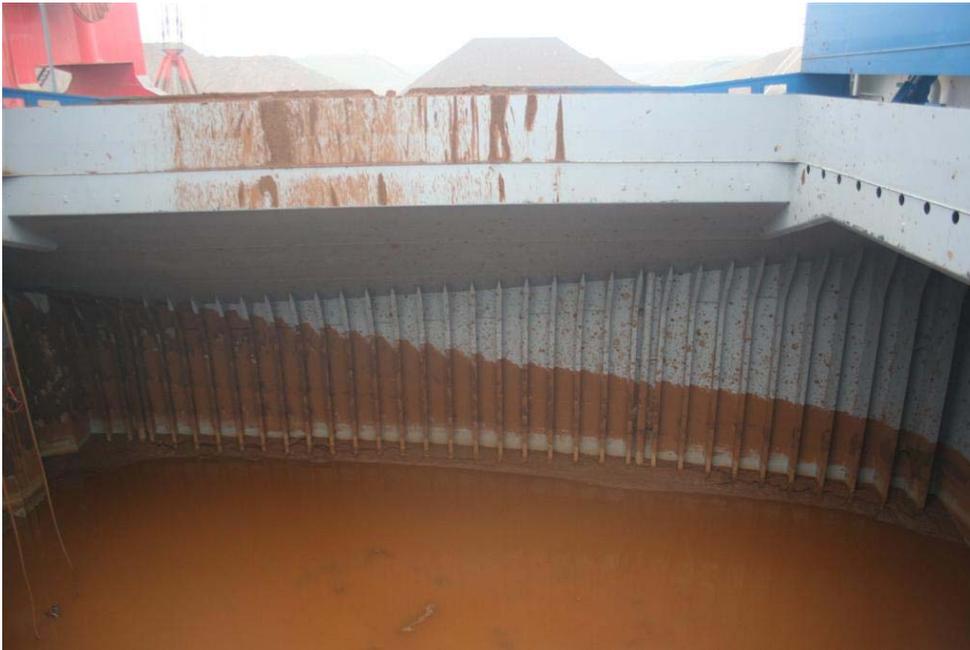
Lateritic nickel ore is known to liquefy. In 1988 the Mega Taurus was carrying ore from the Philippines when it capsized with the loss of all 20 crewmen. In 1988 the Sea Prospect was shipping ore from Indonesia when it capsized with the loss of 10 lives. Other vessels have been more fortunate. In 1990 the Oriental Angel developed a list after loading cargo in New Caledonia; this being repeated in 1999 with the Padang Hawk. The same fate befell the Jag Rahul in 2005 when carrying ore from Indonesia. In December 2007 we attended a vessel after its Philippine cargo had liquefied (see images 4 and 5).

Image 4 - Liquefied lateritic nickel ore

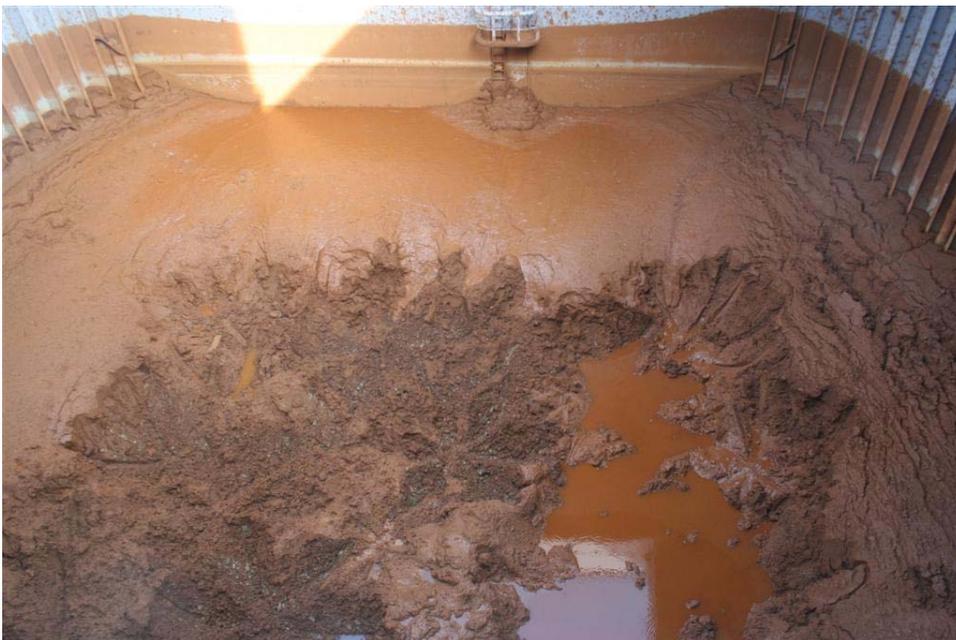
Image 5 - Liquefied lateritic nickel ore
