# LP Bulletin

Friday 3 April 2009

## Bulletin 631 - 4/09 - Direct Reduced Iron (A) (Hot Moulded Briquettes) - Novorossiysk - Russia

### **DIRECT REDUCED IRON (A)** – Hot moulded briquettes

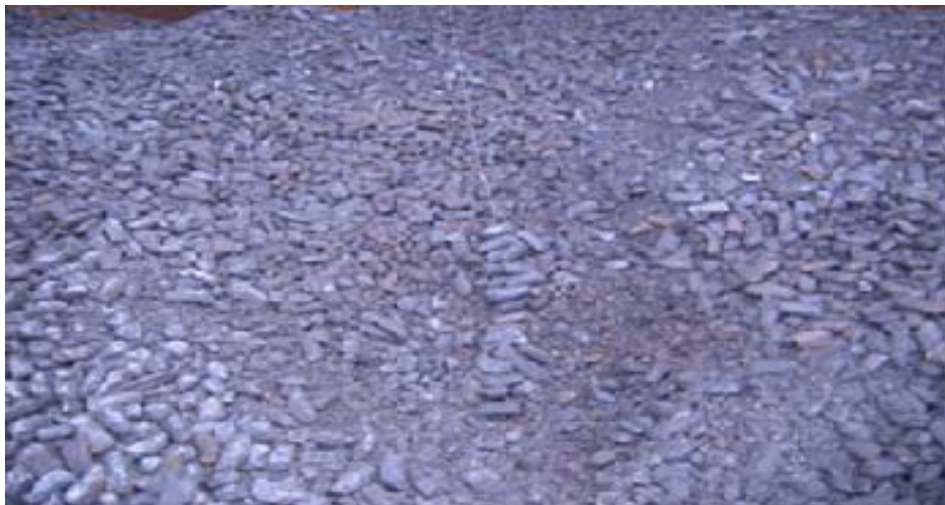
The attached photograph shows the degree of breakage of the briquettes in this case and in particular the vast quantity of fines present. The fines offer an increased surface area exposed to oxidation and reaction with any water or moisture present in the hold atmosphere. In a marine environment any water or moisture would have a salt content which would accelerate the rate of oxidation and hydrogen evolved.

**At discharge it was estimated that the undamaged portion of the cargo was 25%.** Thus 75% of the cargo consisted of broken briquettes and fines creating a vast increase of fresh surfaces exposed to oxidation and reaction with water present in the cargo. There had been water present because bilge records indicated that 178.873 metric tonnes had been pumped overboard. Furthermore because of the practice of almost continuous ventilation of the holds to free the generated hydrogen, moist sea air would have been taken into the holds and would have condensed to run over the cargo and accelerate the oxidation of the HBI and liberate hydrogen.

Prior to this incident we have no record of a DRI (A) cargo heating to a dangerous level or reacting to produce dangerous levels of hydrogen. It would appear that the presence of a high level of fines and broken briquettes and reaction with the water in this cargo resulted in the heating observed and the release of hydrogen.

**Masters should be extremely vigilant when loading this type of cargo and if in doubt as to the extent of breakages, possibly from loading remnants etc, the Club's correspondent should be contacted immediately.**
