The Nautical Institute Marine Accident Reporting Scheme

MARS Report No 190 August 2008

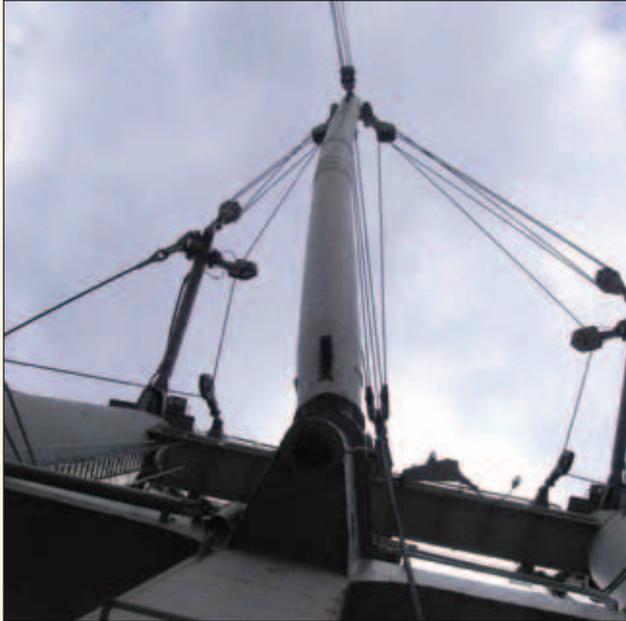
Bent derrick boom

▲ This photograph shows a bent derrick boom. Seafarers must carefully check their ship's gear for such defects. This defect is usually caused by over-stressing the system. Following regulations, such a derrick must be unshipped, permanently repaired under class supervision, re-mounted, proof-tested and certified before being taken back into use.

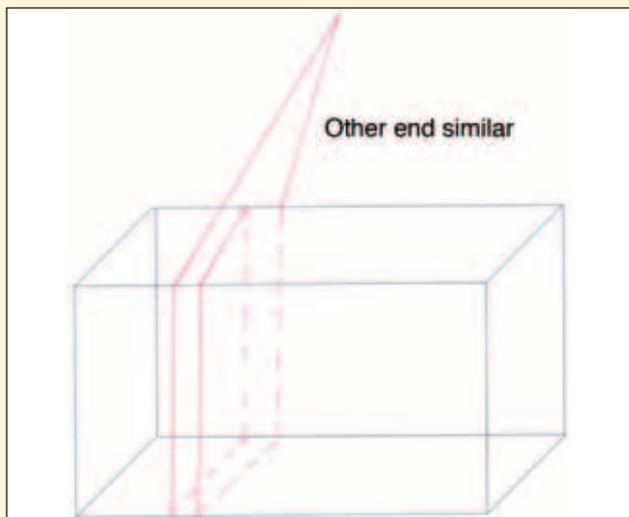
- The value of the goods contained within the crate can easily be established, but the centre of gravity of the contents is (or was) a mystery. Based on the foregoing statement, the suggested method of proper slinging was incorrect as shown in the diagram.
- The only positive method of restraining any movement would be to sling it as shown in the diagram below. This method is an age-old traditional method known as a 'body and soul' slinging arrangement.

■ **Editor's note:** While this arrangement is definitely superior, in the original report, it was mentioned that the case was unusually tall, which would probably mean that each of the pair of slings required would measure upwards of, say, 15 metres in length. Ideally, an efficient slinging arrangement for awkward packages should be provided by the packer. From the report, it appears either that the slings used were not long enough for this method or that the ship could not produce or improvise a pair of slings of suitable length.
