MARS 200875

Fatalities in cargo hold fire

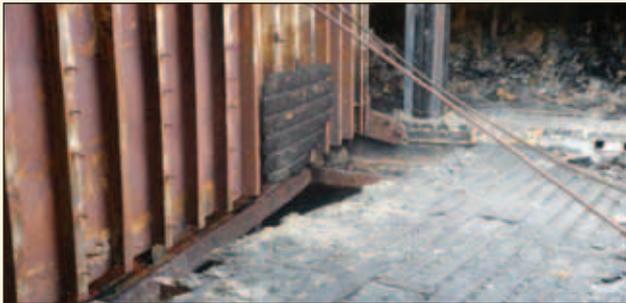
▲ View of fire-damaged tanktop sheathing, spar ceiling and burnt remains of insulation foam

On a general cargo vessel undergoing repairs at a yard, a shore worker was gas-cutting the deck plating of the upper tween deck. The hold had only one means of access available, consisting of a common access trunk with fixed vertical ladder sections. Eight other labourers were engaged in different tasks in the lower hold. Apart from remnants of wooden sheathing on the tanktop and spar ceiling against the side shell, there was an accumulation of flammable debris, consisting mainly of discarded insulation foam both in the tween decks and at the bottom of the hold.

It is thought that falling sparks and carelessly disposed cigarette butts started a fire in the mid-tween deck and was unnoticed by the workers for a considerable time. Fresh air was passing freely through the openings on the upper tween deck and smoke and hot gases began rising via the access trunk.

By the time the workers detected the fire in the lower hold, it was well established in the mid-tween deck and the flames had spread to the access trunk. The gas cutter operator at the top finally became aware of the fire and ran away to raise the alarm.

1. The hot work operation was commenced without any risk assessment or issue of hot work permit;
2. Poor housekeeping resulting in accumulation of flammable debris;
3. Many of the shore labourers were habitual smokers and prone to dispose of cigarette butts carelessly at the work site;
4. The cargo hold had only one escape route;
5. There was no effective deck patrol or fire watch;
6. The yard had no proper system in place for accounting for their personnel.

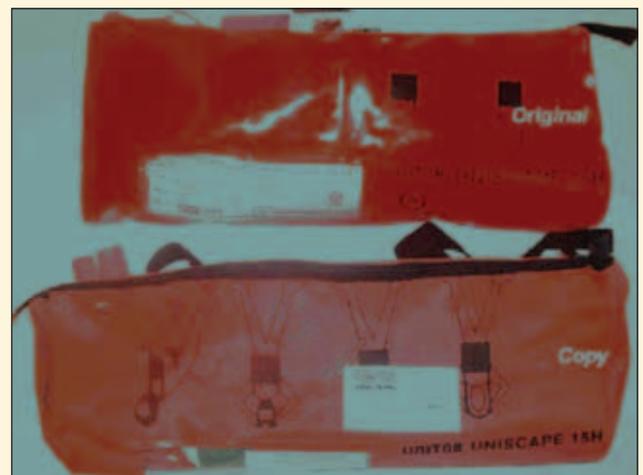
The number of fake units sold and currently onboard vessels is unknown and could be substantial. The fake reproduction will not fit over an individual's head and the

▲ The authentic EEBD, top, and the fake, bottom

automatic air release valve will not open. A crisis requiring the use of an EEBD will be severely compounded, potentially leading to death, should a crewmember inadvertently rely on a fake reproduction.

- An authentic Unitor Uniscape 15H is contained in a shiny PVC bag. When viewed from the front with the instruction icons upside down, the zipper opens from left to right, and at the left most section of the zipper is a two centimetre gap covered by a clear tab that has a button closure.
- The fake reproduction is contained within a dull, canvas-like material bag. When viewed from the front with the instruction icons upside down, the zipper opens from right to left, and at the left most section of the zipper there is no opening, although a tab, made of what appears to be the same material as the bag, is present, with a button closure. This unit will not automatically activate.

The US Coast Guard (USCG) has recently learned that counterfeit Unitor model Uniscape 15H EEBD emergency escape breathing devices (EEBDs) are being sold to ship operators and placed on board commercial vessels. The USCG strongly encourages that all vessel owners and operators with EEBDs onboard carefully and thoroughly inspect them for authenticity. If any doubt exists as to the authenticity, they should immediately contact their emergency equipment vendors and/or the manufacturer for verification or replacement.

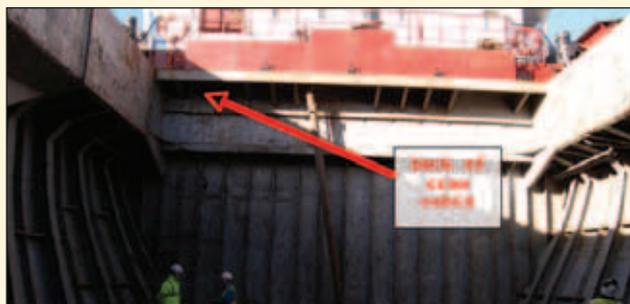
When the vessel arrived in port, tests revealed very high concentrations of phosphine gas in the able seaman's cabin and in the adjacent compartment. Both these spaces were sited over the aft bulkhead of the ship's cargo hold, with their decks extending over the cargo space by 0.5m (see photographs).

▲ 1: The ship's cargo hold

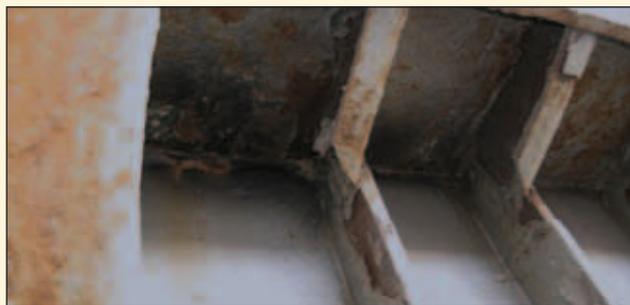
Despite extensive testing, no obvious pathway was found for the fumigant to enter the cabin from the hold. It was only after the under deck area in the cargo hold had been thoroughly de-sealed that pin holes into the cabin were discovered.

▲ 2: Corrosion of deck plating allowed phosphine gas to leak into crew cabin

- The vessel can safely load the planned cargo. Special care should be taken to ensure fumigant gasses cannot enter the vessel's accommodation and extreme caution should be taken before accepting cargoes requiring fumigation at sea when the accommodation spaces extend over the cargo spaces.

- A regime of sampling is established at the earliest opportunity, and thereafter throughout the voyage, to detect the presence of fumigant in accommodation spaces and working areas. Sample periodicity should, as a minimum, be in accordance with the IMO Recommendations, or more frequent if so advised by the suppliers of the fumigant.
