MARS 200901

Fire in palm seed cake cargo

Official report: Adapted from Australian Transport Safety Bureau (ATSB) Transport safety investigation report - Marine occurrence investigation no. 250

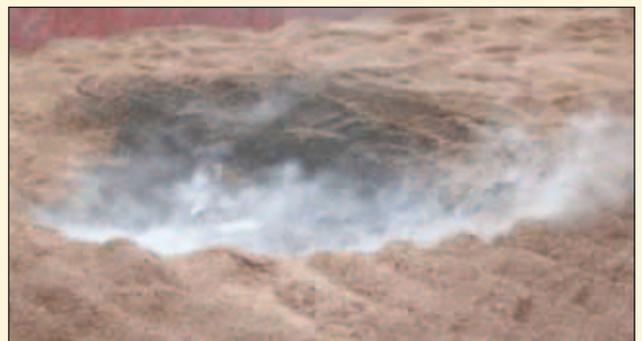
Both fire-affected areas had burned in a circular pattern that was centred on the location of a fumigation sock. However, the fires had not grown in size over the ensuing days because, as they developed, they had consumed the available oxygen in the vicinity. It is likely that the amount of oxygen in the cargo hold atmosphere quickly fell to a level that would not support flame (below 15 per cent). The fires then slowly smouldered until the cargo hold hatch covers were opened, when they were extinguished with water.

▲ Circular pattern of burned cargo

When the fumigation socks were removed from the cargo, many of them were observed to have become charred.

Pure phosphine gas has an auto-ignition temperature greater than 100°C. However, diphosphine gas has an auto-ignition temperature of about 90 to 100°C. As a result, it is likely that the local temperature rose to a level above the auto-ignition temperature of the diphosphine gas and that the gas subsequently ignited.

1. Shipowners, operators, masters and fumigation contractors should consider the safety implications of using aluminium phosphide;
2. The vessel must be given sufficient information to enable the ship's crew to effectively supervise the application of the aluminium phosphide fumigant.

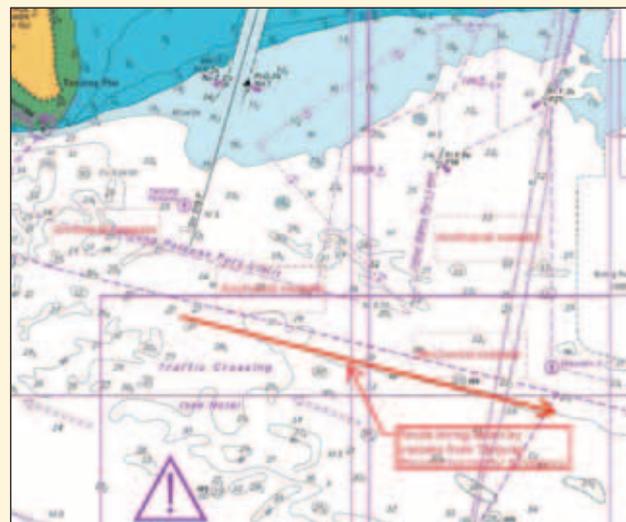
Many vessels occupy the Tanjung Pelepas general anchorage and the inshore zone to the south of this, as well as the anchorage area to the south and east of Johor Bahru port limits. The area of anchored vessels actually extends into the westbound traffic lane. Accordingly, vessels that transit eastbound between Tanjung Pelepas and Singapore WBGA routinely call the vessel traffic information system (VTIS) and request to proceed the wrong way eastbound against the traffic flow in the westbound lane. This situation inevitably leads to head on encounters with westbound traffic and alterations of course by each vessel to port, so that eastbound vessels occupy the northern limits of the lane and westbound vessels move towards the centre of the lane. My point is that, in following this seemingly routine procedure, if a vessel should be involved in any incident, the legal repercussions would be particularly great for the eastbound vessel. Note that vessels undertaking this procedure are without pilots onboard.

▲ Singapore traffic zones

It would be prudent for masters of eastbound vessels between Tanjung Pelepas and Singapore to plan the passage only after carefully scanning the main strait by ECDIS/radar. Should the inshore traffic zone appear congested, then instead of risking a hazardous direct passage of some six miles to WBGA, it would be safer to follow the TSS by crossing the west bound lane, entering the east bound lane, going south of 'Delta' buoy and Takong Kecil beacon and exiting at Raffles light house in order to rejoin the west bound lane – in all some 37 miles of steaming.

Editor's note: The convenience of a direct course and a shorter transit time must not justify the selection of a route that plainly contravenes the Colregs. If the volume of eastbound traffic between TPP and Singapore justifies it, shipping lines and agents may take up the issue with the authorities of both the ports to ensure that anchorage area limits are clearly marked and complied with and that a clear corridor is available for safe eastbound transits through the inshore zone.

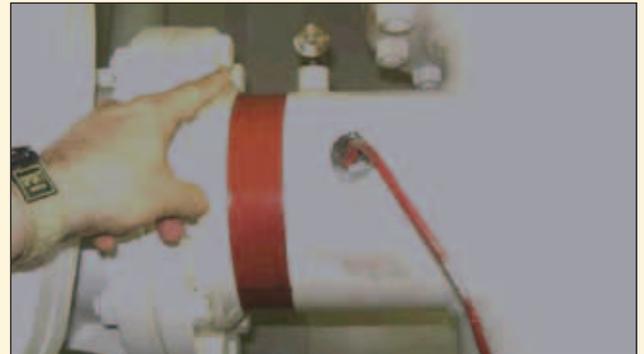
During the ship's construction, the COW system's cargo oil heater outlet pipe was provided with a connection to accept a temperature probe. Due to a mismatch between the threads of the connection and the probe, an additional connection with the correct thread to which the temperature probe was fitted was made by the yard. The original redundant fitting was however left in place, but was not shown in the COW system drawings and data. Its isolating cock, which did not have any position indicator, inadvertently remained in the open position. The investigation also revealed that the planning process did not include a proper assessment of the risks and no risk assessment was documented.

Lack of planning was determined to be the root cause of this incident in that there was a lack of appreciation that the ship sailed from the shipyard with an unknown flaw in the cargo piping system that could potentially compromise environmental safety.

▲ Close-up view showing redundant probe connector with isolating cock and second probe connector in use.

1. Close inspection of the vessel's cargo transfer system, including the crude oil washing line, must be carried out by ship's staff following delivery by the shipyard and valve orientation observed.
2. Where possible, all cargo pipelines should be pressure tested with water prior to first load port to establish that pipeline integrity is as expected and leak free.

1. Fleet and ship management team should clearly establish priority tasks in preparing the ship for first loading and discharging to minimise the risk of pollution.
2. Company procedures are to be improved to ensure appropriate planning and risk management processes are completed. A checklist of critical pre- and post-delivery tasks to be completed will be made available within the management system.
