The Nautical Institute Marine Accident Reporting Scheme

MARS Report No 196 February 2009

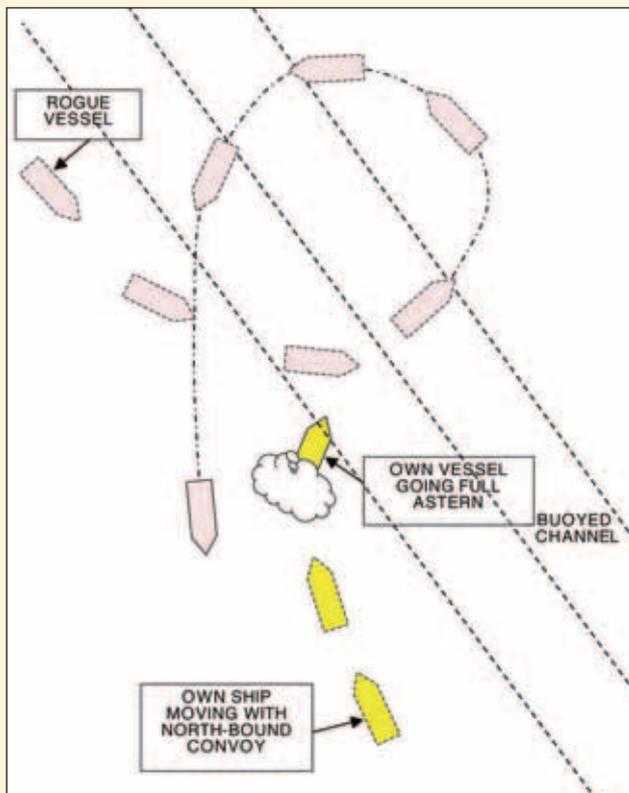
Among the many anchored ships, a southbound vessel was observed, two miles ahead, fine on the port bow and making an almost reciprocal course. As this vessel approached, she appeared to make small adjustments of course to port until she was showing a fine green aspect and was plotted to cross own ship's bow at a narrow angle and too close for comfort. Upon consultation with own ship's canal pilot, he confirmed that he had agreed with his colleague on the other vessel to pass port to port – which was the logical action. We continued to monitor the slow approach, waiting for the expected alteration to starboard of the other vessel, which never came. Own ship's course was altered to starboard as far as possible, being constrained at this time by one of the West Branch channel beacons close in on the starboard bow, and two or three small fishing dhows near the channel.

by own vessel to alert the approaching ship of the perceived danger. Shortly thereafter, at what was deemed to be the cut-off point for effective action, she suddenly altered sharply to port, to cross own ship's bow, and increased engine speed, as indicated by a surge of her propeller wake. Own ship's engine was put to full astern, while the crossing vessel continued her swing to port across our bows, causing her stern to shear even closer towards our bow. The general alarm was sounded.

Collision was avoided by perhaps 15 metres, as reported by own ship's bow lookout. The crossing vessel continued her swing after clearing, finally turning a full 360 degrees counter-clockwise, crossing the West Branch channel twice in the process, before straightening out and finally passing down the side of our own vessel port to port as originally expected.

There was no conceivable explanation for the decision aboard the southbound vessel to alter course to port, which was in contravention of the Colregs and defied the logic of the situation presented.

I would warn masters under pilotage in the Suez Canal to brief their bridge teams very carefully to monitor the actions of the pilots closely. While you are not going to meet counterflow traffic in the Canal proper, situations such as the one described can occur in the lakes, and in the approach channels, so be on the alert.

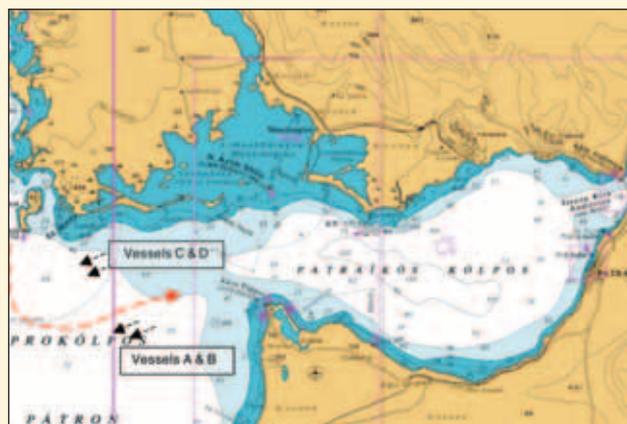
The first happened when my own vessel was rounding Oxia Island from the north and heading into the Gulf. There were two vessels on my port side exiting the gulf which would pass safely ahead of me (A and B on chart below). As I cleared the island a little more, I picked up two more targets on my port side (C and D), also exiting the Gulf. I began to monitor both vessels closely by radar/Arpa as well as visually. I determined that I should hold my course until well clear of the point and then make my turn to port, to enter the Gulf, allowing the second two vessels to pass safely astern of me before my turn (intended track shown in red below). As the targets would pass at less than a mile, my Arpa alarms sounded as usual (which in itself is an unnecessary and unwelcome distraction at potentially critical moments like this). At the same time, when I most needed to concentrate on monitoring the targets as well as my course etc, the VTS called me up to inform me at great length (including names, types of vessels, ranges, speeds and exact positions) that I had two targets to my port side which I should pass red to red. One of the vessels was a tug with towing lights and the only potentially useful information, which would have been about the tow, was not given until I asked.

The second incident which occurred soon afterwards, took place while approaching the Rion-Andirion bridge. My own vessel had been gradually overtaking a small cargo ship (E) during the previous watch and my own watch. At 12 miles from the bridge, the other vessel was abeam and slightly astern of my own vessel. I reported to the bridge VTS as required and continued. At the five-miles reporting station we were fairly well clear of her and the final turn before the bridge would have put us well ahead of her. At two miles, the other vessel called VTS and asked whether she was to follow us under the bridge. VTS told her to wait and then called us, instructing me to reduce speed to 10 knots and follow the other vessel under the bridge (plus long instructions about how to pass under the bridge, where the centre of the bridge is, how many spans on either side etc). I informed VTS that

the other vessel was actually behind us but after two more sets of barely intelligible instructions, it was finally confirmed that the other vessel should be allowed to pass ahead. I reduced speed accordingly and held my course to allow the other vessel to pass. This meant that she came to within just over two cables as she overtook us. The other captain seemed very unsure of which was the overtaking vessel in this very strange situation. I told him that I believed that he was well aware of the VTS instructions I was following and that I believed that he was now the overtaking vessel. In any case, this potentially dangerous situation would never have arisen in the first place if VTS were not micromanaging the passage of traffic under the bridge.

I believe that this style of vessel traffic service is potentially very dangerous and most certainly of no service whatsoever to vessels or traffic. If there is so much concern, surely the safest thing would be to have a TSS put into place through the Gulf, plus some clearly defined east/west channels to be laid out beneath the bridge with small craft channels under each of the outer spans. As it is, the bridge is lit up like a Christmas tree with green and red lights flashing just about everywhere. While competent VTS has its place, it is extremely dangerous to believe that it can replace the vessel's own bridge team.
