MARS 200912 Colregs violation

MARS 200913 Port state control detention

MARS 200914

MARS 200916

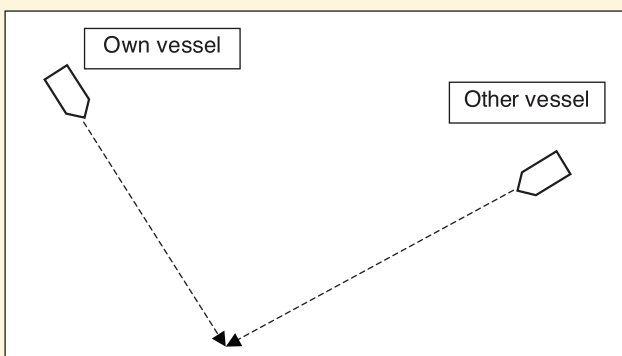
Our vessel, a VLGC in loaded condition, was on a course of 146° (T) at 18 knots in clear weather. We observed a container feeder vessel about five points on port bow at a range of nine nautical miles on a course of 255° (T), speed 12.5 kts, with a CPA of 0.0 nm. At a range of six nautical miles, we established radio contact with the said vessel and requested her to alter course to starboard and pass astern of us. The container vessel did not comply, seeming to convey that it was our obligation to alter course to port. Even after careful explanation and quoting the appropriate Colregs rule, the OOW on the container vessel, seemed to be taking no action. At this time, the vessel was three nautical miles away.

▲ Figure 1: Developing collision situation, other vessel clearly being the give-way vessel

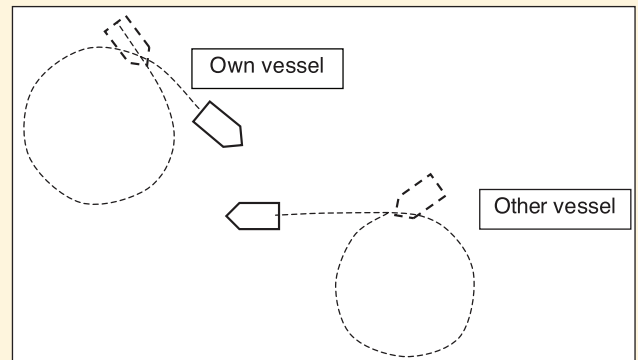
Own vessel began altering course to starboard with the intention of turning 360° and passing around the stern of the container vessel. While our vessel was engaged in this manoeuvre, and still turning to starboard, we noticed that the container ship had suddenly and inexplicably started altering her course to port. We re-established VHF contact with the vessel but could not understand the muttered response. Soon, both vessels began to converge once again, negating own ship's avoiding action. However, due to our reduced speed, now 11 kts, we now had the container vessel four points on our starboard bow at a range of 2.2 nm, on a course of 270° (T) and we managed to pass around her stern with a CPA of 0.5 nautical miles. She was clear, resumed our course, now about 1 nm off our original track.

The full incident lasted about 30 minutes. The OOW on the other ship could not communicate properly in English but it was clear to us that he genuinely did not know the Colregs and was not even aware that he was the give-way vessel. The sudden alteration of course to port by the vessel apparently re-created a new collision situation, but because of the relative changes in positions and speeds, the other vessel was able to cross ahead by a safe margin.

▲ Figure 2: Situation after other vessel's inappropriate alteration to port, safely resolved by own vessel letting other vessel cross ahead.

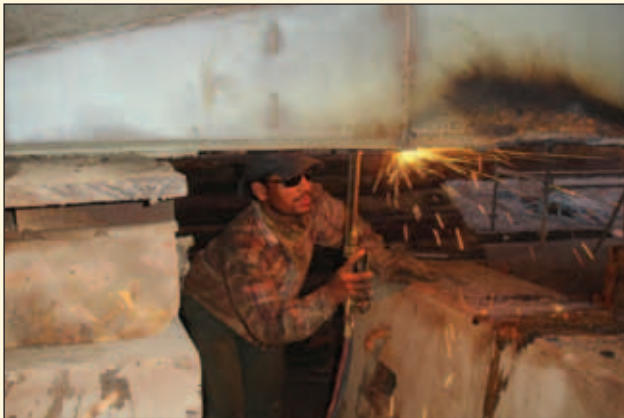
Unsafe gas cutting

▲ Figure 3: Drydock employee wearing inadequate personal protective equipment (PPE) – right hand glove and helmet missing, eye protection does not appear to be of approved type.

Another unsafe situation: gas hoses lying directly under falling sparks.

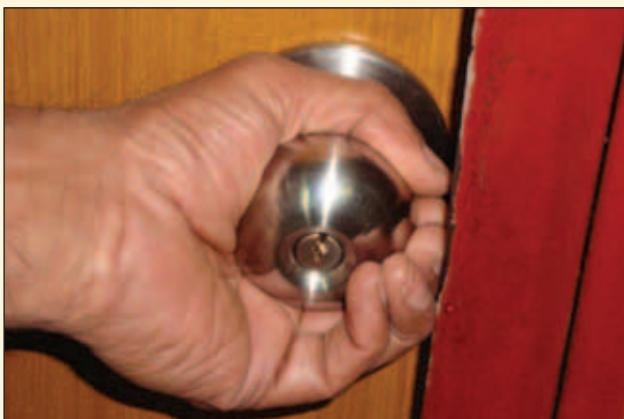
Unsafe door fitting

▲ Figure 4: Doorknob fitted too close to doorway frame, risking crush injuries to fingers. Lever-activated door latches will keep fingers away from the door edge.

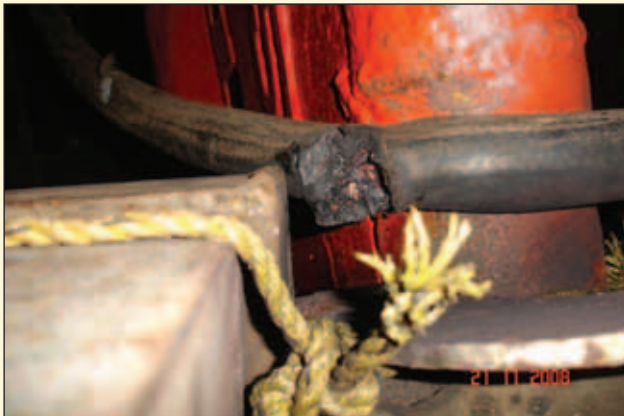
A vessel at a repair berth was on shore power. The heavy electrical cable was led parallel to the shore gangway that was hooked on to the ship's side bulwark on the main deck. During the night, due to the ship's small surges alongside and tidal movements, the power cable slid into a small gap between the ladder and the ship's gunwale. At a certain stage of the rising tide, the cable got severely pinched under the now steep ladder with sufficient force to cause the breakdown of the internal insulation, causing a fiery short-circuit. Fortunately, the breakers on the shore distribution box tripped automatically and there was no fire or injury.

▲ Figure 5: View of the damaged power cable soon after the incident.

1. Power cables must be carefully routed, away from accesses and other obstructions, and secured against movement.
2. The gangway watch of a ship under repair must include continuous monitoring of power cables, besides moorings and shore fire mains, as applicable.

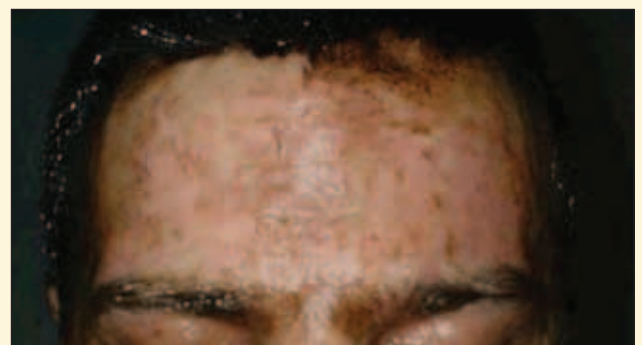
A ship's engineer received first-degree burns to his face when hot fuel oil escaped from the fuel oil purifier as he slackened back the filter casing in order to clean the cartridge. Fortunately, the vessel was near the coast and medical evacuation was effected promptly, and he was repatriated home after a brief hospitalisation.

1. Before opening the casing, the pressure gauges seemed to indicate that the internal pressure had been relieved. However, it is considered that the pressure gauges were not capable of indicating that all residual pressure had been released and the casing was fully drained.

▲ Figure 6: Scald injuries on engineer's face.

1. Ensure all work, even that considered routine, is planned with care and the hazards identified. Clearly some complacency existed in this case.
2. Compliance with written procedures to consider the potential hazards and prevent injury to personnel is not a personal choice, but compulsory.

3. Foster greater awareness of the hazards associated with the opening of any equipment likely to be under pressure with hot liquids or vapours.
4. In general, pressure gauges are not suitable for confirming the absence of residual pressure.
5. Good engineering practice includes the prevention of injury.

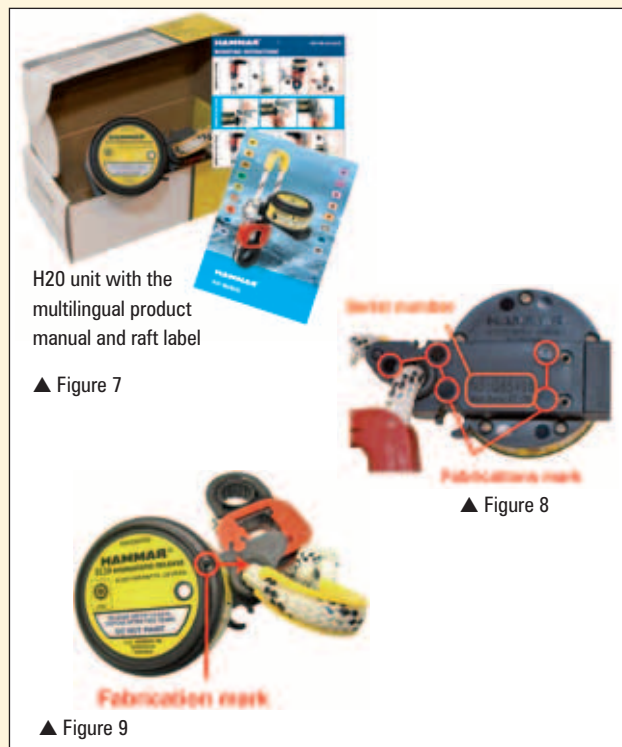
It has recently come to our attention that someone is producing fake copies of our hydrostatic release unit, the Hammar H20. To an untrained eye, the copy is almost identical to the original product, with Hammar's logo and address on the labels. The fake might look almost like the original product, but there is one very important difference: the copy does not work!

3. If you check on the underside of the Hammar H20 you should be able to find five fabrication marks on all units produced since April 2006. Units produced before that date have only two fabrication marks. (Figure 8)
4. The serial number and production date can always be verified by contacting CM Hammar at info@cmhammar.com
5. The fabrication mark on the upper side of the unit must always point directly towards the rope. (Figure 9)

1. Always purchase your products through approved distributors or authorised service points for liferafts and Epirbs.
2. Make sure that you receive the Hammar multilingual

product manual and a raft label with each unit for liferaft H20 or Hammar marking instruction for Epirb H20 (Figure 7).
