# The Nautical Institute Marine Accident Reporting Scheme

MARS Report No 199 May 2009

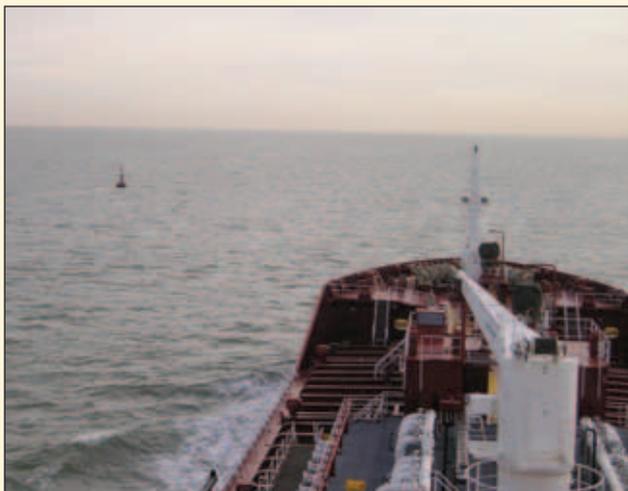
▲ 1. View from bridge showing Sea Reach no. 2 buoy on the port bow

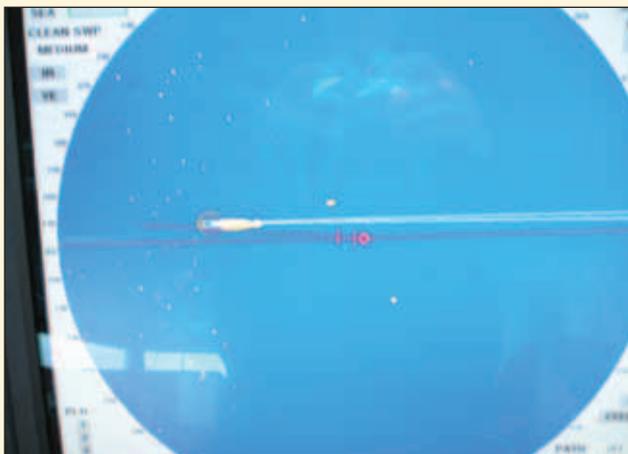
▲ 2. Radar picture showing correct positional information

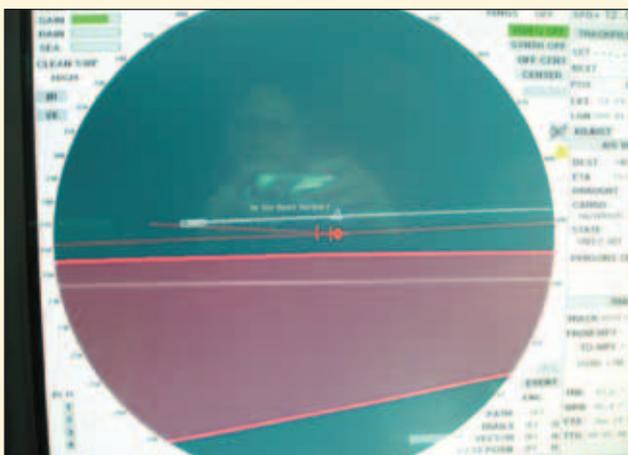
With good visibility, I navigated the ship mainly by eye but when I looked at the ECDIS unit, I was concerned to note that the position being displayed was well over 100 m out, showing the vessel proceeding down the wrong side of the channel (see photographs). The Captain checked the back-up ECDIS unit and discovered that it, too, was displaying the same error. After about 30 minutes the position error suddenly disappeared and the chart subsequently displayed the correct position; however it is of concern that no alarms had indicated any GPS input problems during the period of the position error.

▲ 3. Ecdis wrongly showing vessel's position out of the channel with buoy bearing right ahead

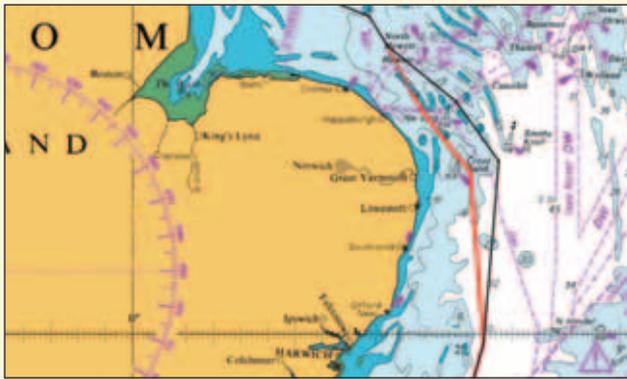
The ship grounded 29 minutes after the OOW had adjusted course to follow an amended passage plan shown on the vessel's Ecdis. The route was hastily revised to ensure arrival at high water. This route took the vessel across Haisborough Sand, where the charted depth of water was considerably less than the vessel's draught.

▲ Original planned route shown in black, revised route shown in red

1. The planned route took the vessel with a draught of 5.9 m across Haisborough Sand where the charted depth was less than 2 m.
2. The ship's navigating officers were not properly trained in the use of Ecdis.
3. The incident was not reported to the vessel's DPA for 23 hours.
4. The chart support certificate had expired.

1. A review of the content of the IMO model course syllabus for ECDIS.
2. As there can be significant differences between ECDIS models in terms of menus, terminology and equipment interface, shipowners must ensure that all bridge watchkeeping officers are familiar with navigation systems in use and they should use both generic and model specific training to meet this obligation.
3. Ships' crews are reminded of the need to ensure that all recorded information including VDR and ECDIS and other electronic data is preserved following an accident or incident.
