### MARS 200935

#### Eye injury due to burst hose

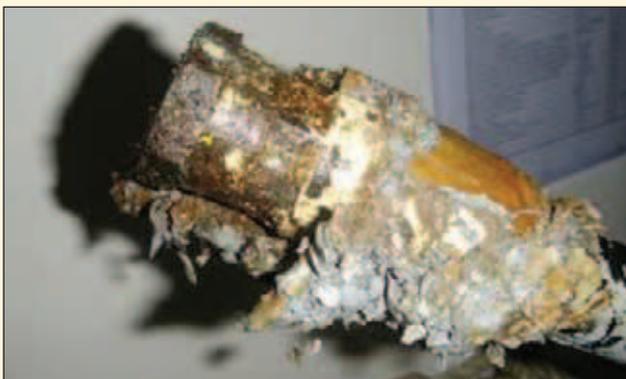
Shortly after our tanker arrived at the designated berth, the bosun was operating the hose-handling crane to position the vessel's gangway to provide safe access to the ship. During this operation, a flexible hose on the crane came adrift from its coupling and hydraulic oil under high pressure sprayed out, some of it entering the bosun's eyes. About 200 litres of spilled hydraulic oil had to be collected from the deck and disposed of appropriately.

1. Inappropriate use of anticorrosive tape, which deteriorated with time and aided the development of undetected corrosion;
2. Routine inspections were carried out without sufficient attention to detail and failed to detect the deteriorated condition of the hose and connector;
3. The quantity of oil spilled on deck was abnormally large, as the crane was not fitted with an emergency stop for the hydraulic power pack. This could only be turned off locally from the fo'c'sle, a considerable distance away.

▲ Figure 1: Deteriorated connector partly covered with protective tape

1. Company procedures revised and circulated among fleet for compliance; the use of anticorrosive tapes no longer permitted on hydraulic lines, as detailed in our company's maintenance policy. All vessels were instructed to remove all existing anti-corrosive tape from hydraulic connectors and apply protective coating (paint) on metal surfaces.
2. More effective onboard inspection and corrective actions ordered for noted defects and deficiencies.
3. Improved communications so that information reaches all key personnel.
4. Recommendation that the use of eye protection should be considered when operating hose handling cranes or other hydraulic machinery where flexible hoses and fittings may be exposed to the aggressive elements of the sea.
5. Recommendation that the flexible hoses on the hose handling crane be renewed every five years or earlier, if inspection indicates it is so required.

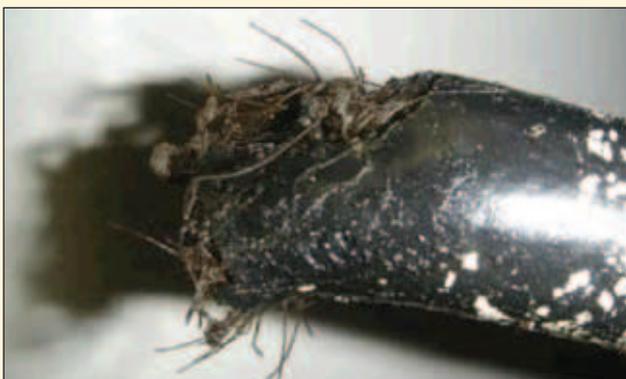
▲ Figure 2: Corroded internal wire braiding after removal of protective tape and connector

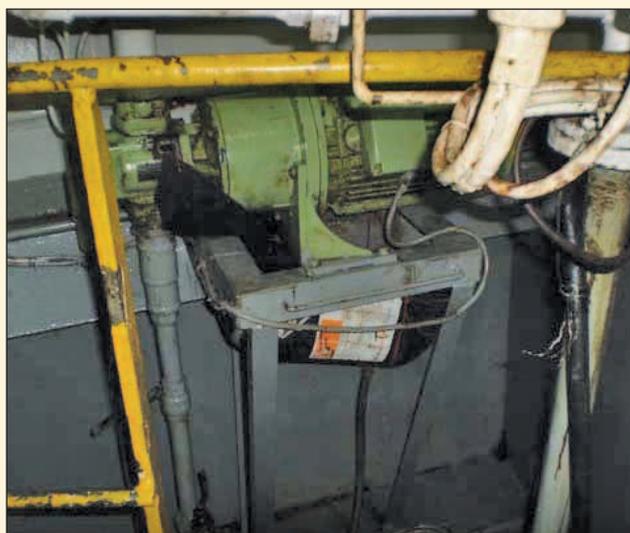
▲ Figure 3: Improvised plastic 'drip tray' fitted under sludge pump

■ **Editor's note:** These photographs seem to suggest a general lack of concern on the part of the onboard management to investigate and eliminate sources of oil leaks from machinery properly. Apart from the obvious fire hazard, these arrangements increase the risk of personal injuries arising from slips and falls. They also present a pollution hazard.

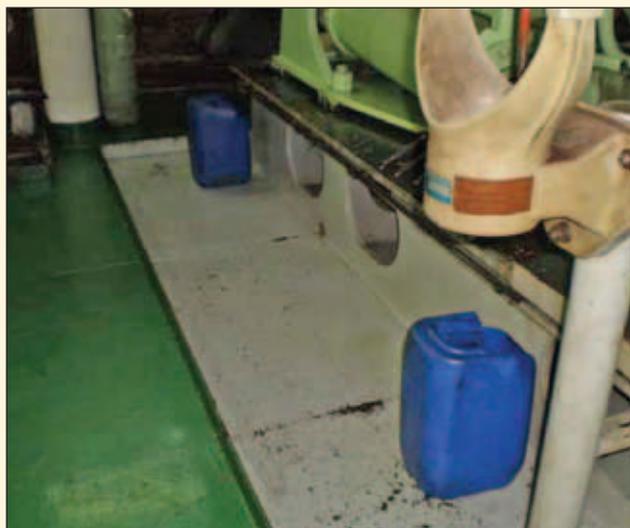
▲ Figure 4: Receptacles placed under leaking hydraulic cylinders of steering gear
