Providing learning through confidential reports – an international cooperative scheme for improving safety

### MARS 200960

#### A fall down stairs

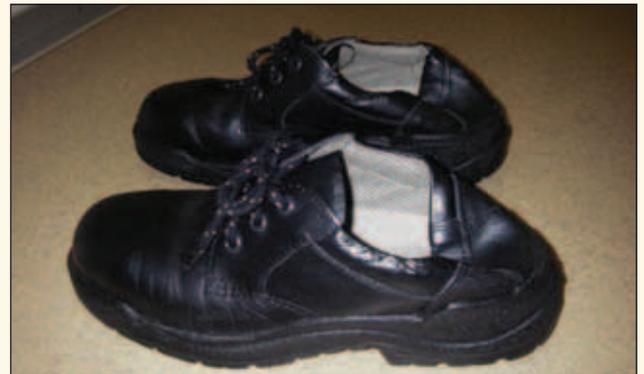
1. There was evidence that the rating was not wearing his safety shoes properly and this was a contributory factor in the accident. The depressed hind-quarters of the rating's shoes indicated that he had only slipped his feet in without putting them on properly.
2. The rating had joined the ship one day prior to the accident after a long flight. It is possible that he might not have been very vigilant as a result of jet lag.
3. Effects of seasickness could also have been a contributing factor.

▲ Figure 1: Depressed hind-quarters shows that the rating had failed to wear the shoes properly

1. It must be emphasised that any personal protective-equipment (PPE), including safety shoes, should be worn in the correct manner and any modification or misuse of PPE is against good seamanship and safety procedures.
2. In the case of safety shoes, these need to be:
  - the correct size – oversized shoes can come off easily;
  - worn properly with the laces secured tight.
3. Crew members should be especially careful when a new tour of duty begins; it requires some time to get familiar with new work environment, equipment or people.

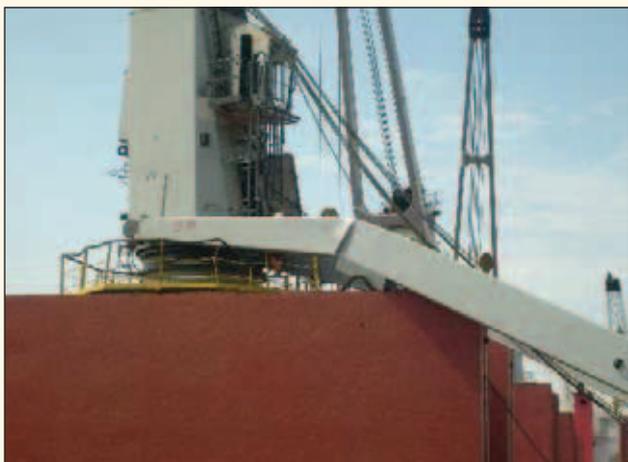
A shore stevedore operating a ship's cargo crane used the bypass key to override the jib luffing lower limit cut-off switch, so that the cargo sling could be landed at the desired spot on

▲ Figure 2: View of damaged crane jib

the wharf. This resulted in the jib lowering out of control, falling heavily on the open hatch covers and sustaining heavy damage.

1. No one other than a responsible ship's officer should operate the crane limit bypass limit switches.
2. The bypass limit switch is provided only for the purpose of parking the jib on the crutch.
3. The bypass switch key must never be available in the crane cabin.

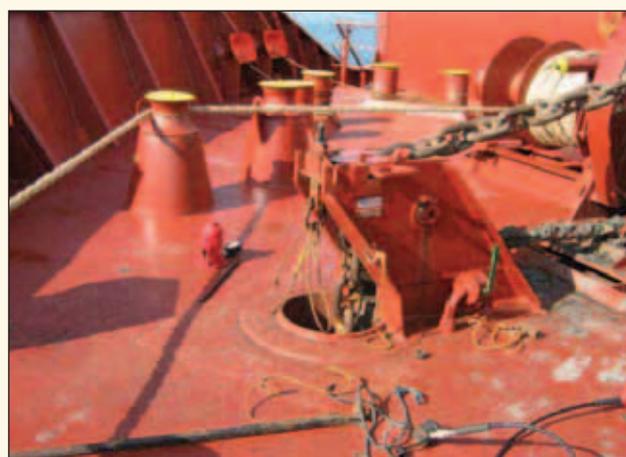
When the weight had been transferred to the wire sling, and the bosun was attempting to turn the slack chain, the wire lashing broke, causing the chain to jerk and hit him in the face, rendering him unconscious. He was revived and guided into the accommodation where he was examined by the chief officer before being taken to a shore hospital, where he was diagnosed with a broken cheekbone.

1. The master and senior officers were not informed of the hazardous task being attempted by the forward mooring party.
2. No formal risk assessment was carried out.
3. Two new wire slings of appropriate size had been recently supplied for securing anchors: the crew had not only failed to deploy them but had used a sling that was too small and also deteriorated due to age and exposure to the elements.

▲ Figure 3: View of twist on anchor cable and parted wire sling

**Editor's note:** In the photograph on p 19, a crowbar is seen lying on the deck in the foreground. MARS 200531 (see MARS archives online) graphically illustrated the hazards of using inappropriate means to hold anchor chains. In that report, a crowbar was temporarily inserted into a link to jam it in the bow stopper when the brake could not hold the anchor cable that was under high tension. The crowbar sheared off and the Chief Officer died after being hit by a flying piece of the rod.

Recommendation that chain be used instead of wire slings for securing anchors.
