Providing learning through confidential reports – an international cooperative scheme for improving safety

MARS 201006

Improperly repacked liferafts

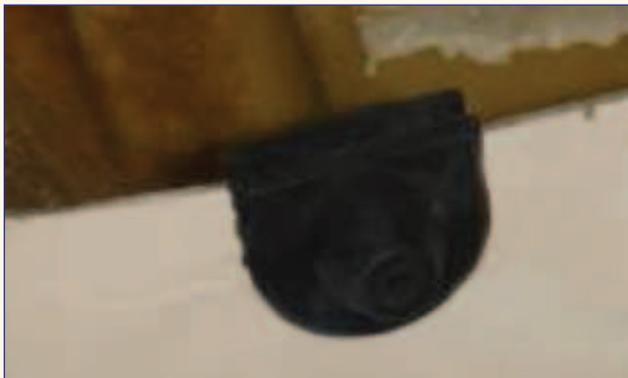
▲ Figure 1: Example of an intact bushing

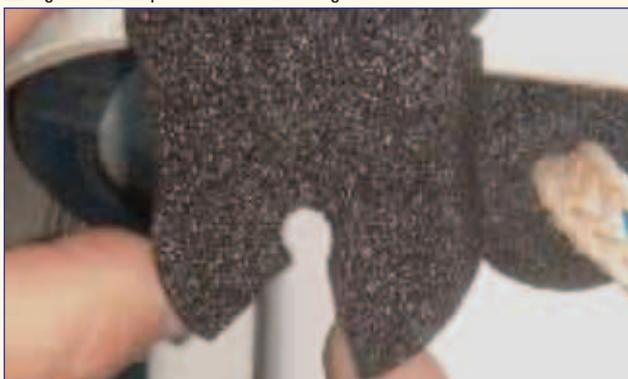
It has become evident that some unscrupulous contractors servicing ships' inflatable liferafts are repacking them improperly – and this can prevent them from operating in an emergency. In order to save on the effort needed to thread the entire length of the painter line through the bushing's central hole, these contractors are cutting the rubber bushing located between the two outer containers radially, and conveniently pushing the painter line through the gap.

The main function of the bushing is to allow the unimpeded streaming of the painter line. When attempting to launch and inflate an improperly repacked liferaft, the painter line may come out of the bushing and get jammed between the two halves of the outer container, which prevents it from being fully drawn out. The liferaft will then become impossible to inflate, either automatically or manually.

▲ Figure 2: Example of a radially cut bushing

There have been a number of reported incidents where inflatable liferafts have failed to inflate in emergencies, including one in Swedish waters, which led to the loss of three lives. It is thought that a cut bushing could have been a contributing factor in these occurrences.

Mariners are advised to inspect the entry point of the liferaft's painter line on the outer container closely. If a bushing appears cut or damaged, the last servicing contractor should be contacted and immediate arrangements made to have the bushing renewed and the liferaft repacked properly.

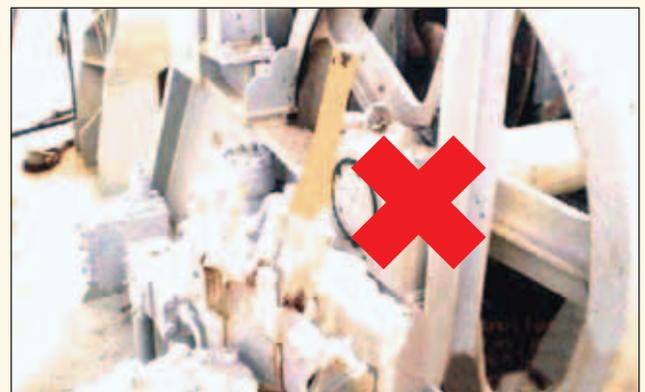
Upon receiving notice that a berthing pilot would be boarding, two crew members proceeded forward to make ready for weighing anchor. While preparing the windlass, an unusual noise was heard, which was thought to be caused by lack of grease on the dog-clutch gear arrangement. One man was sent to get some grease and while he was away, the other crew member secured the windlass control lever in the hoist position with the shaft slowly rotating. He then attempted to remove the old grease from the dog-clutch arrangement. While so engaged, the glove on his right hand was caught by the dog-clutch gear and he suffered multiple complex lacerations on two fingers of his right hand, although fortunately, there were no fractures or injuries to nerves or blood vessels. Subsequently, the crew member was found unfit for duty by a shore doctor and was repatriated from the vessel.

1. Company procedures not followed. When the vessel was advised that the pilot would be boarding, no tool-box meeting was held to discuss the anchor weighing and berthing operation;
2. In violation of safe working practice, the windlass control lever was secured in position with the windlass shaft in motion.

▲ Figure 3: Never lock the winch operating handle in running position

Additional training on operational safety and risk assessment to be conducted for ship's staff.

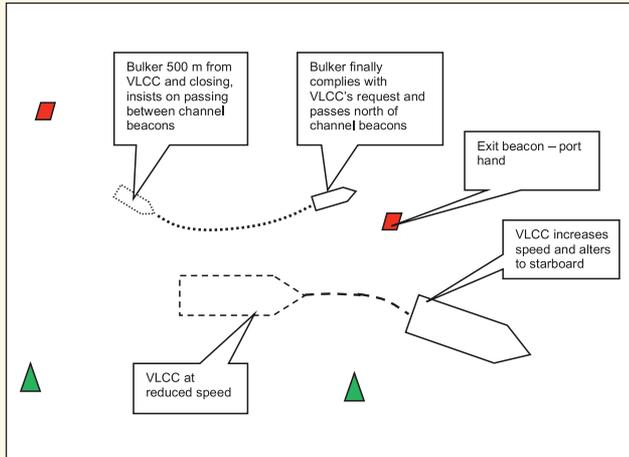
Our master contacted the other vessel to ask her to change her heading to 090° and to keep clear, but her officer of the watch insisted that he had to pass through the beacons, despite the fact that there was sufficient water for him to pass to the north of them. During our transit between the beacons, the other vessel closed to within 750 m. Own ship began to increase speed in an attempt to widen the passing distance and to prepare to turn to starboard after clearing the final set of beacons. The closest noted range was less than 500 m. Eventually, the other vessel altered to port and safely passed north of the channel beacons.

The basic errors here seem to be the failure of the other vessel to comply with the Collision Regulations, particularly with reference to Rule 13 (overtaking) and Rule 18, d, i: 'Any vessel... shall... avoid impeding the passage of a vessel constrained by her draught exhibiting the signals in Rule 28.'

▲ Figure 4: The near collision
