Providing learning through confidential reports – an international cooperative scheme for improving safety

### MARS 201013

#### Hydraulic windlass failures

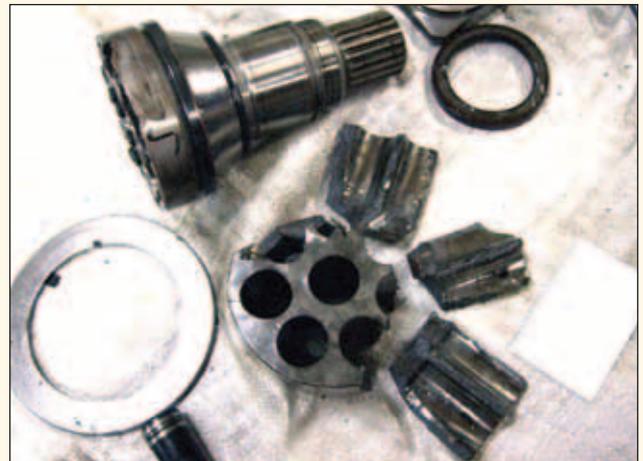
Preliminary findings suggest that these failures are not the result of metallurgical fatigue, manufacturing defects or impact damage, but rather that the hydraulic motor casings fractured after being subjected to extremely high internal pressures and/or on impact with broken components of the hydraulic motor; events that are likely to occur when heaving in the anchor in adverse sea and weather conditions when the anchor chain has been tensioned beyond the intended safe loading of its windlass.

▲ Figure 1: Typical failed components from hydraulic motor

1. Closely monitor the predicted weather and sea conditions and ensuring that the anchor is recovered in good time, before the conditions make this difficult to achieve; and
2. Use the propulsion system to manoeuvre a vessel to relieve tension in the anchor chain before 'heaving in', and stop the windlass as soon as any significant tensioning is observed or difficulty is experienced.

■ **Editor's note:** Where fitted, the pressure manometers, high pressure alarm systems and safety relief valves of windlass hydraulic systems should be regularly inspected and maintained as per manufacturers' recommendations.

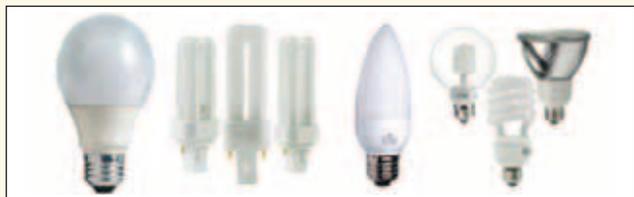
This *Safety Alert* serves to inform the maritime industry that energy-saving compact fluorescent lights (CFL), sometimes known as radio frequency (RF) lighting devices, may interfere with certain communications equipment.

CFLs employ a RF frequency to excite a gas inside a bulb in order to produce light. Until new standards are adopted to regulate their design and use on board vessels,

▲ Figure 2: Examples of some compact fluorescent lights with different shapes and sizes.

manufacturers of CFLs/RF lighting devices, particularly those capable of producing emissions in the 0.45-30 MHz band, are advised to warn users that they should not be installed near maritime safety communications equipment or other critical navigation or communication equipment.

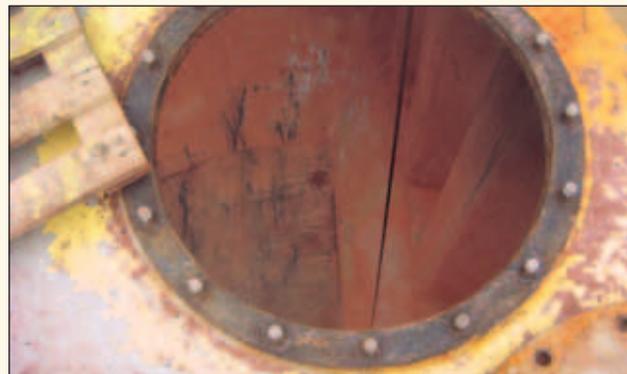
I have been on quite a few bulk carriers but have never seen a deck opening straight into a hold like this before – see Figure 3. There were no guard rails or warning signs, so that a person walking on deck could have easily fallen through the opening, some 20 metres straight to the bottom of the hold below.

This was a relatively new ship so maybe it was a new design feature to facilitate the removal of hold cleanings. A small davit and air winch combination is designed to fit over the opening, which would make it safer if it was in place. However, when the crew is manually raising/lowering small hand tools and small drums, the opening is unguarded, apart from a loose wooden grating, which could easily be displaced by an unsuspecting person’s foot with potentially disastrous consequences. It was actually quite unnerving and frightening to walk near the opening when it was not covered.

▲ Figure 3: View of unsafe deck opening

■ **Editor’s note:** On ships fitted with such openings, it is suggested that deck sockets be welded around them so that portable stanchions and safety lines may be rigged when the covers are removed. In addition, warning signs must be painted on the deck from all possible approach directions, and the perimeter and lids of the openings highlighted in fluorescent paint.

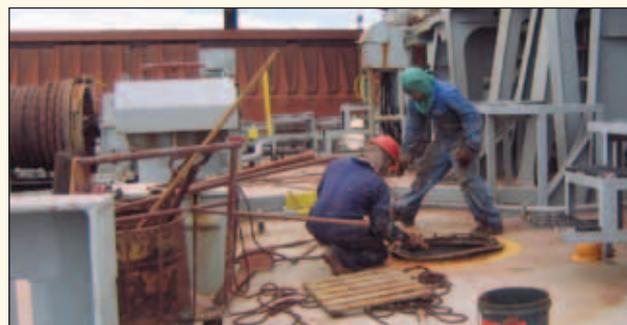
▲ Figure 4: Crew members hauling out cleaning equipment through the deck opening
