The Nautical Institute Mariners' Alerting and Reporting Scheme

MARS Report No 211 May 2010

Providing learning through confidential reports – an international cooperative scheme for improving safety

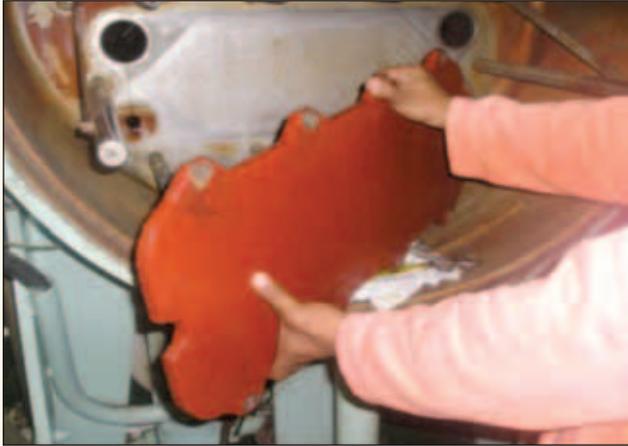
A leak was observed from the fresh water (FW) generator from the vacuum drum cover gasket about a month prior to the incident in question. Appropriate spares had been ordered in advance but there was a delay in their delivery. In the meanwhile, the crew made temporary repairs to stop the leakage by using silicone sealant to repair the damaged gasket.

Subsequently, after the spares had been received, the second engineer assisted by the chief engineer proceeded to install the new gasket. The second engineer temporarily withdrew from the workplace to attend to another task, leaving the chief to open the cover plate without assistance. As he removed the holding nuts and pulled at the cover plate, after considerable resistance it suddenly came away and fell on his little finger, crushing it against casing of the FW generator.

1. No risk assessment carried out prior to conducting the task;
2. Inadequate support/assistance: lack of assistance during handling the heavy steel plate cover;
3. Inappropriate maintenance: damaged gaskets repaired and sealed by silicone sealant. Had the appropriate gasket been used, the plates would have come apart easily.
4. Inadequate evaluation of changes to the steel plate under heat stress: due to build-up of heat stress in the plates, they sprang loose from their securing position when the stress was released suddenly;
5. Delay in receiving spares.

▲ Figure 1: View of FW generator cover plate coming off the holding studs

1. Risk assessment to be carried out before undertaking tasks, and suitable control measures to be taken to minimise/reduce adverse consequences;
2. The importance of using only the correct replacement gaskets and seals. Temporary means of repair should be avoided.
3. The dangers of using inappropriate sealing material for equipment exposed to heat/pressure conditions.

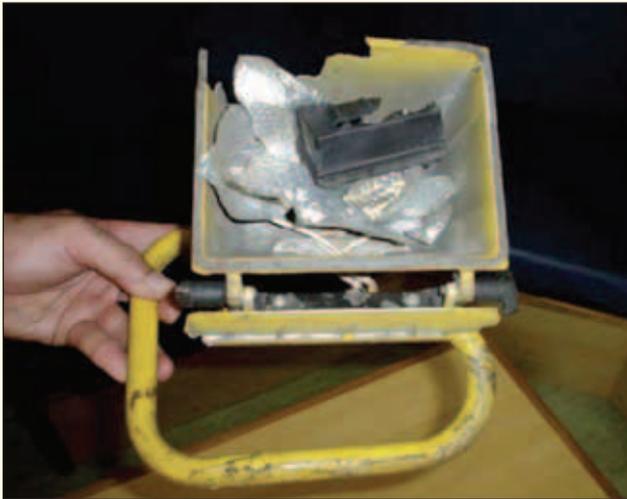
At about 21:45 the steam drum door was opened, and as the contractors pushed the door into the drum there was a noticeable suction as the seal was broken. The workers also moved a non-intrinsically safe halogen lamp to a handrail near to the steam drum. At 22:00, both the cleaning experts approached the steam drum door. No tests were conducted to check the steam drum atmosphere for either toxic or flammable gases. The UK expert picked up the halogen lamp and placed it just inside the steam drum. The Danish expert saw a small flame or spark, and an explosion immediately followed.

1. Accumulation of hydrogen gas in the steam drum, which evolved during the cleaning procedure. As the steam drum door was opened, the air combined with the hydrogen to create a mixture that was within the hydrogen's wide explosive limits;
2. Insufficient arrangements were made to ventilate the boiler and so release the evolved gases to atmosphere. Had the boiler been properly ventilated, the hydrogen build up would not have occurred;
3. The introduction of the hot halogen lamp into the untested, confined space of the steam drum, which was known to have possibly contained flammable gases, was a serious error of judgment.

▲ Figure 2: remains of the non-intrinsically safe halogen lamp that caused the explosion

6. Only intrinsically safe lighting systems shall be used in confined spaces.

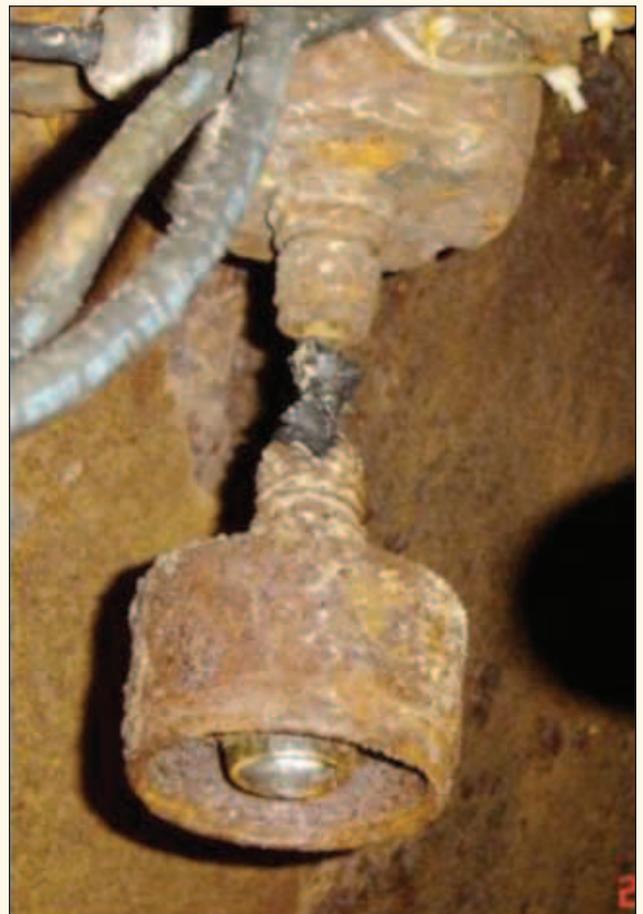
▲ Figure 3: View of the damaged light fixture with exposed live components

The investigation revealed that the heads of both crew members had contacted a deckhead lamp fixture that was damaged and improperly repaired. The fixture lacked a light bulb, a globe, and a guard. It appears that, at one time, the fixture was separated from its connection box and a repair was made using insulation tape to cover some open wires without properly replacing the connecting fitting between the fixture and the box. It also appears that the connection box was not earthed due to the use of plastic cable ties

instead of solid metal fasteners.

As a result of this casualty, the Coast Guard strongly recommends to vessel owners/operators, port captains/engineers, crew members, and marine inspection personnel, especially those associated with older vessels, to be alert for such hazards and to take immediate action to report, properly document and correct any hazardous condition.
