Providing learning through confidential reports – an international cooperative scheme for improving safety

### MARS 201030

#### Gangway fall wire failure

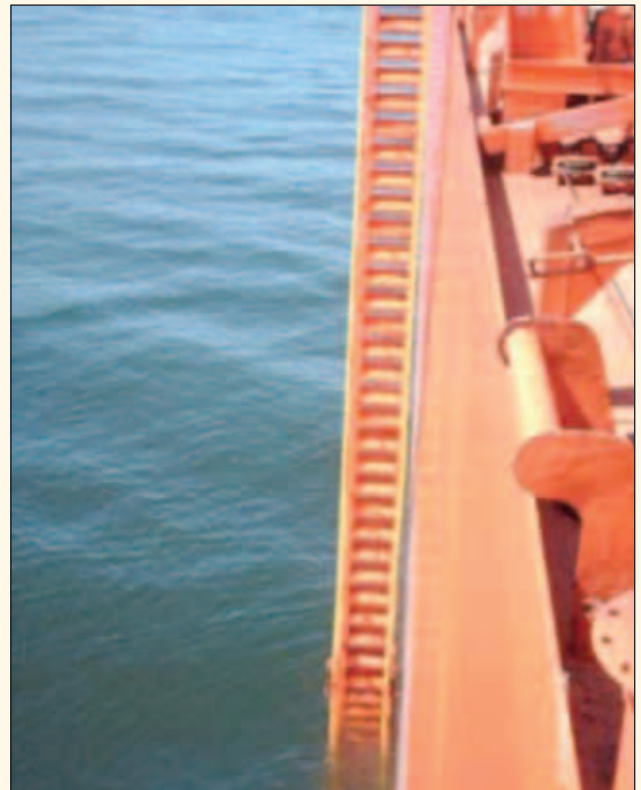
The vessel was at anchor and a launch had been arranged for shore leave. Several crew members left the vessel via the port side gangway and the gangway was then returned to the stowed position. As the gangway reached the main deck level and was about to be brought inboard, the fall wire parted causing the end of the gangway to fall into the water, it being supported only at the upper platform turntable. Fortunately no one was on the gangway at the time and the launch had cleared the area.

1. Lack of compliance with procedures – the fall wire failed at a damaged section that had been reported and not acted upon on two previous occasions.
2. Those aware of the damage and lack of action had not reported the matter to a more senior officer, in this case the master.
3. The fall wire had been renewed about two years back, however, investigation on board showed that some of the crew were aware that the wire had sustained further damage more recently. This had been reported to the chief officer at the time. Unfortunately, this was not acted upon, neither was the matter raised at any safety meeting nor was a near miss recorded.
4. A new chief officer joined the vessel and again, the damaged fall wire was apparently reported. Once again, no action was taken, even though the damaged section of the fall wire was visible in the stowed position being just before the drum.

▲ Figure 1: View of gangway after parting of fall wire

1. The master promptly held a safety meeting at which all present assisted in the investigation.
2. A spare wire was on board as per company requirements and this was fitted with a replacement spare being ordered immediately.

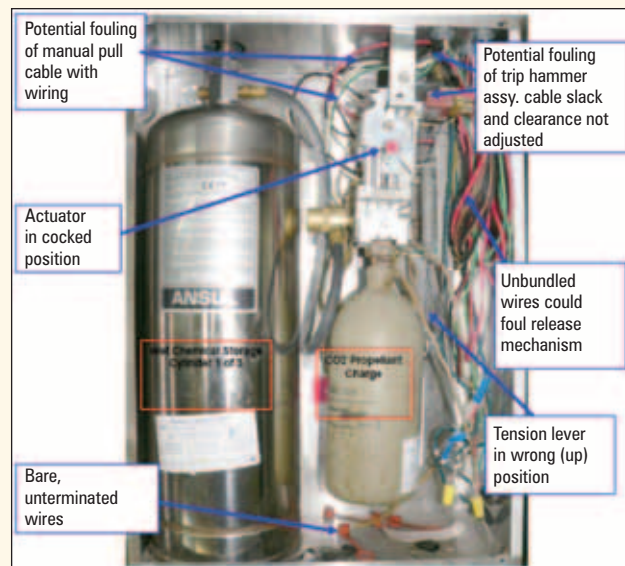
- Fusible link cable tensioner in wrong position: tensioning lever was in 'up' (untensioned position), meaning that automatic operation of system would not have been possible when fusible links separated.

- Improper cable slack adjustment: cable locking clamp at the trip hammer assembly was not adjusted properly to allow the recommended slack (when cable tensioned), as instructed in the service manual.

- Sloppy wiring within actuator cabinet: poor installation of the wiring when this system installed consisted of unbundled wiring groups, damaged insulation, unterminated spare wires and fouled wires in way of manual pull cable and trigger release mechanism.

- Broken wire pulley elbow at range hood entrance: possibly due to galley gear being secured to or hung from this conduit in past, which broke a pulley elbow connection. This broken joint had potential to cause a fouled cable and inoperability of automatic fire suppression.

▲ Figure 2: Actuator cabinet as found when cover opened

1. Vessels fitted with similar systems advised to check for potential problems as found on our vessel. A 'cocked' indicator on the exterior of cabinet may not mean that all components of the system are ready for use;

2. All vessels instructed to ensure availability of the service/maintenance manual on board – many can be downloaded in PDF form from the manufacturer’s website;
3. All vessels instructed to ensure the timely stocking of spares and to maintain correct inventory of these and special tools;
4. The company to investigate the possibility of carrying a system recharge kit(s) on board. This would allow continued protection after the system was used in a real fire or accidentally discharged.

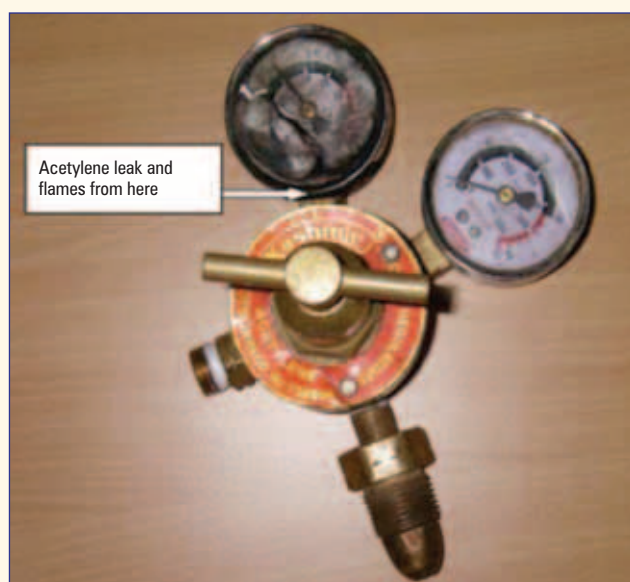
On an offshore support vessel, sub-contractors were engaged in burning and welding sea fastenings on the main deck. After flames were observed at an acetylene tank regulator, operations were suspended and the fire was successfully extinguished. After cooling, the regulator was removed for inspection (see Figure 3) and it was found that thread sealing tape had been inappropriately used in all the connections on the contractor’s equipment.

▲ Figure 3: Wrongly fitted acetylene regulator pressure gauge

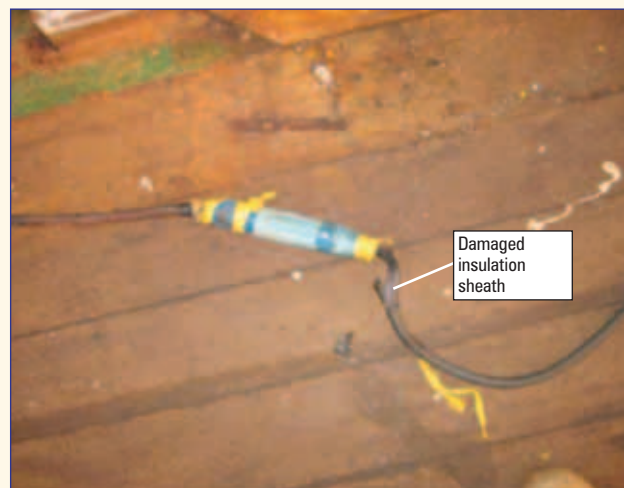
- A welding cable was found to be smoldering at a connection point where the cable had been pinched and the insulation sheath was cut and the wires exposed (see Figure 4);

▲ Figure 4: Damaged insulation sheath

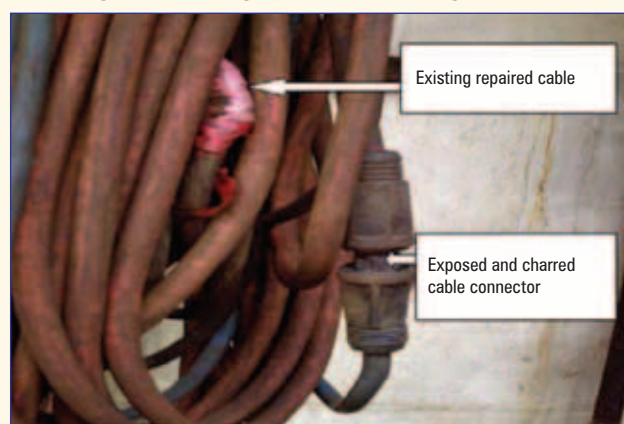
- A midway cable connector was found arcing and smoking during deck welding operations (see Figure 5);

▲ Figure 5: Midway cable found arcing and smoking

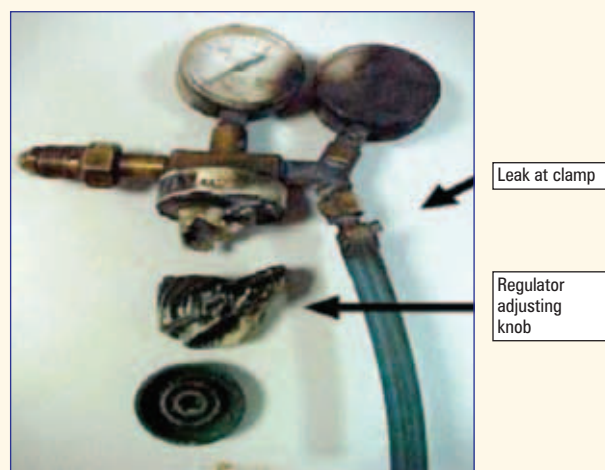
Whether belonging to the vessel or sub-contractors, poorly-maintained burning and welding equipment present a serious hazard to personnel and vessel. In a separate incident, a welder’s hand was severely burned while he was adjusting the pressure, on an oxygen regulator. The welder had oil on his hand and there was an oxygen leak from the hose clamp. The oxygen stream under pressure instantly caused the hydrocarbons (oil and grease) on his hand to catch fire, the violence of which even blew away the regulator knob. Never allow oil or grease or any organic matter to come into contact with oxygen under pressure (see Figs 6 and 7).

▲ Figure 6: Fire-damaged oxygen regulator

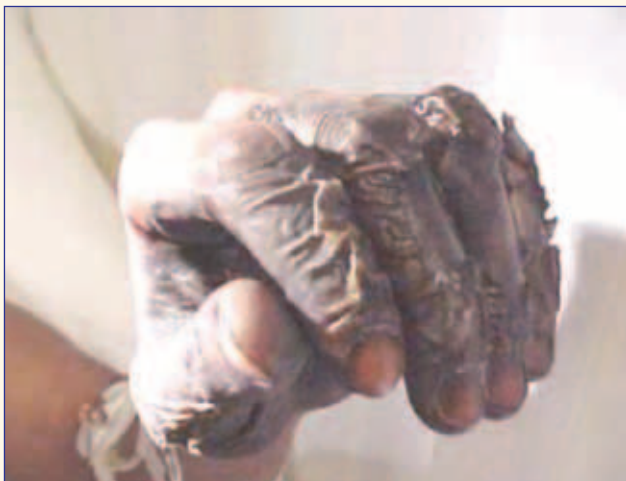
▲ Figure 7: Oil-coated hand severely burnt by escaping high pressure oxygen
