Providing learning through confidential reports – an international cooperative scheme for improving safety

### MARS 201040

#### Head injury due to dislodged lifting spreader

### Submarine gas pipeline damaged by anchor

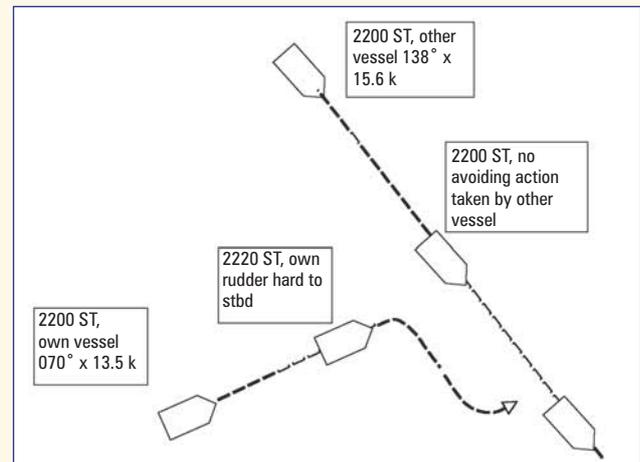
On a clear night at about 22:00 hrs, own vessel sighted another vessel, crossing from our port bow. Compass bearing showed no appreciable change and CPA showed that the other vessel would pass across our bow at a distance of less than two cables. As we approached, our radio and light signals were not acknowledged and we stood on for a considerable time, expecting the give-way vessel to take appropriate action under Rule 15 (Crossing situation). By 22:20, the distance between the two vessels had become less than 1.5 nm, and reducing rapidly. Accordingly, under Rule 17 (Action by stand-on vessel), we turned hard to starboard, paralleling the other vessel's course. Once the other vessel

▲ Figure 1: Colregs violation

had drawn sufficiently clear, we turned slowly to port and crossed its wake and resumed our original course.

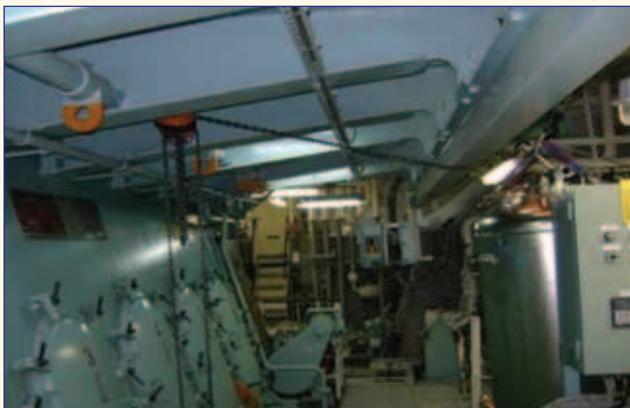
Work was being carried out on the 15ppm oily water separator (OWS). An existing lifting arrangement, meant primarily for work in the main engine crankcase, was used for the job. It consisted of a chain block shackled to a lug on a portable pipe 'spreader', each end of which was designed to sit in a support made out of half-pipe sections welded on two adjacent overhead beams. To reach the OWS, the hook chain was led sideways for a considerable distance, passing under and around a girder and other obstructions. When the chain block was tightened, the hook chain snagged on an obstruction and the large sideways force caused the spreader to move up and out from its semi-circular supports. The spreader and chain block fell on to the bottom plates violently, inflicting a head injury on a crew member.

1. Lack of planning – failure to properly assess the operation before commencing the task;
2. Person in charge unable to have a full view of work site;
3. Chain block lifting chain snagged on some obstruction(s) creating large sideways force;
4. Crew members not wearing head protection due to limited headroom.

▲ Figure 2: View of unsafe arrangement of chain block showing hook chain leading sideways to OWS

■ **Editor's note:** In any lifting operation, the applied force must be as close to the vertical as possible. In this incident, it appears that a suitable lug was not available directly above the OWS. For such situations, it is suggested that each vessel to be provided with a number of certified portable beam clamps of assorted capacities. Before such a clamp is to be used on board, the responsible person shall ensure its proper rigging and be fully conversant with its limitations.

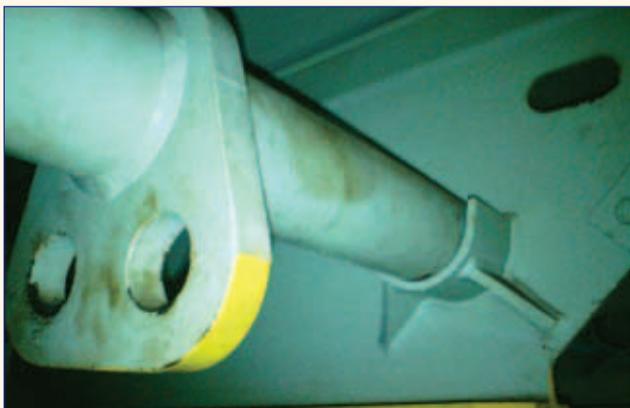
▲ Figure 3: Close up view of portable pipe 'spreader' with lugs. Note that the end supports have no securing arrangements to prevent the inadvertent dislocation of the portable spreader

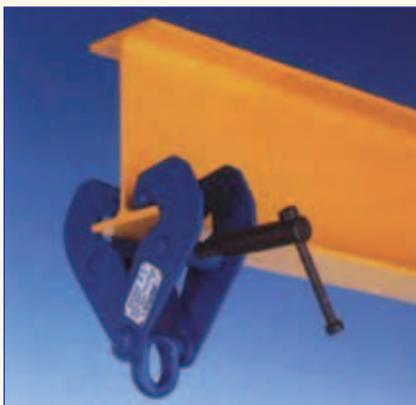
◀ Figure 4: Typical portable beam clamp with integral lifting lug

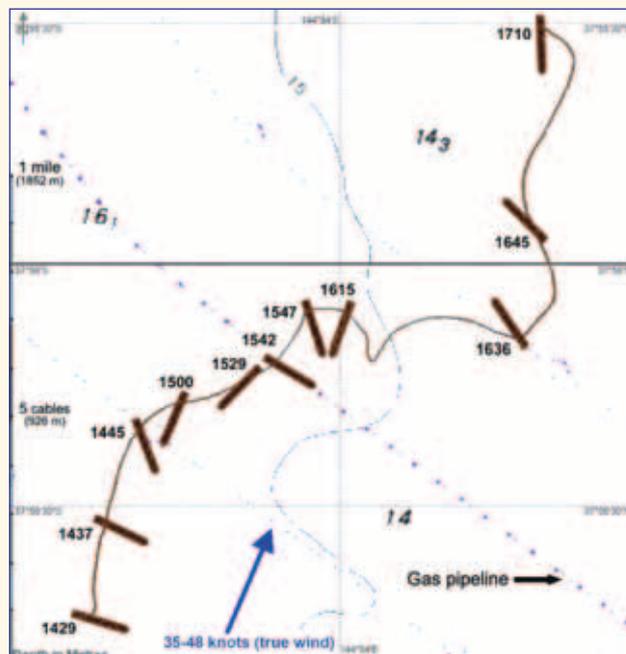
Figure 5: Plot of vessel's positions

of 108° with a 35-knot gale blowing from 200°. (The heading was chosen to create a lee for the sea pilot to disembark safely, and the drift rate increased substantially under this beam wind situation until the ship became wind-roded at about 14:55. Evidence suggests that the ship was never 'brought up' to five shackles and was continuously dragging anchor and drifting in a NE'ly direction.)

15:49: Ship's starboard anchor presumed to have snagged the pipeline.

16:21: Submarine gas pipeline ruptured.

1. The rupture was the result of attempting to dredge the anchor instead of slipping it;
2. The anchor had also been let go too close to the pipeline in the poor weather conditions;
3. Deficiencies in the port's risk management with respect to the pipeline and anchorage boundaries and its shipping control procedures;
4. Deficiencies in the ship's safety management system with respect to passage planning, the master's authority, crew familiarisation and the working language;
5. Deficiencies in the pilotage company's procedures for anchoring and mobile telephone use;
6. Windlass failure at a critical time due to excessive loading in the system

1. Australian Notice to Mariners 26 advises that in the event of any vessel fouling a pipeline, the anchor or gear should be slipped and abandoned without attempting to get it clear. Any excessive force applied to a pipeline could result in a rupture and, in the case of a gas pipeline, the consequential sudden release of gas at high pressure – somewhat like an explosion – could cause serious damage or loss of the vessel. There would be an accompanying severe and immediate fire hazard.

2. The *Mariner's Handbook* notes that if it is suspected that a ship has fouled a gas pipeline with its gear or anchors, excessive weight should not be placed on the gear as it could damage the pipeline and the ship 'could face an immediate hazard by loss of buoyancy due to gas aerated water or fire/explosion'. Given the high risk and because many pipelines were laid before accurate GPS receivers became commonplace, it would be prudent to be cautious rather than completely rely on the accuracy of their charted locations. In essence, the only appropriate course of action if a ship has, or is suspected to have, snagged its anchor on a gas pipeline is to avoid placing weight on the anchor cable and to slip the cable as soon as possible. Had this been done in this case, the gas pipeline probably would not have ruptured.
