Providing learning through confidential reports – an international cooperative scheme for improving safety

MARS 201051

Seaways October 2010

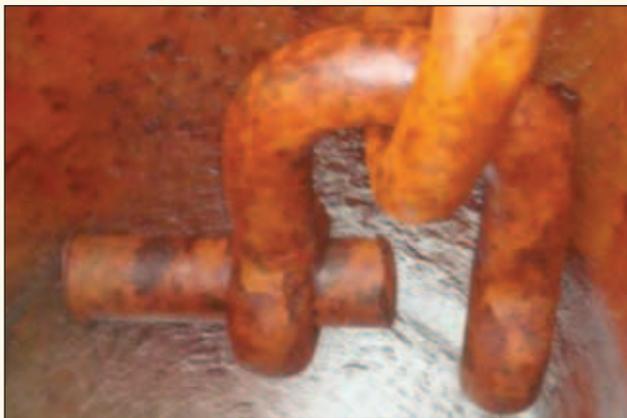
One of our vessels recently lost her starboard anchor when under way. On investigation, it was determined that the spile pin securing the main pin of the 'D' shackle had come free, allowing the main pin to dislodge and causing the anchor to drop into the sea. The loss was detected at a later stage by ship's staff, during their rounds of the forecandle deck.

▲ Figure 1: 'D' shackle showing main pin displaced and anchor missing

1. Fleet instructed to inspect anchor connections at the first opportunity and report the findings to the management office;
2. In accordance with recommendations in OCIMF Publication 'Anchoring Systems and Procedures For large Tankers', Chapter 11.3, fleet instructed to spot weld the shackle pin during the next planned, gas free mode, following the company-approved hot work procedures at all times.

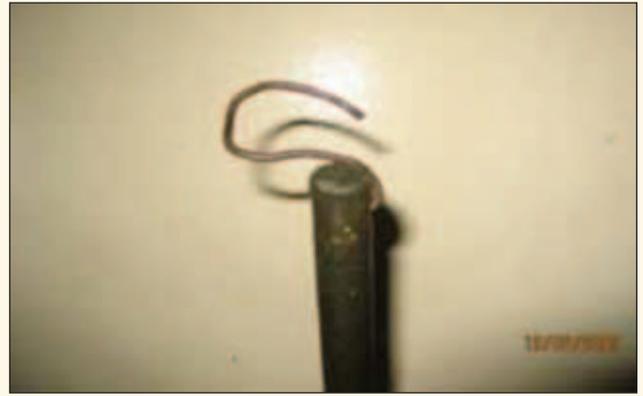
While carrying out routine maintenance of a fire hydrant in the engine room, a crew member decided to use a wheel key spanner to free up the stiff valve. The spanner handle's free end was fitted with an open wire tail as a convenient hanging device when not in use. When the crew member tried to open the wheel with the spanner, his hands slipped along the handle and the wire tail penetrated the gloves, resulting in a gash injury between his ring and middle fingers.

1. Hazardous sharp and open wire tail fitted at the free end of the wheel key spanner handle;
2. Improper/insufficient grip between key and valve operating wheel;
3. Working gloves found to have insufficient grip.

▲ Figure 3: View of open wire tail fitted on handle's free end for hanging spanner

1. All vessels are to discuss the above incident at their next safety meeting;
2. A tool box meeting is to be held by those assigning tasks to ensure that personnel involved in the job are aware of the hazards and that proper precautions are exercised;
3. Proper personal protective equipment (PPE) in accordance with the company's PPE matrix must be worn at all times. If gloves are worn out, they must be replaced;
4. Personnel should take care while being involved in any work. Due diligence should be exercised.
5. Wheel keys should be fitted with non-hazardous hanging/securing arrangements.

■ **Editor's note:** If wire tails are considered necessary for securing tools when not in use, it is suggested that they are bent double to form a closed loop and fitted in such a way that there are no sharp projections

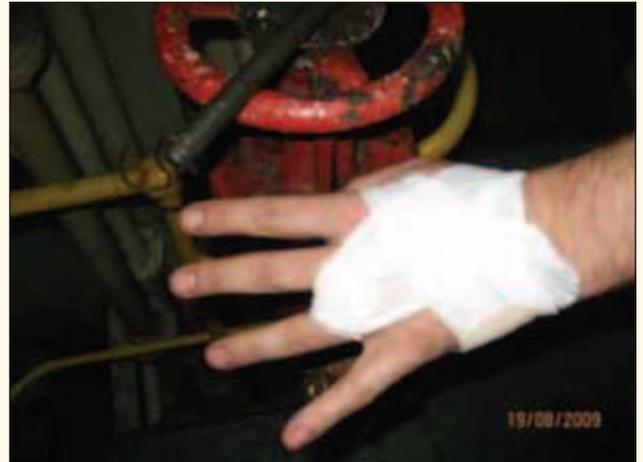
▲ Figure 4: Injured hand pointing to the open wire tail

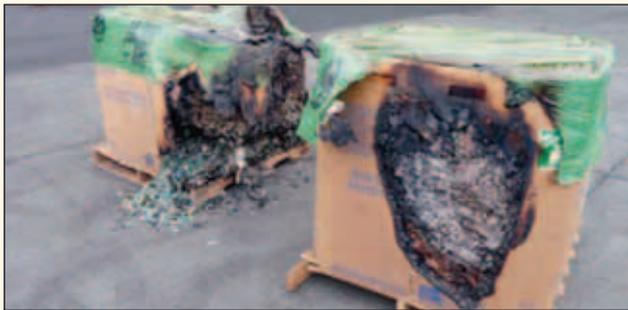
The side of a laden container had been damaged and was repaired by welding, with the cargo of scrap electrical components on pallets still inside. This caused a smouldering fire to start in the container, which could have resulted in a serious fire on the ship. Members and ships' crew's should be aware of the risk and be on the lookout for potential problems with any container showing signs of recent welding repairs.

▲ Figure 5: Smouldering pallets after emergency destuffing

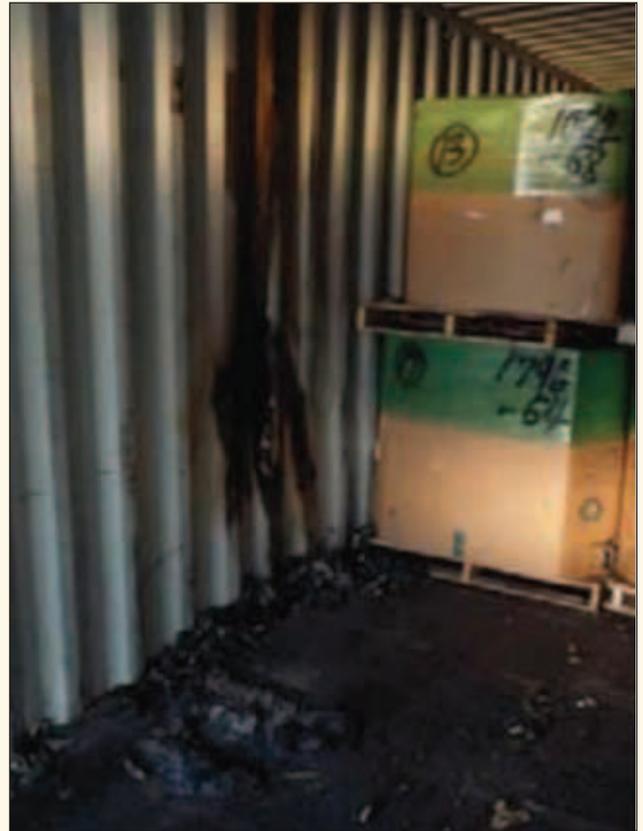
▲ Figure 6: Heat damage to inner surface of container's side panel
