Bulletin 387 - 11/04 - Chemical Drum Explosion in Engine Room Workshop

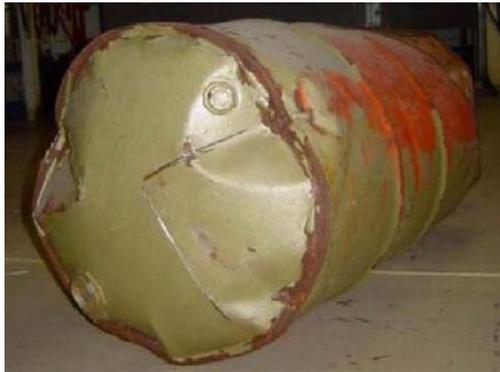
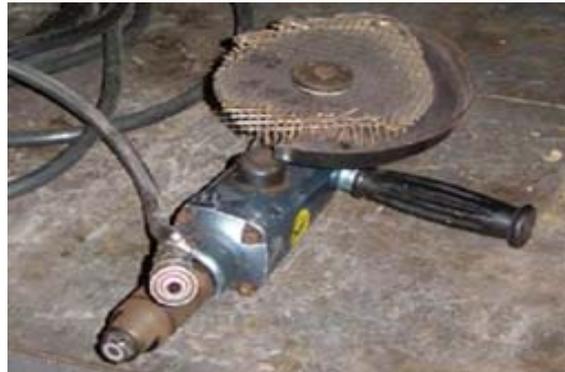
Apparently the two men lowered the drum to the E/R workshop, without any water rinsing, and the engine boy proceeded to use a pneumatic grinder to cut the drum. Evidence on the drum shows that they had barely penetrated the drum when it exploded from the bottom, owing to the explosive atmosphere within the drum (the drum was sealed with both its caps on, see picture below).

The engine boy bore the brunt of the blast and became engulfed in flames, a fitter who heard the blast was on the scene quickly and helped to extinguish the flames. The motorman was reportedly standing a little behind the engine boy, and his boiler suit had also caught fire although he was able to take his boiler suit off and assist the fitter.

The engine boy died on his way to hospital and the motorman suffered 2nd degree burns.

The crew obviously did not fully appreciate the inherent risks involved in the task. The lack of supervision allowed the engine boy and motorman to pick up a drum from the deck, lower it into the engine room and proceed with the job of disc cutting the drum without any checks either from the Chief Officer, regarding why the drum was being removed from the deck, or the 2nd Engineer as to why the drum was being cut up in the engine room workshop. The procedures for hot work in the onboard safety manual did not specifically include how to deal with empty drums. Consequently, in this case, the crew did not treat the task as dangerous and failed to carry out the risk assessment/procedures associated with hot work.
