## Bulletin 397 - 01/05 - Non Standard Container Repairs

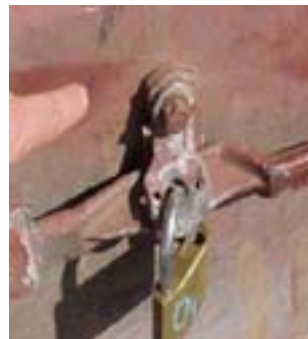
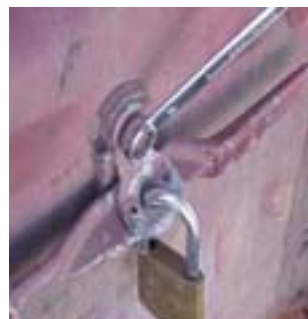
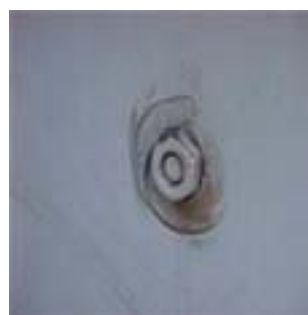
On investigation it was discovered that the door handle retainer plate and retainer itself on many of the leased containers received had been repaired at one time or another and, instead of replacing the bolts with the correct "mushroom" head type of bolt, they were replaced with common hexagonal head bolts.

The result of this is that a seemingly sealed container can be opened in a matter of minutes using an ordinary spanner or pair of pliers, leaving the seal intact. The bolt is then replaced after the cargo has been removed using putty to hold the inner nut in place.

We would recommend Members ensure that damaged containers are repaired to a proper standard, insisting that, in the case of damaged securing devices, all bolt fittings used have blind mushroom head nuts on door handle retainer brackets - or some other type of tamper proof fixing mechanism. Members should ensure that they do not approve the illustrated type of repair and containers with simple hex nuts should be rejected.
