Ship Type: All Trade Area: All

Bulletin 420 - 07/05 - Lifeboat Drill Fatality - Worldwide

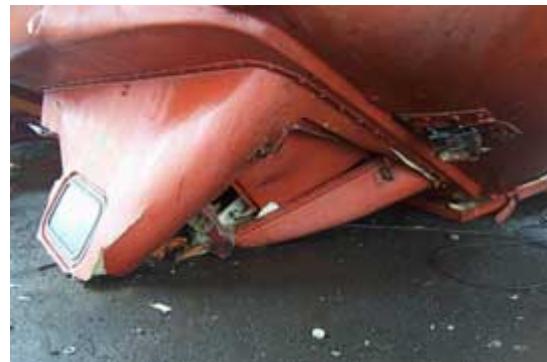
The image (right) shows the damage sustained by the lifeboat conning tower on impact with the water after falling five metres and landing upside down during a lifeboat drill in the case highlighted here.

The accident happened on recovery of the lifeboat, which requires the crew inside the boat to manually hook the lifting rings of the falls into the fore and aft hooks of the lifeboat. In this case, the lifeboat was lifted approximately 20cm from the water at which point it was checked and confirmed that the hooks were holding. Unfortunately, as the lifeboat was then being recovered it suddenly fell from a height of five metres, causing the death of a crew member inside and serious injury to others.

Upon inspection it was found that all equipment was in working order and both lifting rings remained on the lifeboat falls. It should be noted that if one hook releases, the other will not hold the weight of the boat and inevitably will release also. It was concluded that one of the lifting rings was only partially inserted into the hook on the lifeboat and slipped out during recovery. On this particular lifeboat, the forward hook faces forward and the crew inside the boat do not have a good view through the access hatch when handling the hook and checking that the lifting ring is correctly inserted.

If the crew members had a good understanding of the operation of the hook and the indications that the lifting ring is fully inserted then this accident could have been prevented. The recovery procedures included the checking of the hooks with the falls taking the weight but the crew failed to identify the problem.

The Club recognises the need for lifeboat hooks to provide a clear visual indication of the release mechanism's status and recommends systems such as the 'SAFELAUNCH Lifeboat Release Hook' manufactured by Survival Craft Inspectorate Ltd in the UK. Each SAFELAUNCH release hook is provided with a colour coded indicator that provides a clear visual status of the release cam and the system is designed to be compatible with all existing types of conventional lifeboat and can be installed into new lifeboats or retrofitted to old lifeboats as an upgrade.
