Bulletin 424 - 07/05 - Orders under Pilotage

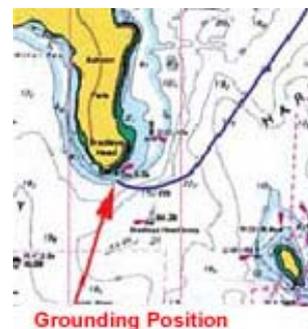
The Club would like to highlight to Members a case where a ship ran aground on a mud/sand patch just south of Bradleys Head light in the middle of Sydney Harbour. When the ship came to an intended course alteration position in the harbour east of Bradleys Head, the pilot initiated the turn to starboard to round the headland. He firstly ordered 5° starboard rudder and then, when the ship did not respond quickly enough, he increased the order to starboard 10°. The rate of swing increased markedly and so the pilot ordered port 20° to slow the swing. The seaman on the wheel confirmed the order as port 20° and instead applied starboard 20° wheel. Before the consequences of this error could be corrected, the ship ran aground on a mud/sand patch just south of the light on the southern end of the headland.

It is a common convention that, before ordering counter helm, a pilot would order the rudder be put amidships. This practice increases the salience of a potential change of rudder direction by directing the attention of the individual towards it. Therefore, without this cue, the possibility that a change of rudder direction was potentially imminent was reduced. This strategy is implemented as a means of reducing the risk of the type of error that occurred in this incident. It would be reasonable for a helmsman to anticipate such an order before applying the rudder in the opposite direction, especially given that the pilot had used this order before.

At the time the helmsman made the misapplication of the pilot's order for 'port 20' the other members of the bridge team were not directly monitoring his actions. Both the pilot and the master were looking forward, watching the foremast move in relation to the land, to assess the vessel's rate of turn. The second mate was busy at the radar on the starboard side of the helm taking a range. While all three men quickly realised the helmsman's error and responded rapidly to correct it, the vessel's proximity to Bradleys Head, its handling characteristics and rate of turn were such that the grounding was possibly inevitable at this point.

- Pilots and bridge teams should ensure the conventions governing helm orders are observed, particularly the use of 'midships' when changing rudder direction and also consider the use of hand signals to supplement verbal steering orders.
