Ship Type: All Trade Area: Worldwide

Bulletin 530 - 06/07 - Fatal Elevator Shaft Incident - Worldwide

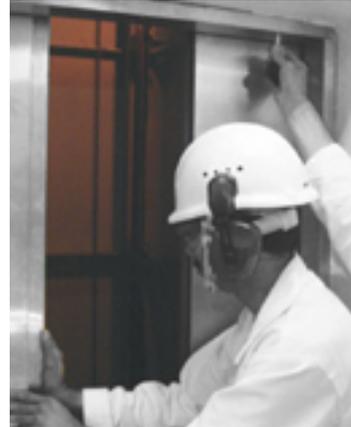
The incident occurred after the electrical technician stepped into the elevator shaft and the second deck elevator landing doors were allowed to close behind him. When the doors closed, the landing door safety circuit was completed. The elevator control system then reset itself and, shortly afterwards, the elevator responded to a landing call. The elevator car moved upwards until its movement was obstructed by the electrical technician. The resultant damage to the elevator car allowed the car doors to open slightly, causing the elevator to stop.

From the evidence available, the ATSB concluded the following contributing safety factors:

1. The ship's elevator instruction manuals did not provide the crew with sufficiently detailed and unambiguous safety guidance.
 2. The ship's safety management system risk minimising strategies, including the permit to work system and the risk assessment process, were not implemented before the electrical technician started working on the elevator second deck landing door switches.

3. The electrical technician, the second engineer and the third engineer were either not aware of, or did not consider, all of the hazards associated with working in the ship's elevator shaft.

4. The ship's crew were not supplied with sufficient guidance or instruction that would have assisted them in determining which tasks required a formal risk assessment.

5. Appropriate safeguards were not put in place to ensure that the elevator car could not inadvertently move while the electrical technician was working in the elevator shaft.

- The ATSB recommends that the elevator manufacturer takes action to address point 1 above.
 - With regards to points 2 and 3 above, the ATSB (through Marine Safety Advisory Notices MS20070005 and MS20070006) advises ship owners, operators and masters to consider the implications of this safety issue and to take action when it is considered appropriate.
