# LP BULLETIN

## Bulletin 548 - 10/07 - Automatic Identification Systems (AIS) Errors - Worldwide

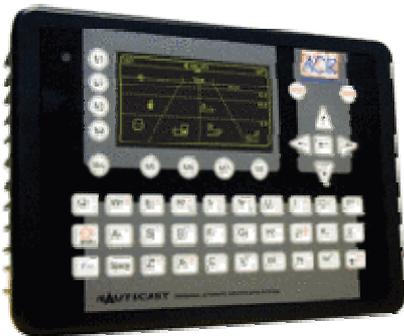
Replacing MIN 243, this recent notice warns that a small number of the ACR/Nauticast AIS systems transmit a default MMSI (1193046). This has the potential, in certain circumstances, to cause 'target swap' with a possible consequence that more than one ship can appear as a single ship.

The problem may be caused by the MMSI not being set when installed, or by the system memory reverting to default settings in the event of loss of power. The MCA notice contains manufacturer information on how to check and change your MMSI numbers.

Users of this system should check the operation of their AIS to assure that an MMSI has been correctly installed in the AIS. Check the condition of the memory backup battery periodically as follows:

- With the AIS powered up, check that the MMSI is entered into the AIS system
- Remove power from the AIS system for approximately two minutes
- Apply power to the system and check that the correct MMSI is present
- If step 3 shows the default MMSI of 1193046 then the memory backup battery is probably discharged and must be serviced.
