# The Nautical Institute Mariners' Alerting and Reporting Scheme

MARS Report No 218 December 2010

## MARS 201065

### Gangway fall wire parted

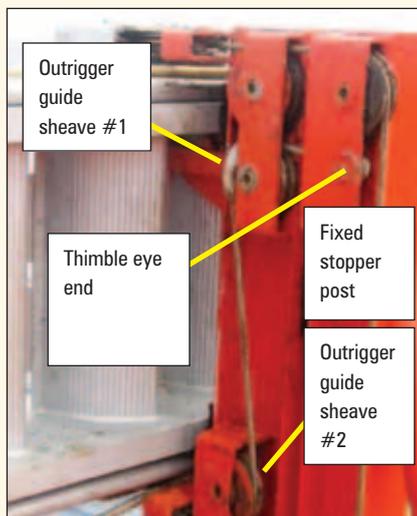
3. Although the visual inspection was done in accordance with company requirements, considering the position where the wire parted (see Figures 1 to 3, p18), we have to assume that due to difficulty of access, this particular part of the wire fall was neither thoroughly maintained nor inspected, although overall greasing of the wire falls was carried out monthly and recorded in the monthly maintenance reports.

◀ Figure 1: Stowed gangway with outrigger housed against stopper post

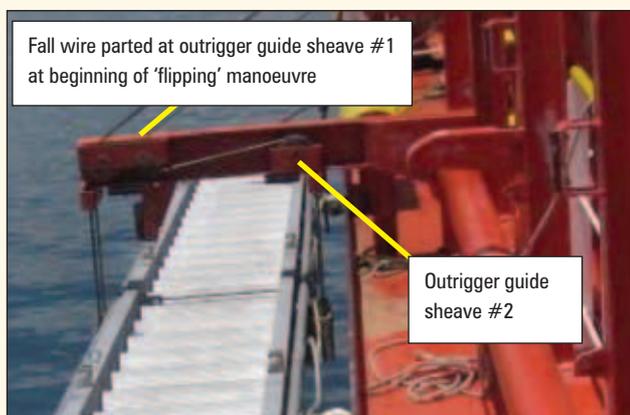
▲ Figure 2: Gangway being hoisted, approaching 'flipping' point, when the system will be subjected to maximum stresses

**Editor's note:** In this arrangement, the wire fall will have permanent high stress-points on the sections in way of the sheaves when the winch begins flipping the gangway and outrigger together. This perhaps explains why the fall wire parted precisely at that time and location. Apart from the strain at these points, constant exposure to wind and sea and difficult access can prevent proper inspection and maintenance of the wire fall. A dry pivot bearing of outrigger can also impose additional load, so proper greasing and lubrication of all moving parts is important.

It is not clear in the report if the gangway hoisting system was fitted with an operational limit switch. Such a safety device will ensure that during final stowing, the power is cut off before the system is overstressed due to operator error. The final tightening of wire falls must be always done manually and only efficient sea lashings must bear the dynamic loads at sea.

It is also suggested that the makers of the accommodation ladder and the wire falls be informed of the incident, with a request for a recalculation of maximum stress in the system. If appropriate, a larger diameter wire for the falls may have to be used. This will require the replacement of all sheaves as well.

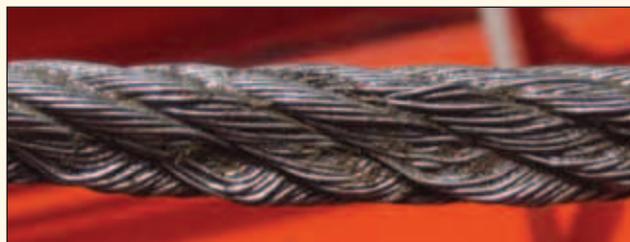
gangway's fall wire rope was thoroughly inspected and was found to be deformed at the same corresponding section. This wire was also renewed and a satisfactory hoisting and static load test on both port and starboard accommodation ladders was undertaken.

▲ Figure 3: Port gangway wire fall showing deformation

1. Fall wires were renewed on both accommodation ladders and thereafter they were closely inspected and successfully tested under load;
2. Safety officers will be duly trained on how to carry out safety inspection on board the vessels;
3. Company quality, safety and environmental (QSE) manual is being revised to include specific instructions/guidance on how and when to carry out inspections;
4. The safety officer inspection checklist has been amended with specific requirements over the control of the condition of all wire falls;
5. Inspection guidance to also include instructions related to components/parts that are not easily accessible, to ensure that their condition is properly verified;
6. Incident report circulated to the fleet. Masters have been
