Friday 16th March 2012

Bulletin 816 - 03/12 - Dangers of pressing up ballast tanks - Worldwide

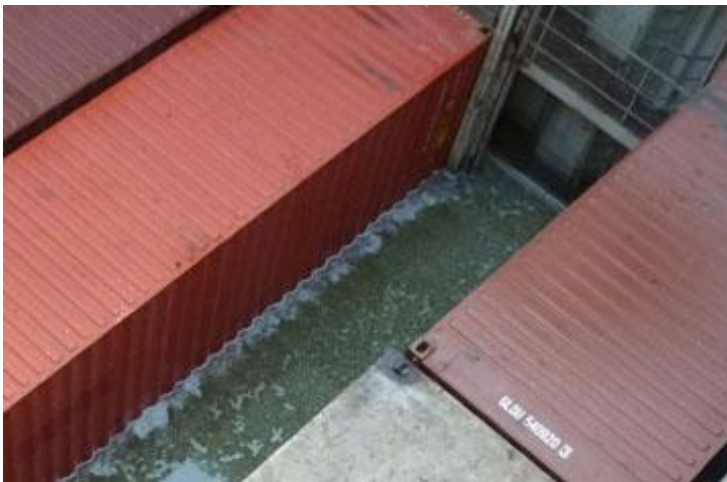
An entered containership was carrying out ballast exchange operations mid voyage and pressed up one set of double bottom ballast tanks. On arrival it was observed that one of her holds had significant water inside and considerable damage to bottom stow cargo.

The vessel had recently opened up several manhole covers for routine inspection of her ballast tanks.

After the incident it was noted that the high level bilge alarms in the hold were not functioning.

Whilst investigations are still continuing into this particular case it maybe timely to remind Members that poorly secured manhole covers are still a frequent cause of water ingress into holds, many, but not all, arising after drydocking where shore staff have not secured covers properly.

- If double bottom manhole covers are removed for whatever purpose it is recommended a note be made of where and when, this not only acts as an aide memoire but also helps in defending claims should water ingress occur

- Good maintenance should also be in place, the manhole covers/gasket arrangement and like should be routinely checked, if not already included as part of the routine inspection / maintenance programme associated with the ship's ballast tanks
- Hold high level bilge alarms should be tested on a regular basis, logged and defects, if any, rectified immediately.
