Seaways

The International Journal of The Nautical Institute

Mariners' Alerting and Reporting Scheme

MARS Report No. 266 December 2014

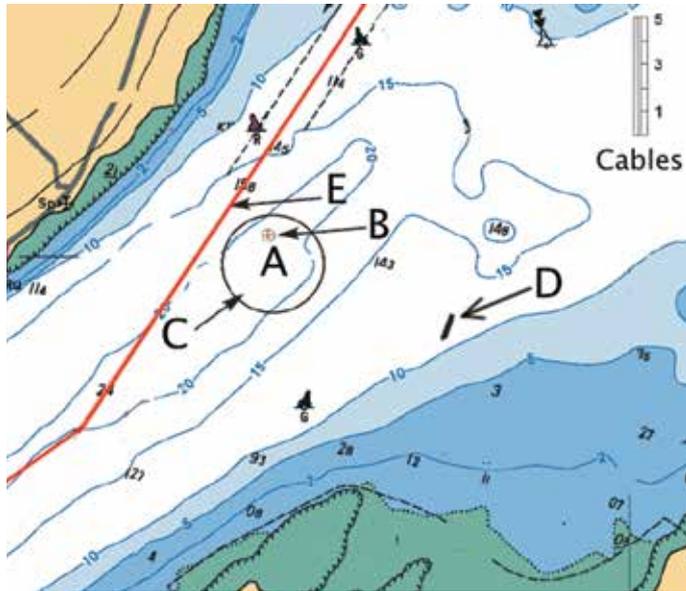
➔ The vessel, loaded to a draught of 13.5 metres, was upbound in a river estuary. Before arrival, the Master was advised the intended berth was not yet free and to anchor at a short term, ad-hoc anchorage downriver from the port. The vessel was anchored using seven shackles of chain in position A (see diagram), which gave a swing circle as indicated by C. The weather forecast for the next few days was relatively good; as per the agent's arrangement, the captain released the pilot.

The main engine, windlass and other equipment were kept on emergency standby and the position of the vessel was monitored frequently. The next day, the pilot of another vessel in transit reported to VTS that the anchored vessel was a hazard to shipping due to its proximity (B in the diagram) to the upstream end of the main fairway (E). He also indicated that the vessel had probably dragged its anchor although it was still within its swing circle. Concerned about the safety of the navigation, safety of the vessel and given that there was no pilot on board, he suggested that the vessel be moved.

As the winds increased, and with an ebb tide running northeast at 2.5 knots the vessel began to drag anchor. The Master tried to manoeuvre the vessel but it continued to be driven by the wind and current toward the shore; during the attempts to manoeuvre the anchor was weighed. About an hour after the initial dragging the vessel's crew reported they had been pushed aground (D on diagram).

After re-floating, the damage survey showed the vessel had sustained damage to its bottom plating in way of the forepeak and ballast tanks 1, 2, and 3. Additionally, three blades of the propeller were deformed and two were fractured. Also, the port bilge keel in way of ballast tank 3 had buckled over a length of about 1 metre.

- Considering the large size and deep draught of the vessel, the low keel clearance, the strength of the currents and winds and its limited room for manoeuvre, the vessel was not anchored safely in an appropriate anchorage.
- A risk-based approach was not used by various agencies to identify anchorages that pose unique risks. This in turn permitted vessels to be assigned anchorages that may not be suitable.
- Water depth to draught ratio (Wd/D) is an important factor to consider when anchoring in strong currents, as smaller ratios will cause greater forces to act on the hull (and thus may cause the vessel to drag anchor). For example, a large full-bodied vessel in a five knot current will experience nearly three times as much hydrodynamic force on its hull with a Wd/D ratio of 1.2 than had the ratio been 3.

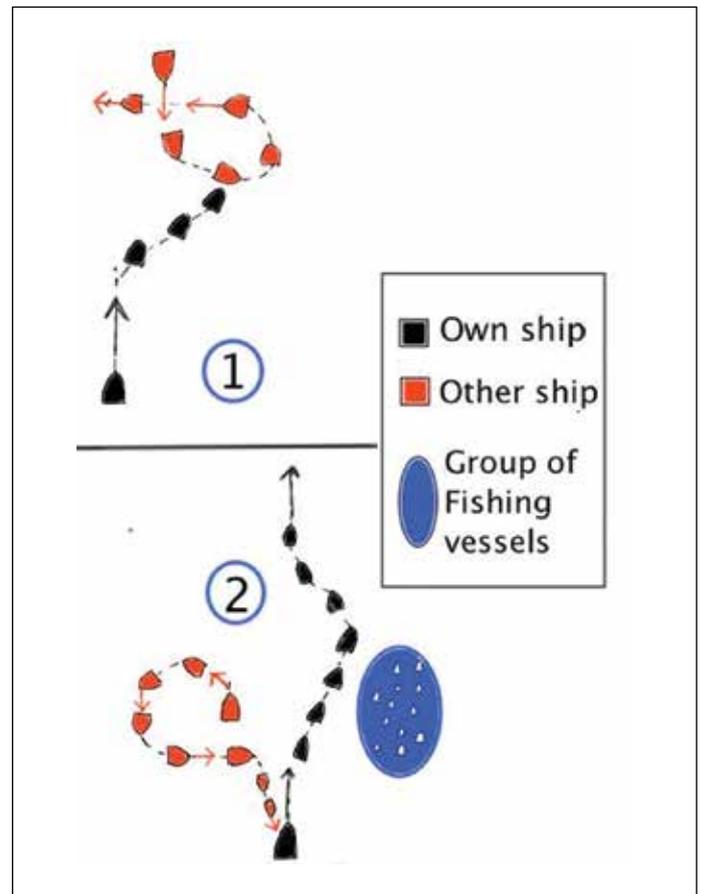
➔ Own vessel was making way in a busy strait. The OOW and the Master were on the bridge; the OOW plotted another vessel on reciprocal course passing on the starboard side with CPA of 2.5 nm. A few minutes later, the other vessel was observed to alter course to port, ostensibly to increase CPA. However, shortly thereafter this vessel was observed to continue altering to port, effectively coming around 270 degrees and transforming the meeting into a crossing situation (red ship in diagram number one). Since own vessel was now the give way vessel, appropriate action was taken by altering course to starboard.

After about 10 minutes, both vessels were now heading in the same direction (diagram number two) when the other vessel again altered to port and created a crossing situation. Own vessel had numerous fishing vessels on the starboard side and could not safely alter in that direction. The OOW noted that own vessel was the stand on and the other vessel was required to take avoiding action. As the situation developed the other vessel did not take avoiding action so own vessel altered to starboard to the extent possible given the fishing boats. Once the situation was clear the other vessel called up own vessel on VHF radio and advised that they were carrying out 'Safety Manoeuvres' and asked own vessel to stay clear.

- All the actions taken by own OOW were in compliance with R.O.R. Other vessel showed clear disregard for R.O.R and to their and own vessel's safety. Since it was open sea condition with sufficient sea room available as compared to congested waters, actions taken by own OOW were correct and in compliance with company's procedures.
- A short navigation meeting was carried out with all bridge team members to inform them of the situation. The importance of proper lookout was emphasised.

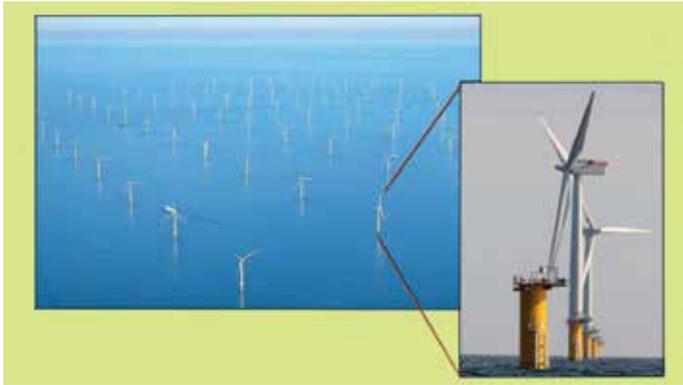
➔ The captain of a wind farm service vessel was navigating within the wind farm as the weather worsened, with winds gusting to 40 knots, driving rain and heavy seas and swell. The captain, as was the practice once 'inside' the wind farm, had put the radar into standby mode. Trials have demonstrated that, at close range, a wind farm may

produce multiple reflected and side lobe echoes that can mask real targets. Employing radar within a wind farm is not reliable; therefore, the decision by the captain not to employ the radar while transiting the wind farm was understandable.

Although the chart plotter, with all the turbine towers clearly indicated, was operating on an appropriate scale, the captain chose not to use the system to monitor the vessel's position. Given that the safety lights of the turbines were functioning, and his familiarity with navigating in the wind farm at night, he was confident in his ability to maintain situational awareness by eye alone. However, as he attempted to navigate through the wind farm by visual means, the vessel struck a turbine tower at approximately 12 knots. The collision resulted in minor injuries to some of the crew and considerable damage to the vessel.

The investigation revealed that passage plans had not been completed for any part of the journey. Additionally, the captain was navigating visually and relied on the safety lights located on the wind turbine towers for his situational awareness. However, in this instance, the tower which the service vessel struck was not illuminated.

- The captain was relying solely on the turbine safety lights and didn't make good use of the lookout and navigation equipment on board.
- There was no formal assessment of new Masters, allowing the possibility of ingrained poor working practices being passed on and perpetuated.
- Poor seamanship was evident by failing to keep a proper lookout using all available means appropriate in the prevailing circumstances. Many investigations commonly highlight an OOW having relied too heavily on navigation equipment and not 'looking out of the window'. In this case, the opposite was true as insufficient use was made of the navigation equipment available.
