Providing learning through confidential reports – an international cooperative scheme for improving safety

MARS 201135

Hazards of Hydrogen Sulphide (H₂S) gas

Loose grating causes fall and injury

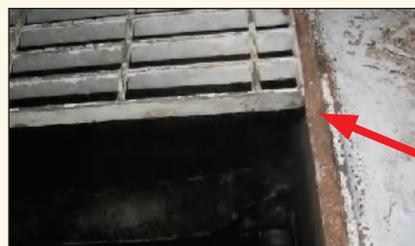
During coastal passage, the chief engineer inspected the lower side of the forward seal of the stern tube as part of his rounds. He then turned around and proceeded forward towards the ladder leading up to the bottom plates. He stepped on a flat-bar and rod grating section forming part of the walkway along and underneath the tail-end shaft. The grating section was too small for the bilge well that it covered, and fell down into the well. Thrown off-balance due to the fall, the engineer's right leg hit the exposed sharp edge of the bilge well with great force, inflicting a serious gash wound extending almost the full length of his shin bone. After being rescued and given first aid, he was medevaced by helicopter to receive medical treatment on shore.

1. Mismatch in dimensions of grating section and bilge well opening resulting in grating being insufficiently supported by the edges of the bilge well;
2. No lock bolts fitted on the grating;
3. Due to the location's low lighting levels and difficult access, the potential hazard could not be readily seen;
4. The location was not included in the unmanned operation route risk assessment check list as crewmembers rarely go there.

◀ Figure 3: View of loose and under-size grating

Grating just touching edge of bilge well opening instead of resting fully on lip

1. Fleet advised to thoroughly inspect all gratings, floor plates, their supports and locking devices for proper and secure fit.
2. Safely carry out necessary modifications to any similar deficiencies and/or deformed floor plate(s). For example, proper lock bolts or an angle bar support should be welded in place to prevent the fall of a grating or floor plate section. Alternatively, hinges should be welded on those sections that are frequently removed for inspection.
3. Post appropriate warnings and fence off the opening when any grating or floor plate is removed temporarily for access.
