# The Nautical Institute Mariners' Alerting and Reporting Scheme

MARS Report No 229 November 2011

Providing learning through confidential reports – an international cooperative scheme for improving safety

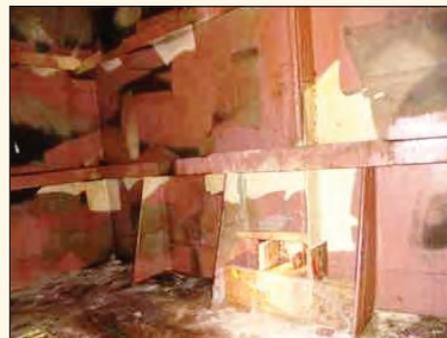
A double-hulled oil tanker with segregated ballast tanks (SBT) was standing by off-limits at a loading port in good weather. In accordance with the pre-arrival schedule and loading plan, extra ballast was being pumped out. When 2S Water Ballast Tank (WBT) was discharged, an oily sheen was observed on the sea surface. Deballasting was immediately stopped and investigations detected an oil layer (innage) of about 15 cm on top of the ballast water in the tank. Shore management was informed, the oily mixture from tank 2S WBT was skimmed off with a portable salvage pump and transferred to 3S cargo oil tank (COT) and from there, to the slop tank. Thereafter, No. 2S WBT was superficially washed and gas freed to make the tank safe for human entry. After complying with all safety procedures, the inspection team entered the tank. They discovered that during the previous loaded voyage, oil from the adjacent cargo tank had leaked into the ballast tank through a crack on a weld seam approximately 3.5 metres below the deckhead, at the intersection of the longitudinal bulkhead and first stringer flat.

Poor standards and improper workmanship / quality control on the part of the shipbuilder.

◀ View of temporary repairs showing cement box within retainer plate wedged between stiffener brackets

1. With approval from shore management and under close monitoring of tank atmosphere, temporary repairs were carried out by drilling crack-arrestor holes, jamming a retaining steel plate between adjacent brackets and casting a cement box over the crack;
2. Risk assessment was carried out for a revised loading condition with reduced quantity of oil in the adjacent cargo tank so as to load to a level below the crack in the weld seam;
3. On the loaded passage, regular atmosphere and content checks were carried out on all ballast tanks. No leakage or ingress of hydrocarbon vapours was observed in any tank;

6. On completion of discharging operations in North Europe, the vessel proceeded to a reputable ship repair yard for permanent repairs which were executed safely and without any incidents.

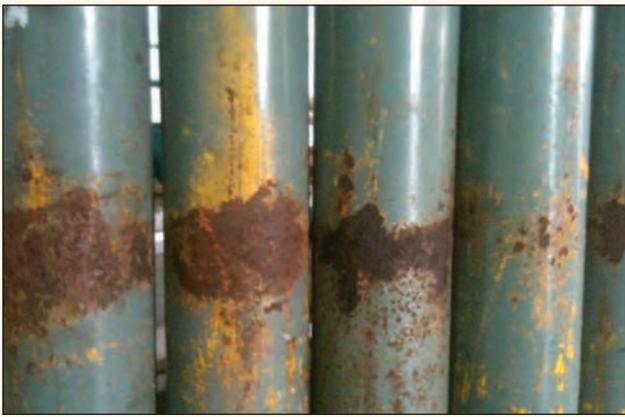
▲ View of localised corrosion on the exterior of air cylinders

the vessel arrived in port, a local lifeboat service company was contracted to investigate the incident and assess the damage with a view to carrying out repairs. In the absence of supporting documents (certificates/ work reports etc.) and from the dates punched on the cylinders, it appeared that it was more than six years since the last hydraulic test of the air cylinders. (IACS Recommendation No.88: Air bottles for air supply in totally enclosed lifeboats should be hydraulic pressure tested by a competent service station recognised by a Recognised Organisation at intervals not exceeding 5 years and the hydrostatic test date must be permanently marked on the bottles.) The substantial corrosion of the cylinders' exteriors suggested that routine inspections and maintenance had also been seriously neglected. After the air cylinders were removed and closely examined, it was ascertained that the cylinder shells had suffered a 50% diminution in thickness in the corroded patches.

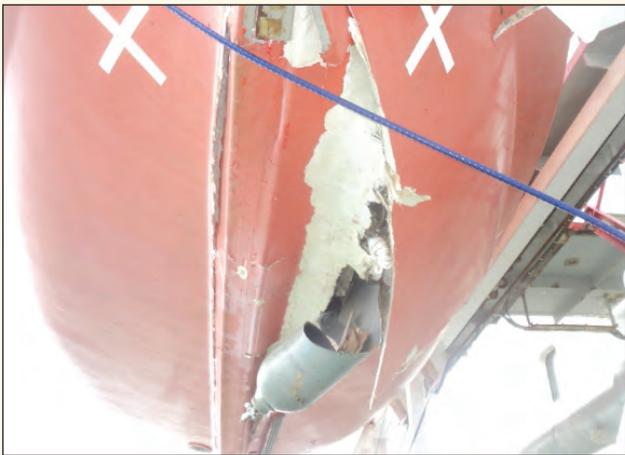
An oil tanker's totally enclosed fibreglass lifeboats were equipped with high-pressure air cylinders stowed beside the keel. One day at sea – shortly after the lifeboats had undergone a 5-yearly inspection by an accredited contractor – one of the compressed air cylinders suddenly and spontaneously burst, resulting in extensive damage to the lifeboat's keel and hull. Fortunately, no-one was injured. Once

▲ View of damaged hull and ruptured air cylinder

After assessing the damage, the lifeboat was deemed to be beyond economical repair. It had to be scrapped and a replacement lifeboat obtained.

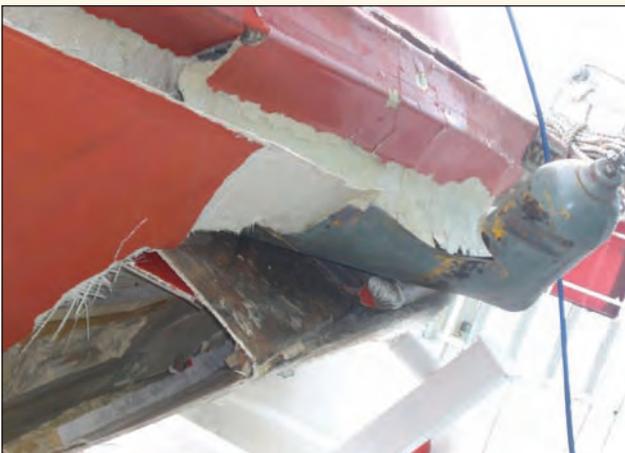
▲ Close-up view of damaged hull and ruptured air cylinder

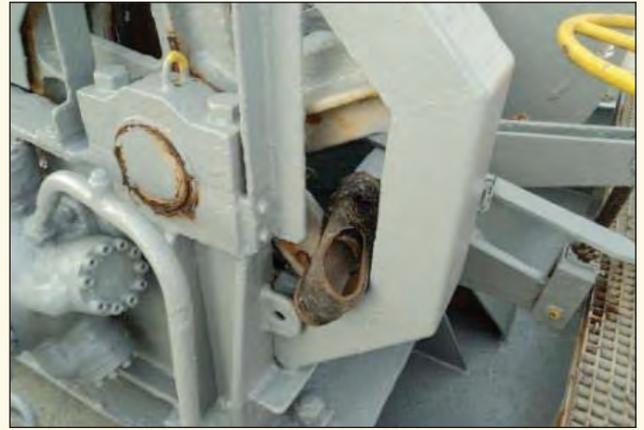
In preparation for arrival in port, two seamen were assigned to bring out mooring ropes from the forward rope store and coil them on the forecandle deck. The OS was operating the windlass/mooring winch control lever, which was at about chest-level for a person of average height, and the AB was handling the rope on the warping barrel, situated about 4 metres outboard. Presumably in order to adopt a more ergonomically efficient stance for holding the control lever in its operating position, the OS placed his right foot on a welded pad eye on the supporting bracket for winch shaft bearing. Inadvertently, he pushed his foot into the gap between this bracket and the circumferential guard of the main driven gear wheel and into the path of the rotating spokes. Instantly, his foot was trapped and crushed. He was given first aid and was hospitalised soon after arrival in port the following day.

▲ Reconstruction of accident showing how OS's right foot was trapped between a rotating spoke, gear wheel guard and winch shaft bearing support bracket

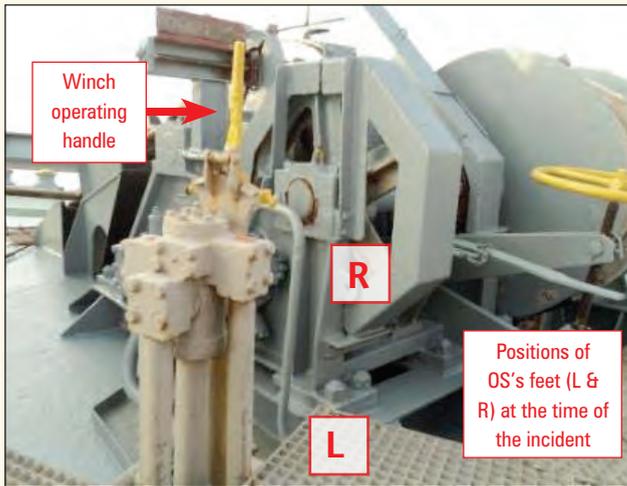
▲ View of accident site

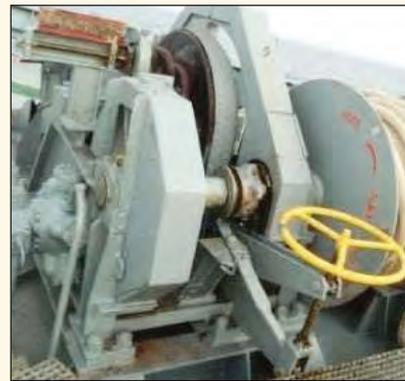
◀ Preventative action completed – steel plate guard made and bolted over gap between gear wheel guard and winch shaft bearing support bracket

A steel guard plate was fabricated and fitted over the gap existing between winch shaft bearing support bracket and peripheral gear wheel guard.
