Providing learning through confidential reports – an international cooperative scheme for improving safety

MARS 201156

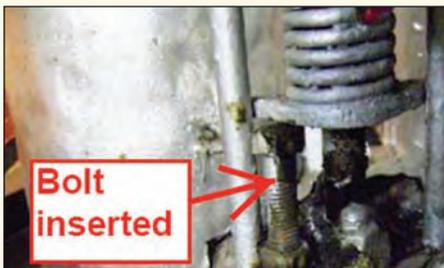
QCVs are positive shutoff valves that are designed to isolate oil tanks in the event of a fire and also prevent fuelling of a fire in circumstances where system piping and components are compromised. These valves are designed to be remotely operated, and are also capable of being operated and reset locally. Inoperable QCVs can put the vessel and its crew at greater risk in the event of a fire and it is absolutely critical that they operate correctly, are properly maintained, and ready for use at all times. Adequate knowledge, training, instructions and stocks of replacement spares must be provided to ship's staff to ensure the reliability of the remote operating arrangements. Intentionally blocking or disabling these valves (as shown in the following photographs) is unacceptable under any circumstance.

◀ QCV disabled by inserting a bolt (Note: The bolt is partly painted, indicating it has possibly been there for some time.)

Bolt inserted

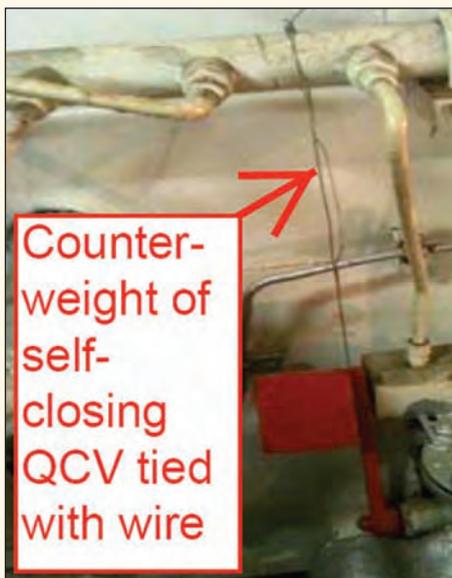
▶ QCV disabled by tying the counterweight with wire

Counterweight of self-closing QCV tied with wire

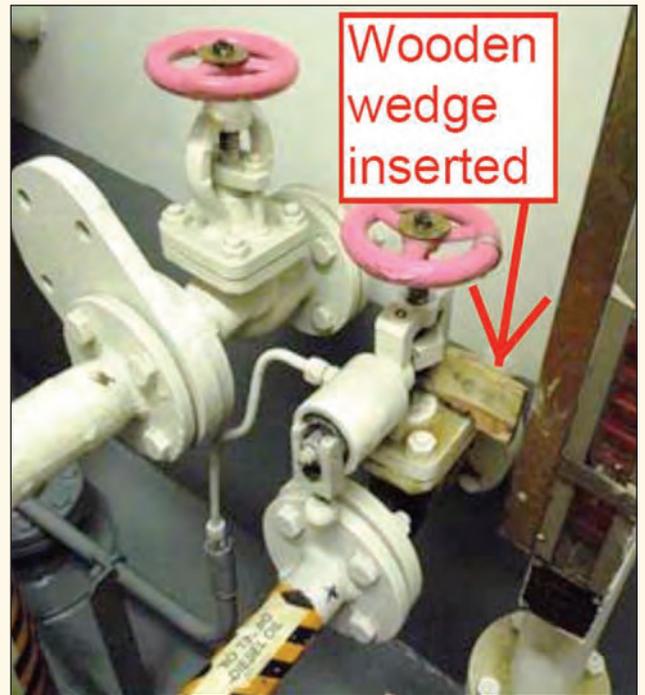
Wooden wedge inserted

▲ QCV disabled by inserting a wooden wedge
