Providing learning through confidential reports – an international cooperative scheme for improving safety

MARS 201215

Release of inert gas/cargo vapour mixture at berth

MARS 201217

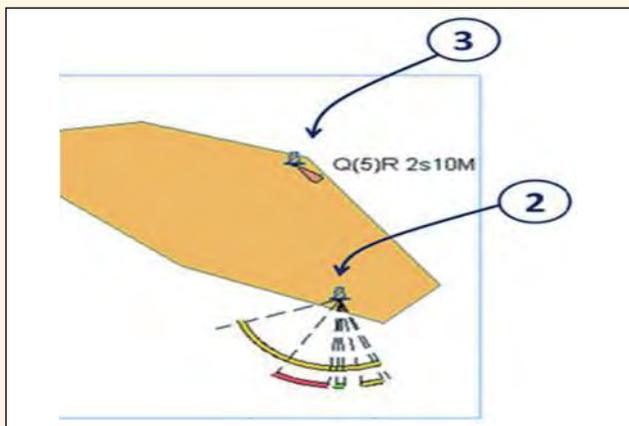
While the anomalies range in their potential seriousness for safety of navigation, there were concerns raised over the display of underwater features and isolated dangers; the display of complex lights as intended; the display of 'submerged wreck - dangerous' as intended by the standards; the display of 'underwater hazard with a defined depth' and the display of Archipelagic Sea Lanes (ASL), Environmentally Sensitive Sea Lanes (ESSA) and Particularly Sensitive Sea Areas (PSSA) properly.

▲ Q2 & 3 portrayal of complex lights. Is object 2 same as in the illustration? Are light characteristics same as in the illustration

In order that all mariners using ECDIS are fully aware of any limitations in the use of their particular ECDIS, owners, managers, ship operators and ships' officers should ensure that they complete the IHO data checks on their ECDIS/ECS and also report the results back to IHO. If you have not yet received the check data it can be downloaded from the IHO website (<http://www.iho.int>) via the Newslink button on the homepage.

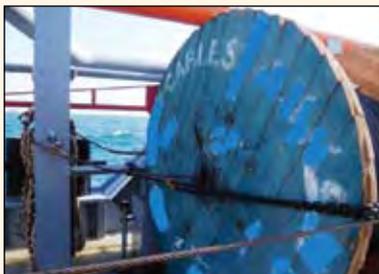
Soon after sailing, the ship rolled and pitched heavily in a gale, and the accelerations imposed large forces on the lashings. Suddenly, a link in the chain parted and the tugger wire instantly became slack. Subsequent movements displaced the wedges and the bridge watch observed the reel moving freely on the deck. The Master was called, speed reduced to minimum and heading altered into the sea and swell. With the ship now pitching gently, the crew managed to throw some square timber (4x4's) across the path of the runaway reel path and gradually regained control over the hazardous situation. A dunnage 'grid' was quickly nailed around the base and the reel remained safely inside this

▲ View of unpacked wooden cable reel – note very narrow central hole with lifting wire sling rove through, chain and tugger wire tightened at mid-height.

1. Unpacked wooden cable reels, especially those with a very narrow central hole, cannot be effectively secured and must be shipped only in containers or skids;
2. Cable reels made of steel with exposed cross-members or spokes may be shipped unpacked, but must be secured with sufficient number of lashings (chains or wires) and wooden wedges as determined from the vessel's approved Cargo Securing Manual (CSM) or as per the guidelines contained in the IMO publication Code of Safe Practice for Cargo Stowage and Securing (CSS Code);
3. Packing a cable reel inside a timber and plywood skid before shipping on a vessel offers an effective and economical method for safer carriage by sea.

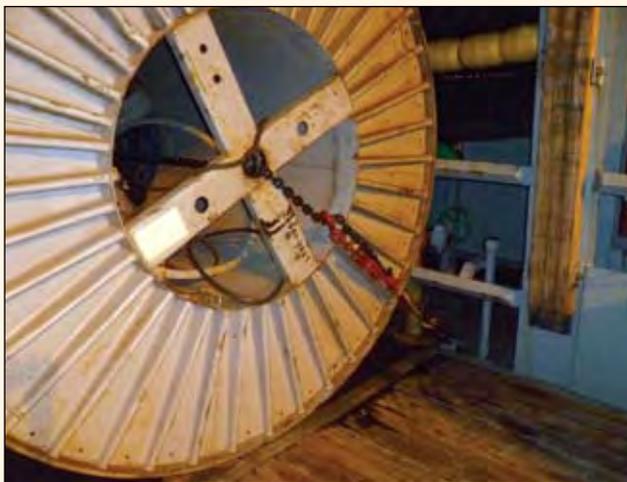
▲ Cable reels made of steel can be more effectively secured

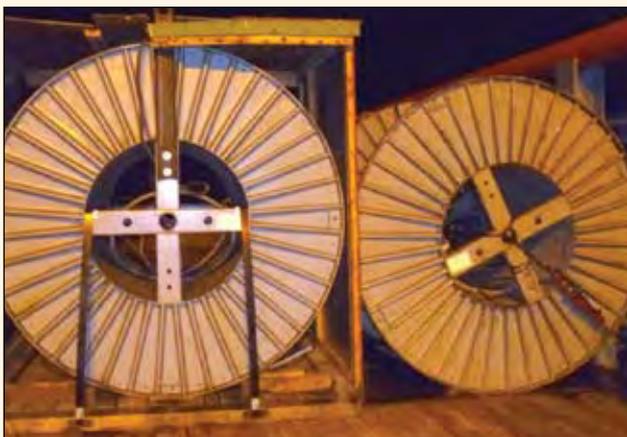
▲ Unpacked cable reel blocked by another cable reel packed on a wooden skid

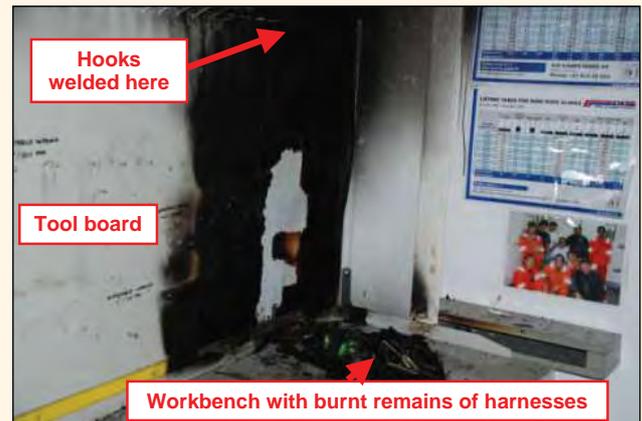
The bosun completed a permit for hot work form, which was approved by the OOW (2/O), who failed to detect several factual and procedural errors and did not conduct a proper discussion or risk assessment. Working alone, the bosun welded one of the hooks to the bulkhead and attended briefly to another errand. The second hook was then welded adjacent to the first one, this time with a seaman also present. Neither of the men paid attention to the cardboard box containing harnesses (made of flammable synthetic fibre) that was lying on the workbench directly under the weld site. They then left the area for a short break. Some minutes later, as the master exited the wheelhouse, he found thick black smoke billowing from the open door of the workshop. He shut the door, returned to the wheelhouse and informed the bosun on the radio that there was a fire in the deck workshop. While the bosun rushed to the site with the other ratings, the master sounded the fire alarm and ordered the 2/O to take the nearest fire extinguisher to the location. Upon arrival at the scene, the bosun opened the door and could see flames on the work bench through the dense smoke. He briefly entered the space and rapidly discharged a portable CO₂ and a foam extinguisher. This was followed by a water jet from a charged fire hose and the fire was soon extinguished.

1. No proper risk assessment was conducted;
2. Combustible materials were not removed from the worksite prior to the commencement of hot work;
3. No dedicated fire watch was in place either during the hot work or after it was completed.

▲ View of interior of deck workshop cum store showing fire damage

1. A system for the delivery of training in use of the permit-to-work system, risk assessment methods, and the general management of hazardous tasks is developed and implemented. The system shall include a review of training in general to determine if training is also required in other areas;

3. The definition of hot work (previously only gas-cutting and welding) is expanded to include burning, brazing, grinding, soldering, thermal resistance heating, etc;
