Mariners' Alerting and Reporting Scheme

MARS Report No. 236 June 2012

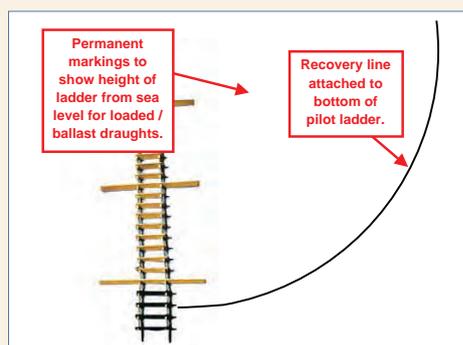
Corrective action No 5 implemented

- 1 Gangway to be lowered to designed level ($\leq 55^\circ$ angle above horizontal);
- 2 Pilot ladder rope lashing changed from 8mm to 16mm since the larger rope requires only one turn around the ladder and cleat;
- 3 The fore side of the pilot ladder to be lashed first and then the aft side;
- 4 During rigging and unrigging operation, the pilot ladder's bottom steps shall be kept at least 4 metres above the sea level by means of the recovery line;
- 5 Pilot ladder marked to indicate at upper deck one, two and three metre clearances from ladder bottom to sea level for both ballast and laden conditions.

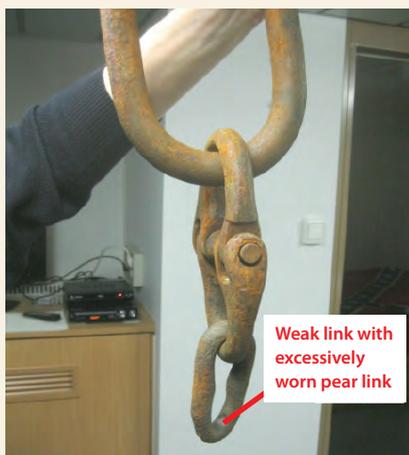
- 9 Ineffective maintenance of terminal's mooring system – excessive wear on small pear link of the weak link which was not noticed or rectified by the terminal operator;

Weak link with excessively worn pear link

After re-mooring, the SPM mooring string's weak link was temporarily removed, inspected and also found to be worn beyond safe limit

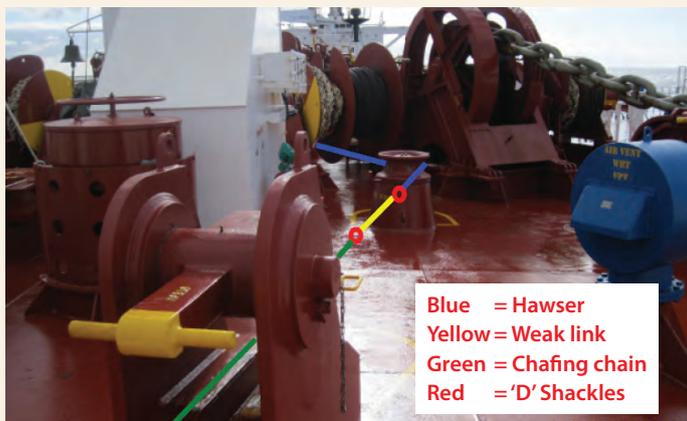
- 10 Sharp nip in the hauling part of the chafe chain at the deck pedestal roller;
- 11 Failure to lower the cargo hoses into the water before releasing mooring;

Illustration of mooring arrangement before commencing heaving on the hawser – note the sharp nip around the pedestal roller

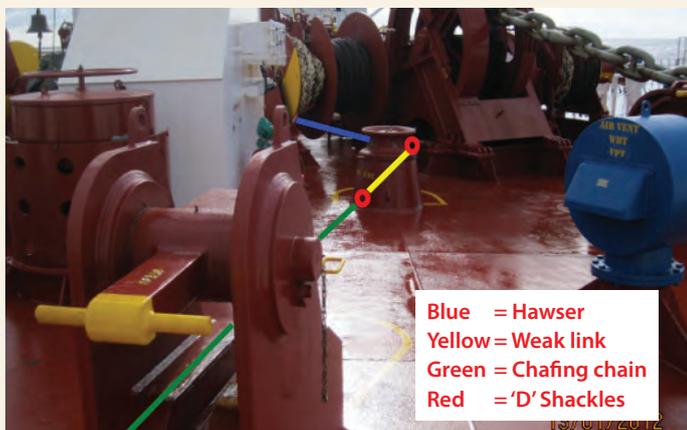
In this position, the weak link lay exactly on the roller of the pedestal fairlead. Due to the sharp nip around it and the resulting high stress, the inboard pear link parted without warning and the chafe chain together with the outboard end of the broken weak link violently flew out through the chain stopper and fell into the sea. Fortunately, no serious injury resulted among the dangerously exposed crew, except for a small piece of rust that embedded itself in the Bosun's face, just above the left eye. The bridge was informed and while the other crew attended to the wound and removed the rust particle, the vessel now started slowly moving astern, away from the SPM.

Illustration of mooring arrangement after the hawser was heaved in with the weak link sharply nipped on the pedestal roller. The pear link parted at this point.
