# Mariners' Alerting and Reporting Scheme

MARS Report No. 237 July 2012

## Collision and oil spill in TSS

### Engine room fire

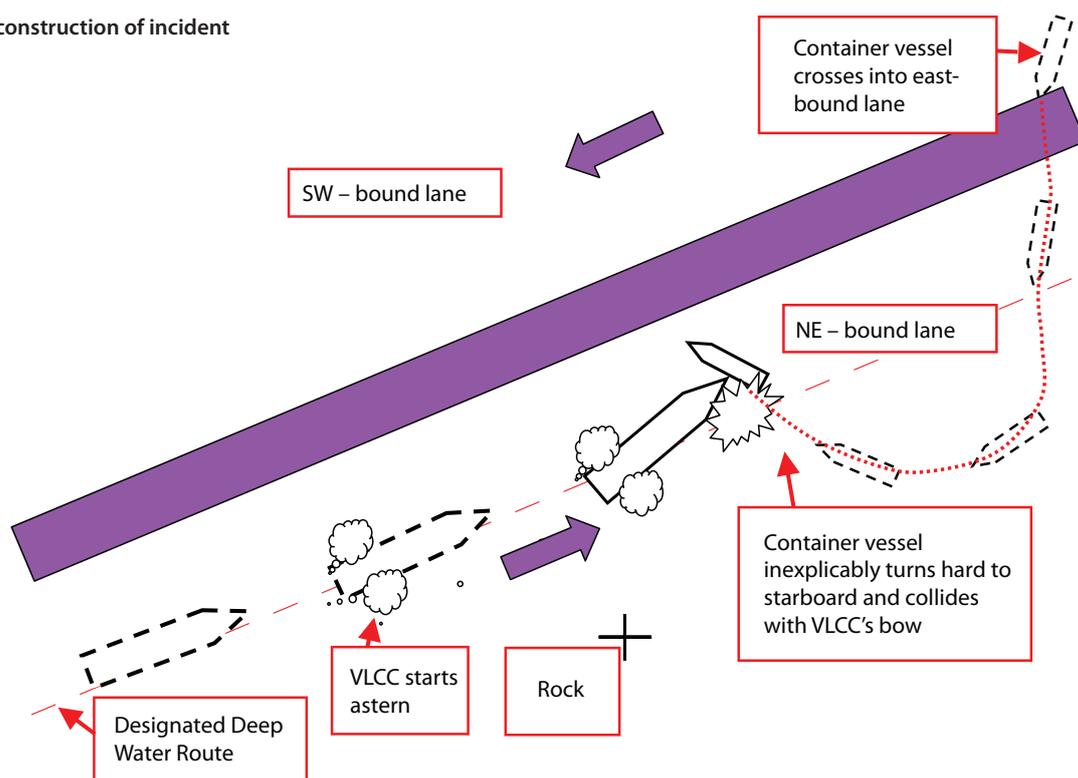
starboard and, on a NW'ly heading, was heading directly for our tanker's bow. With our ship still making headway, the container vessel's port quarter came into contact with our vessel's bow. The collision resulted in multiple indentations on our vessel's bow area and a breach in the container vessel's port bunker tank, resulting in an oil spill.

Hypothetical reconstruction of incident

- 1 Violation of COLREGS Rules 5 (Lookout), 8 (Action to avoid collision), 10 (Traffic separation schemes), 17 (Action by stand-on-vessel) and 18 (Responsibilities between vessels) by rogue container vessel;
- 2 Residual headway of own vessel despite the emergency full astern manoeuvre.

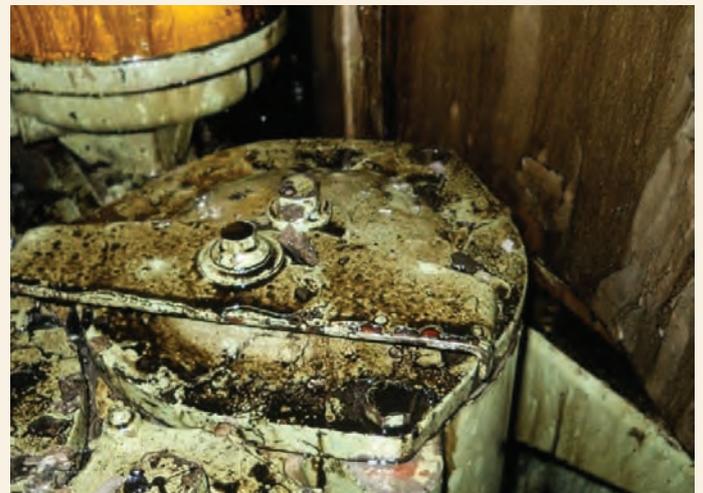
- 1 Sudden shearing off of one of the three bolts that secures the lubricating oil filter cover of A/E #2. The cover was displaced and lube oil under pressure splashed on to various hot components of both running generator engines and ignited;
- 2 Although the engineers reacted correctly and quickly stopped both generator engines, the lube oil priming pumps continued to operate, powered by the emergency power source. This resulted in the unintended spill of all the lube oil in the sump of the A/E #2 engine, which fed the fire;

View of displaced fuel filter cover

- 1 A special safety meeting was held on board to emphasise the importance of carrying out risk assessments, tool box meetings and discussing all the anticipated risks when allocating jobs for the day;
- 2 Anti-splash sheaths, guards for filter covers and extra securing arrangements for cover bolts were fabricated and fitted for all lube oil pipes and filters on generator engines; even though these are not formally required;
- 3 Renewal/cleaning of the filters and other critical parts of the generators will be supervised by the senior engineers;
- 4 Restoration of all engine room areas affected by the fire (coating renewal, renewal of damaged electrical wires and other associated fittings) was commenced immediately;
- 5 All auxiliary engines were made fully operational and successfully load-tested.

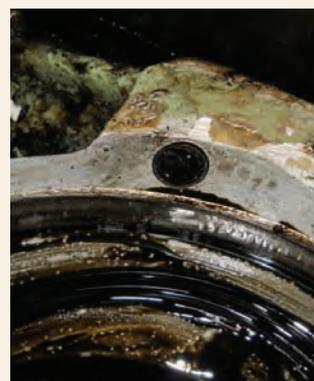
Close-up view showing sheared bolt of filter cover

- 3 Suspected improper tightening of the filter cover bolts and lack of proper inspection, especially as it is known that these fittings could be subject to wear down or loosen due to vibration / internal pressure;
- 4 Presence of combustible material such as felt filter covering the engine turbocharger (T/C) blowers, plastic light fixtures that added to the intensity of the fire.

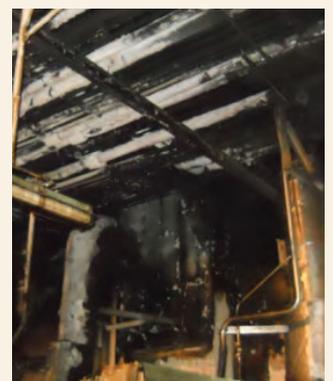
View of fire damage

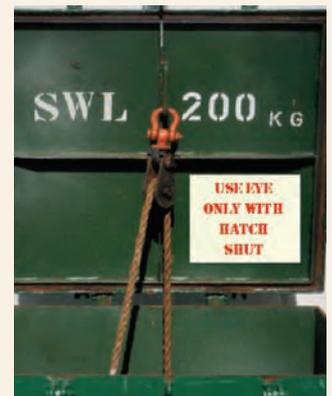
View of pump room hatch in shut position
