### MARS 200866

#### Traffic lane violation

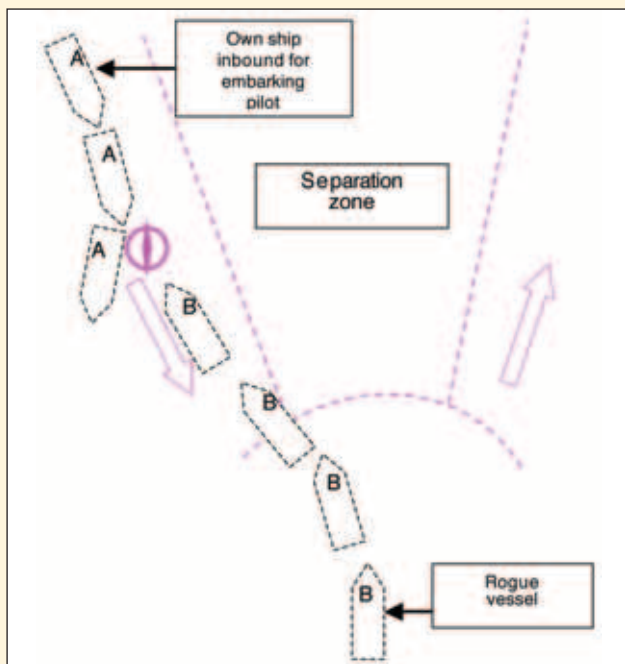
Our inbound vessel was approaching the pilot station, just off the harbour entrance, by day and in clear weather. There is a clearly marked and well-known traffic separation scheme leading to the port (see sketch below). A large outbound container vessel disembarked the pilot inside the breakwaters and, instead of following the north-bound lane, proceeded to come up the opposite way along the south-bound traffic lane. With a distance of less than one mile between our two rapidly-closing vessels, we executed an emergency turn to starboard with engine going full ahead. Collision was averted by only 80 metres.
