# The Nautical Institute Mariners' Alerting and Reporting Scheme

MARS Report No 210 April 2010

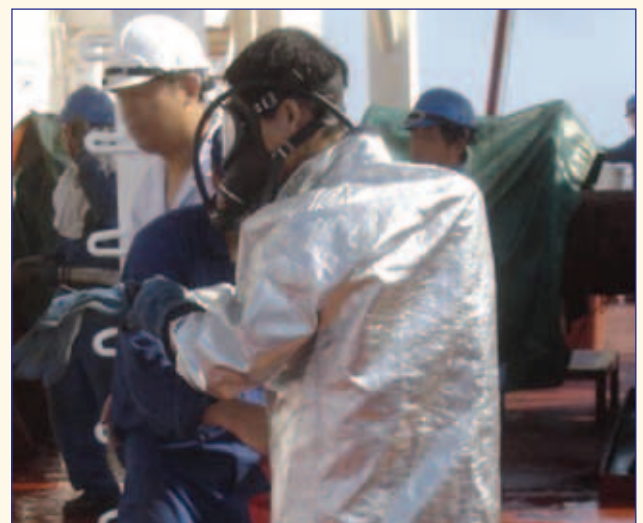
During a fire drill with a newly-joined crew, the designated fire-fighting team was observed to wrongly put on the firefighter's suit over the self-contained breathing apparatus (SCBA). This caused the jackets to be torn under the armpits, restricted movement and prevented quick changing of the air bottle. The error was pointed out and the equipment was then worn correctly. It appears that the seamen had previously received fire-fighting training with outfits that were designed to be worn over the SCBA, having suitable pockets in the back to accommodate the same. However, the ship's firefighters' outfits were not of this type.

▲ Figure 1: With this type of firefighter's suit, the SCBA set must be worn over the jacket.

This illustrates the need for crews to receive thorough and proper familiarisation with safety equipment immediately after boarding. In the absence of such type-specific training, there is a real danger that emergency response may be ineffective if they wrongly assume on board equipment to be the same or similar to those as previously encountered in other companies, on other ships or in shore-based training.

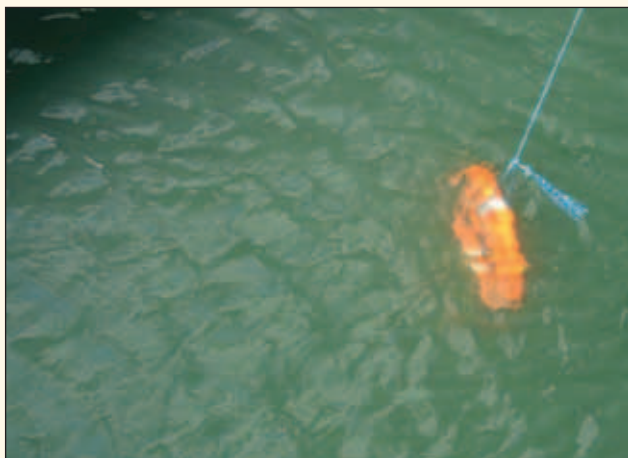
While engaged in carrying out maintenance on deck, a seaman on board a merchant ship had to temporarily remove one of the vessel's lifebuoys from its holding bracket. When lifting it off, he felt that the lifebuoy seemed to be unusually heavy and appeared to be saturated with water. Water was also seen to be dripping from under one of the retro-reflective tapes. When he pressed the damp section of the tape, it gave way, revealing a 15 mm diameter hole through which several litres of water had entered and filled the space between the plastic outer shell and the buoyant material. In this condition, it was seen that the lifebuoy was unable to float freely and would have been useless in an emergency. Further investigations on board other vessels revealed more such defective lifebuoys that had been manufactured in European Union countries and were accompanied by valid type-approval certificates.

▲ Figure 2: Water-logged lifebuoy has insufficient buoyancy to float by itself

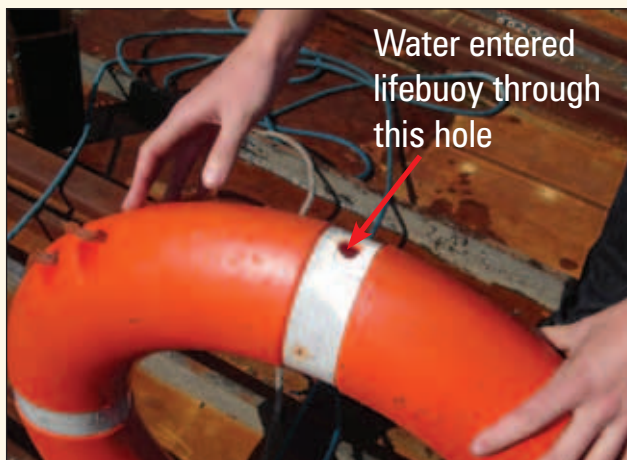
▲ Figure 3: Hole in the lifebuoy

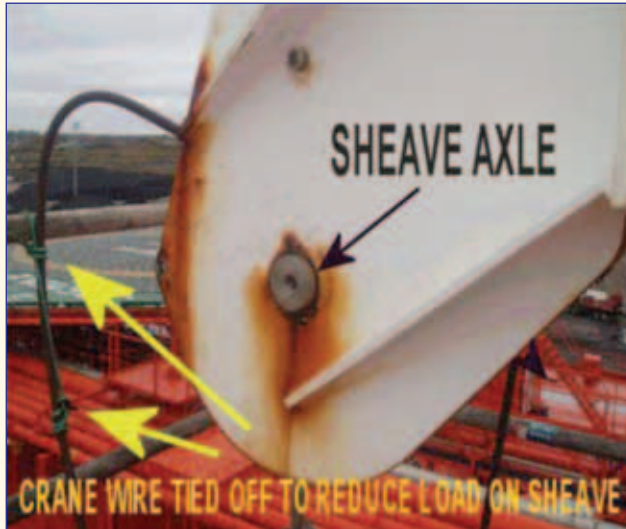
The necessary scaffolding had been erected earlier under the supervision of the leading seaman. After completing an inspection of the scaffolding, the chief engineer and leading seaman proceeded to climb it and began the work. Both were properly fitted with appropriate personal protective equipment (PPE), including approved full body harnesses and fall arrest equipment. The cadet remained on the deck, serving as a helper. The first step in the work process included tying off the crane wire to reduce the load on the sheave.

▲ Figure 4: Crane wire tied off to reduce load on sheave

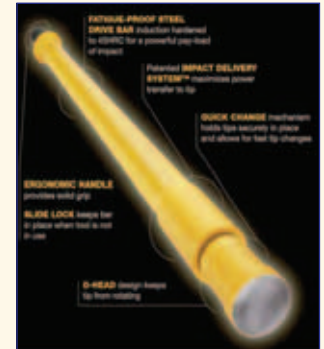
▲ Figure 7: Patented hand-held 'pump-action' hammer permits one-man operation and increases safety and efficiency. Further information on this equipment can be seen on the link [www.youtube.com/watch?v=tHtk1hIVvbw](http://www.youtube.com/watch?v=tHtk1hIVvbw)

6. Share findings of this report with the industry.
7. Issue company safety bulletins to create awareness of safer hand tools.
