Seaways

Mariners' Alerting and Reporting Scheme

MARS Report No. 278 December 2015

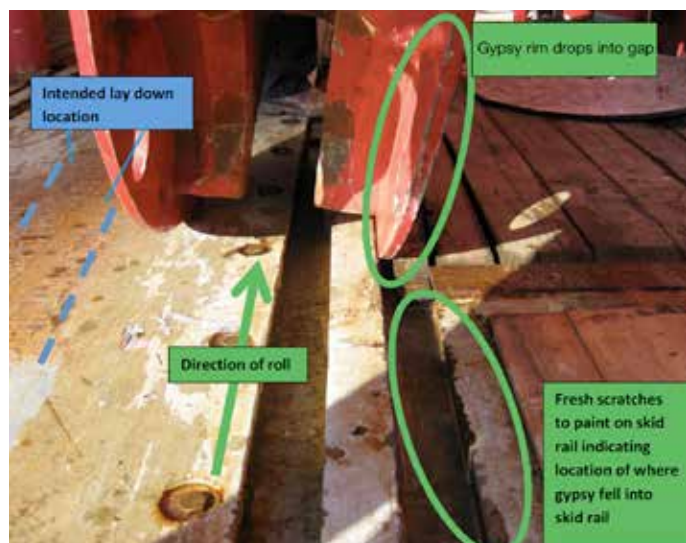
Heavy chain wheel crushes crew member

The crew disconnected the 84mm gypsy from the crane without checking its final landing position. They did not initially see that the rims of the gypsy were on each side of the skid rail instead of further to the left, on the smooth deck. After disconnecting from the crane, the crew started to roll the gypsy to position it for installation. However, during this manoeuvre the right hand rim dropped into the gap in the rail, causing the gypsy to tip beyond its balancing point. It fell over and pinned two crew members against the bulkhead. After rescuing the crew members from their precarious position, one required first aid while the other was subsequently pronounced dead.

- Identify all hazards and risks prior to starting a job. Due to their size and weight, gypsies should not be manually handled or rolled.
- If the execution of the job does not go according to plan, stop and re-evaluate.
- Ensure there are adequate lifting or handling appliances for handling the intended job.

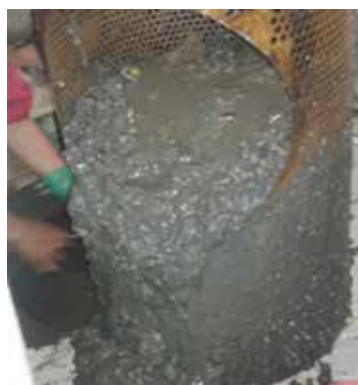
Mud causes main engine shutdown

The investigation found that due to the low UKC, and to silt build-up at the berth, one of the cooling suction inlets had ingested large quantities of mud while alongside. On departure, the mud blocked the starboard main engine cooling pipework and heat exchanger. This subsequently caused the auto-shutdown of the starboard engine.

- Normal practice was to bunker first in order to ensure as much UKC as possible, then to load cargo after taking bunkers. In this instance the sequence was reversed with the resulting negative consequences.
- When established procedures or best practices are not followed, negative consequences can often occur.

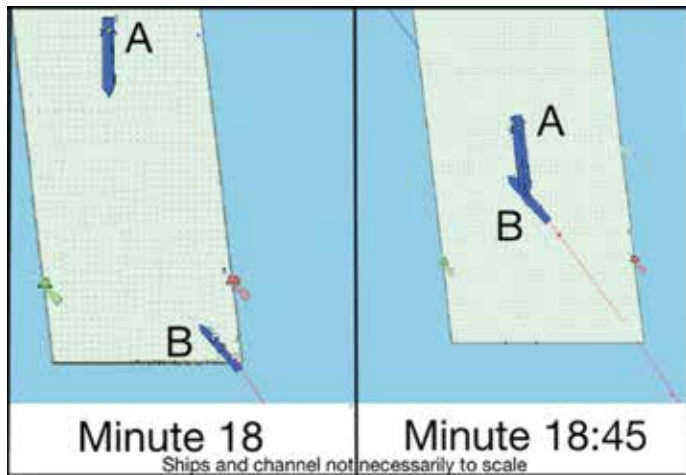
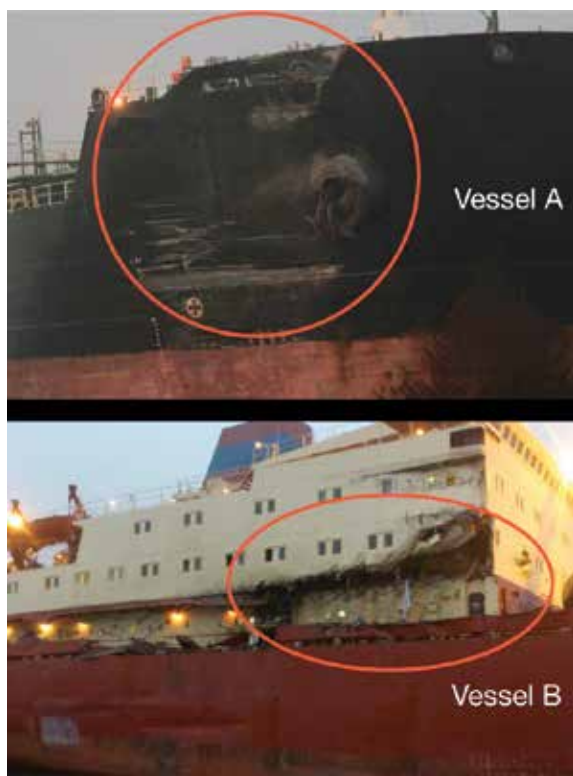
Collision in fog

were under the impression they were turning as planned and were near the eastern side of the channel. In reality, the turn brought them to the middle of the channel, which was not the plan. Within 45 seconds the situation went from one which both bridge teams perceived as normal to one that was far from being normal. The vessels collided near the middle of the channel and sustained substantial damage.

- Both bridge teams lacked adequate situational awareness. Each thought their position was appropriate for the meeting but in fact, neither was.
- Meeting in a narrow channel can be a challenge for bridge teams, especially when visibility is reduced. In this instance, factors such as a closing speed of nearly 20 knots, a pilot boat tied onto one ship and the other vessel making a turn all combined to make an unacceptably small margin for error.
- Navigators should act instead of react. Acting means taking early and substantial action to avoid situations that leave little chance for a good outcome.

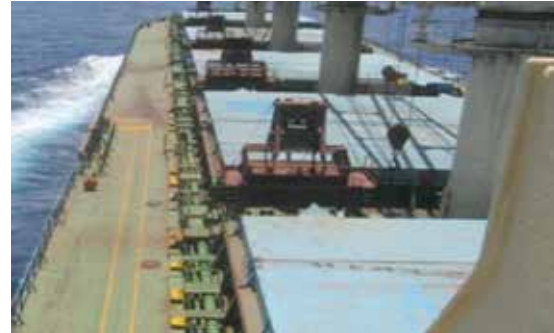
→ A bulk carrier was equipped with four cranes, each with a grab. When not in use, the grabs were normally stowed and secured on the pedestals between the cargo hatch covers, as in the photo.

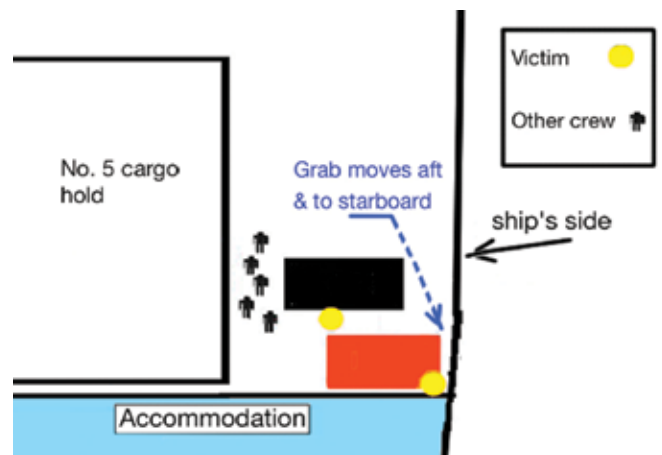
As the vessel made way the wind increased in strength, becoming force 8 to 9, with wave height of about 4.5 metres. The lashings of the grab loosened and the grab shifted away from its position on deck. In order to avoid damage to the grab and the vessel, crew members were called to put on extra lashings. While the crew members were lashing the grab (black in diagram), a large wave washed on deck and the grab was pushed aft and to starboard. As the wave came on deck, most crew took shelter near the hatch coaming but one crew member was crushed between the grab and ship structure (position to which the grab shifted is shown red in diagram). While some crew sustained minor injuries, the victim that was crushed was later pronounced dead.

- Hindsight is often 20:20. In this case the grab was secured by belts and chain blocks but without any frame or welded structure on deck. Given the size and weight of the grab, and the difficulty of getting proper securing points on deck in an ad hoc manner, this was unwise.
- Before sending crew to work on deck in heavy weather all contingencies should be considered; among others, deviating to a more sheltered area, changing course and speed to reduce green seas on deck and planning crew placement and the work procedure before placing oneself in a hazardous position.
- **Editor's note:** Make your foresight as good as your hindsight – when deviating from an established practice, brainstorm with your team and think about the possible consequences. Mitigate risks accordingly.

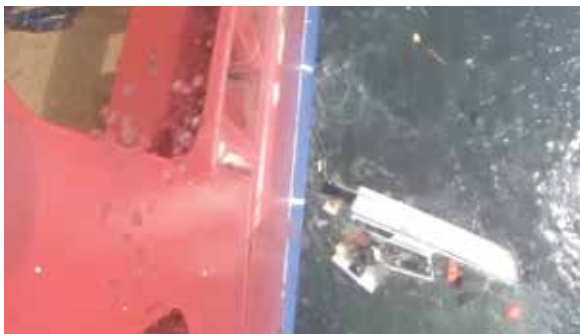
Swamped taxi boat as seen from ferry shortly after collision

The official investigation notes that neither vessel took evasive action to avoid the collision as none of the vessel operators realised the other vessel was present. Although the official report is silent on why the operators of both vessels were ignorant of the other vessel, the absence of sound signalling from both ships is mentioned as a contributing factor to the collision. Also, the report mentions that had the taxi boat been equipped with AIS, there may have been a better chance of that vessel being detected by the ferry.

- When in thick fog, use your sound signals as prescribed by the Collision Regulations.
- When in thick fog, slow down.

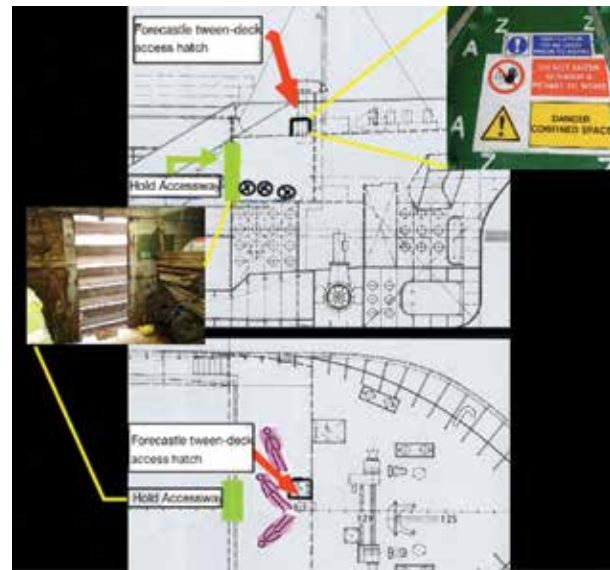
Three deaths in an enclosed space

The investigation later found that halfway down the ladder to the forecastle tweendeck, oxygen concentrations were in the order of 10% and only 5-6% at floor level. The victims had succumbed to oxygen starvation. Since the forecastle tweendeck had an access way to the hold, the timber cargo had reduced the oxygen content of forecastle space to below life sustaining levels.

- Placards and signs are a good safety measure but they are never enough. Training, awareness and procedural integrity are needed to ensure safety.
- Never descend into a confined space to save a victim unless you are equipped with proper breathing apparatus and have support from other personnel.
- A confined space untested for adequacy of oxygen or the presence of harmful gases is a death trap.
