Seaways

Mariners' Alerting and Reporting Scheme

MARS Report No. 256 February 2014

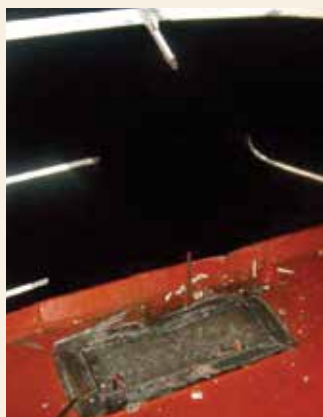
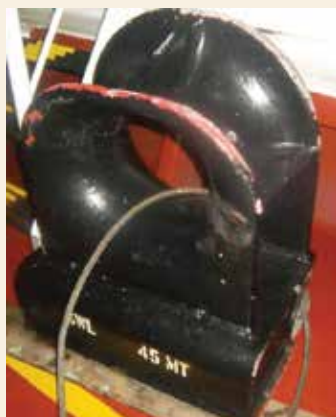
The incident caused considerable damage, with the Panama fairlead detached from the deck plating, an air vent pipe detached from deck mounting, the accommodation stay side frame and plating buckled, the poop deck plate buckled in way of sheared Panama fairlead, internal transverse bulkhead and one bracket buckled, side shell plating bent at the upper edge and adjacent guard rails on the starboard poop deck damaged.

- 1 Failure to follow instructions: The tug boat Master did not follow pilot's instructions.
- 2 Incorrect use of equipment: Rendering capacity of the tug rope used for the pull up was much higher than the SWL of the fairlead.
- 3 Adverse sea/weather conditions: Weather was bad, sea was rough, and wind was brisk. The incident also took place during night hours. The bad weather may have contributed to incorrect handling of the vessel.
- 4 Inadequate supervision. Since the tug boat was using a line with strength considerably higher than the SWL of the deck fittings, the officer on deck should have alerted the Master.

■ **Editor's note:** Although not common, mooring equipment damage of this nature does occur with a frequency that may surprise some. Powerful tugs can exert extreme forces on a vessel's gear. In this case the fairlead came through the incident without any apparent deformation even though it tore loose from the deck; a testament to its indicated SWL. However, its attachment to the deck may have been less than the rated SWL and may be an area for further investigation.

All vessels in the fleet advised to undertake a risk assessment specifically for mooring operations with tug assistance and use the lessons learned from this incident.

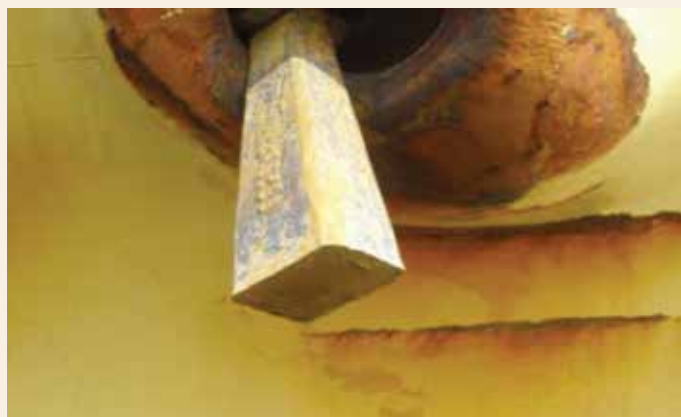
As the starboard anchor broke the surface of the water the officer on duty informed the wheelhouse that the flukes and crown of the anchor were missing.

This could be due to a latent defect, as such an occurrence is unusual under normal usage. Even under excessive load conditions, the D Shackle on the chain, which is the weaker link, should break first. This indicates a probable casting defect which has surfaced after three years of use.

■ **Editor's note:** Although it is difficult to appreciate a lesson learned here, casting defects do occur from time to time. It is prudent practice when in drydock to carefully examine all ground tackle for defects. But even a thorough visual examination can miss a casting defect which is hidden within the gear. Some inspectors use a hammer test that may reveal casting problems or other defects.

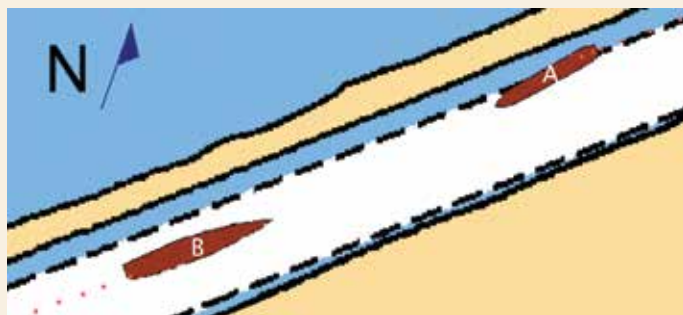
As the vessels close, vessel A experiences bank suction

- The bank suction effect on vessel A became progressively more pronounced, requiring increasing starboard helm; placing the helm amidships caused the vessel to sheer to port.
- There was no relevant communication between the pilots of the two vessels throughout the developing situation.
- Ineffective Bridge Resource Management (BRM) aboard vessel A resulted in critical information not being shared with the pilot, thus precluding timely action.

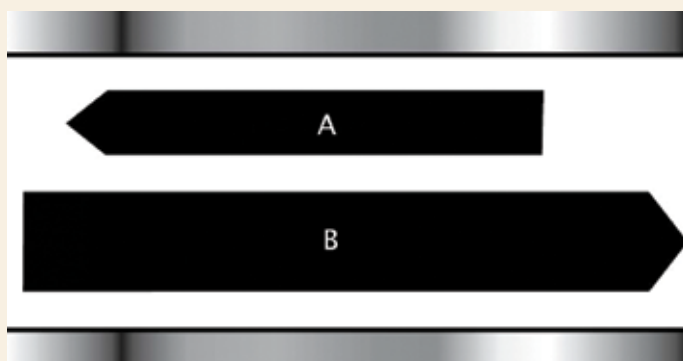
Ideal meeting, vessels and canal to scale

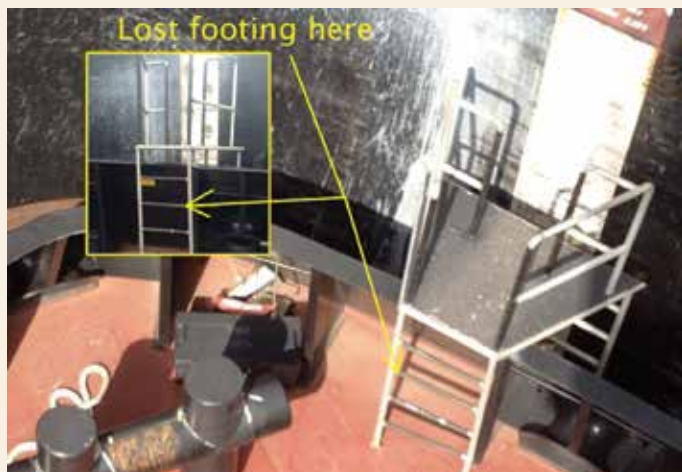
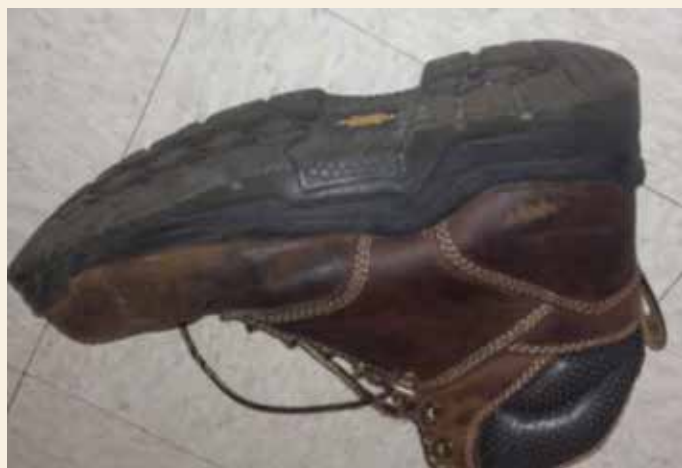
He first descended the pigeon holes in the barge to a platform with a ladder approximately 1.5 metres off the deck of the tug. He later stated that there was no rush to get down and that he was taking his time. While stepping down from the platform his right foot slipped on approximately the third step of the platform. He then fell feet first to the deck, and was later diagnosed with broken bones in his right foot.

- The platform, steps, and tug deck were found to be in good condition, clean and dry.
- Decks on the barge were checked for moisture that might have coated the tread of the work boots – no moisture or slick surfaces found.
- The crew member was wearing all the required PPE including work boots, FRC, hard hat and safety glasses.
- The crew member's rest hours were checked (from the incident to 96 hours prior) and he was compliant for this period of time.

Masters to hold a safety stand down with their crew to advise them of this injury and generally heighten awareness. Also, crew are to review safety requirements when transiting the notch.

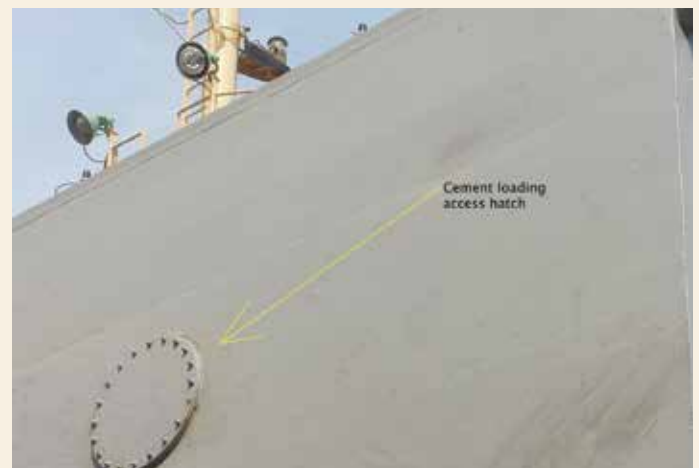
➔ My vessel was en route to Norway to load cement in bulk through a chute. The cement was to be loaded through the cement access hatch on the main hatch covers. I had joined the vessel two weeks previous as chief officer and found that the cement holes were frozen due to lack of maintenance. A fitter and the deck crew worked many long hours for two days to open the frozen manholes and there was much stress due to this unforeseen complication.

I think many ship staff nowadays are unaware of the purpose of these openings, hence this report. The fatigue/stress/panic of such an event can be easily avoided by doing annual maintenance of these openings, which takes only about 45 minutes; that is opening, cleaning, greasing and boxing back. Some bulk carriers also have ullage ports on top of the hatch covers of ballast holds and the same applies there as well.
