Seaways

Mariners' Alerting and Reporting Scheme

MARS Report No. 260 June 2014

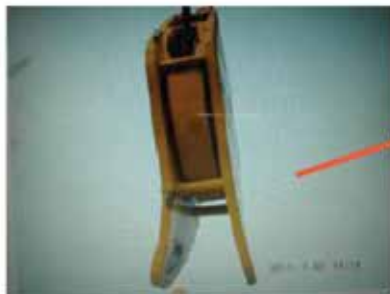
In the other case, the crane operator swung the lift, which subsequently caused the cargo block to impact the cargo hold. This subjected the cargo block to excessive force and deformed the cheek plates.

Cheek Plates deformed

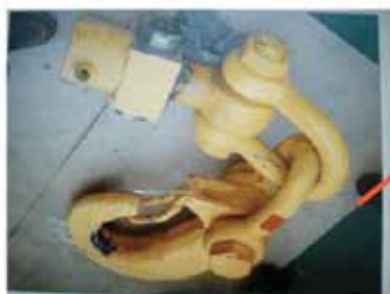
→ During various cargo operations, two different manoeuvres have recently caused close calls where the cargo hook and associated equipment have fallen free.

Trunnion, shackles and hook dropped off

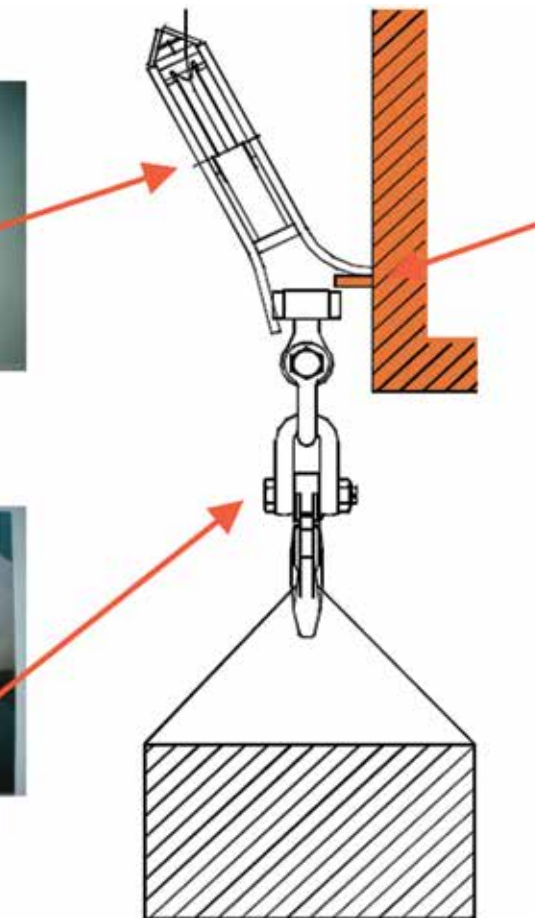
In one, the crane operator continued lowering even though the cargo block became snagged on a structural plate in the corner of the hatch coaming. This damaged the cargo block by opening the cheek plates and could have caused serious consequences.

Illustration of cargo block damage

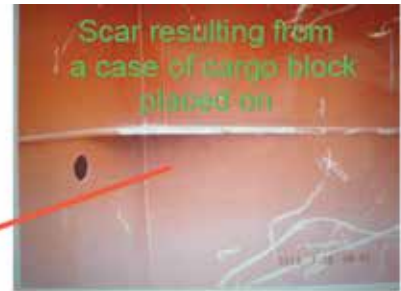
Scar resulting from a case of cargo block placed on

Structural plate of corner of hatch coaming

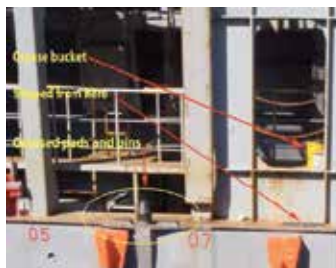
Figure 1

➔ The vessel was in port undergoing cargo operations. The stevedores stopped work for a shift change, and in the quiet period between the two shifts, one of the ship’s seamen decided to grease the hatch landing pads around the open cargo hold (Figure 1). The chief mate and the bosun were apparently not advised of the work and permission had not been obtained.

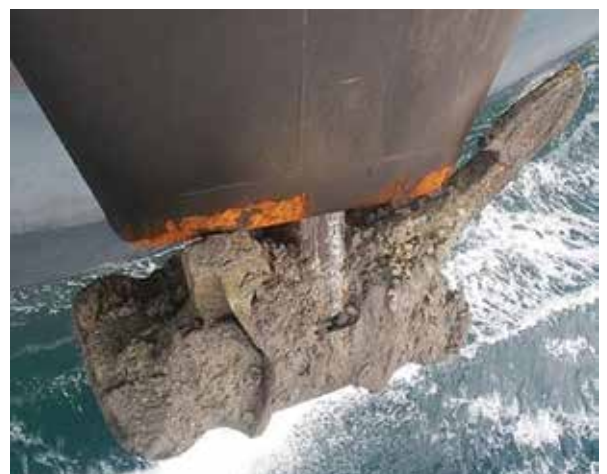
However, during watch handover the 2/O informed the relief that the vessel had dragged about half a cable to the SW. Subsequent monitoring of the vessel’s position confirmed a slow drag but luckily the pilot was due on shortly. As the anchor was lifted the bosun informed us that one fluke was missing. Everyone was amazed that a fluke from an anchor weighing 10,500kg had been broken in such benign conditions.

Once the anchor was on board everyone was very surprised to see the condition of the steel. Incredibly, we even found small pieces of rags trapped by some cement or plaster within the cast metal. A few weeks later, after the suspect metal had been analysed in a laboratory and a follow-up investigation done, we were informed that some anchors produced for the shipyard where our vessel was built had casting failures so bad that they were ‘corrected’ prior to final inspection and delivery to the shipyard.

■ **Editor’s note:** Even at a safe and benign anchorage a watchkeeper must always be vigilant and check the vessel’s position often. Also, use your anchor alarm if so equipped. Anchors and chains, even relatively new ones, can break at any time due to bad assembly or manufacturing faults.

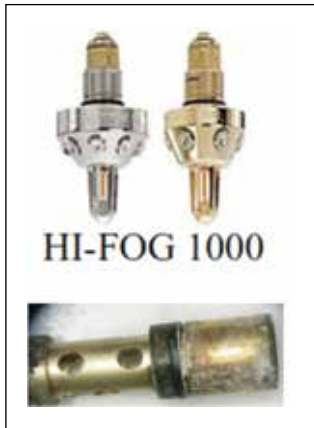
→ A 1600 GT vessel built in 2006 was fitted with a MARIOFF high pressure water mist fire suppression system throughout the vessel. At a routine maintenance and test programme, 22 of the 'wet pipe' system sprinkler heads were found to be faulty and would not have operated had the system been activated in an emergency. A photograph of a typical head is shown, with an example of a contaminated spindle.

- The manufacturers had issued a bulletin in June 2012 identifying risks of contamination of the spindles and heads due to poor water quality, but this was not appropriately disseminated or shown on their web site. Water dosing and testing was recommended.
- The manufacturers had issued a second bulletin, also in June 2012, recommending that at least two heads from each section

- IMO MSC.1/Circ.1432 does provide some guidance on this issue.
- It is considered that there is a high risk that the system will not work as required in an emergency unless all sprinkler systems, including the water within the system, is correctly maintained and tested.

- The manufacturers had issued a third bulletin in May 2013 recommending increasing the standby water pressure from 25 to 40 bar to ensure that the spindles were operated when the system operated. Again this appears to have not been appropriately disseminated.
