The International Journal of The Nautical Institute

Mariners' Alerting and Reporting Scheme

MARS Report No. 265 November 2014

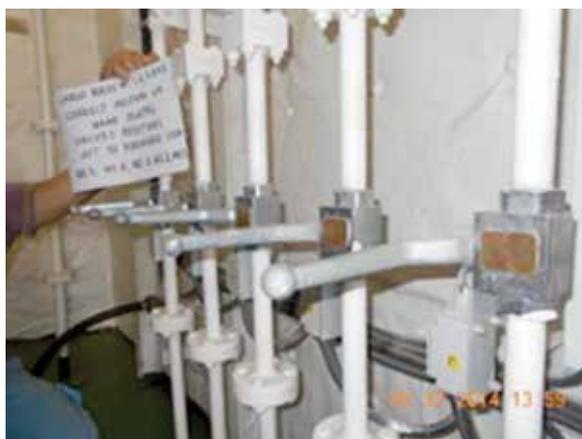
During fire safety equipment verifications, the fixed CO₂ cargo hold line identified as number five hold was tested by blowing compressed air into the system line. Despite this, no air passed through to the other end located at the forward and aft hatch coaming of number five hold. The CO₂ line's air drain in the engine room was checked and found to be in order. The CO₂ pipe aft of hold five was dismantled to check for any clogging but none was found. Again, compressed air was blown through but there was no air arriving at the exit end.

Further investigation found that in the CO₂ room, the identification for the release valves for holds one, two, four and five were mis-identified. Only hold number three was correctly identified. As it turned out, the system was mis-identified upon initial installation from right to left instead of from left to right. Hence, only hold number three was correct, the others being in reverse order, and the error had not been caught.

Testing for the proper operation of the CO₂ system is to be thoroughly conducted including physical check of outlets, not just cursory test or simply paper documentation for compliance.

Proper communication with personnel involved in the test must be established in order to confirm which valves are opened and that the release valve and lines match the labels on the information plate in the CO₂ room.

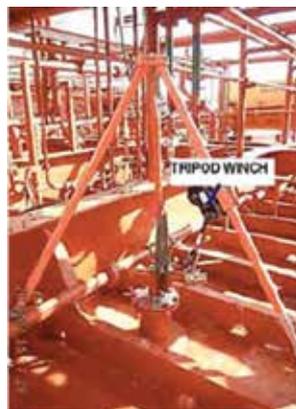
Three crew were in the process of overhauling a tank cleaning machine for one of the cargo tanks. At the end of the overhaul the cleaning machine was being repositioned in the hold using a tripod winch. As the inlet housing of the cleaning machine was being lowered in a controlled manner using the tripod winch, one of the crew inserted his fingers under the flange to retain the O ring in its groove as it kept slipping out of position. The inlet housing was approximately five cm off its final resting place when the winch, clamped on tripod leg, suddenly and unexpectedly moved. This caused the inlet housing flange to drop on the middle finger of the crewman's right hand causing deep lacerations.

- Inadequate engineering; the clamp holding the winch slipped on the tripod leg causing the suspended load to trap the crew's finger.
- Retaining the 'O' ring in the groove using fingers is incorrect practice. In such cases, it is good practice to use Loctite (or similar) to maintain the correct position of the 'O' ring in the groove of the flange.
- Lack of thorough risk assessment prior to undertaking the job.

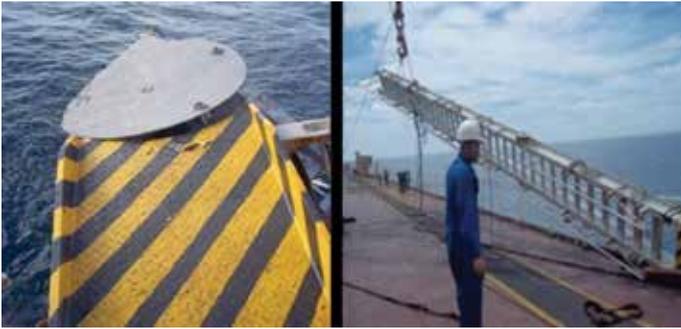
the procedures for stowing the accommodation ladder in its seagoing position. Suddenly the hoist wire broke, letting the shore-end of the ladder fall. The ladder was now only attached to the ship by the main ramp. The vessel's speed was reduced and the cargo crane was used to retrieve the ladder and place it on deck.

The wire was found to be in generally good condition and had been recently greased. Records and related photos indicate that inspection and maintenance intervals had been followed. The wire was almost two years old and was without indications of rust or defects along almost all of its length. However, it was observed that the point where the wire broke had more rust and less grease than elsewhere. After further investigation using the wire layout it was found that the break occurred at a point where access is difficult, thus rendering maintenance and greasing more arduous and less efficient. The wire at this particular point is continually exposed to sea/weather conditions yet can be less well maintained than the rest of the wire. Additionally, when the ladder is about to be stowed or deployed these same wire parts experience the maximum amount of tension.

1. The wire was already wasted at the roller positions, which are always exposed to sea and weather. Given their location, these two points are hard to access for verification and maintenance.
2. The ladder's limit switch may have been bypassed during the operation.

1. All vessels' accommodation and pilot ladders should be checked for vulnerable points and wastage.
2. Instructions should be given to vessels on how to treat the wires on these accommodation ladders.
3. Crew should be given instructions on the use of limit switches and how they help protect the wire from excessive tension.
4. The accommodation ladder manufacturer should be informed of the weak design.

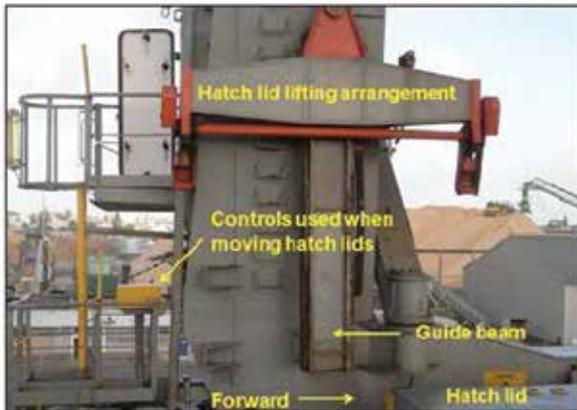
At the time of the accident, this hatch lid was double stacked on another lid. The little clearance between the guide beam on the aft leg of the gantry crane and fittings on the hatch lids is even further reduced when they are double stacked. Each gantry crane was fitted with warning devices that operated automatically whenever the gantry crane travelled along the length of the deck.

Hatch lifting assembly and guide beam shown next to a single stacked hatch lid

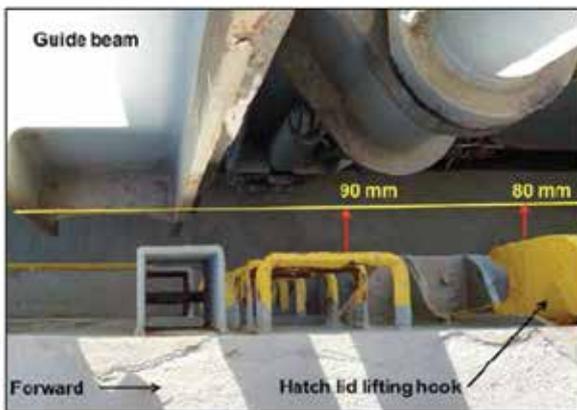
Guide beam shown next to double stacked hatch lid.

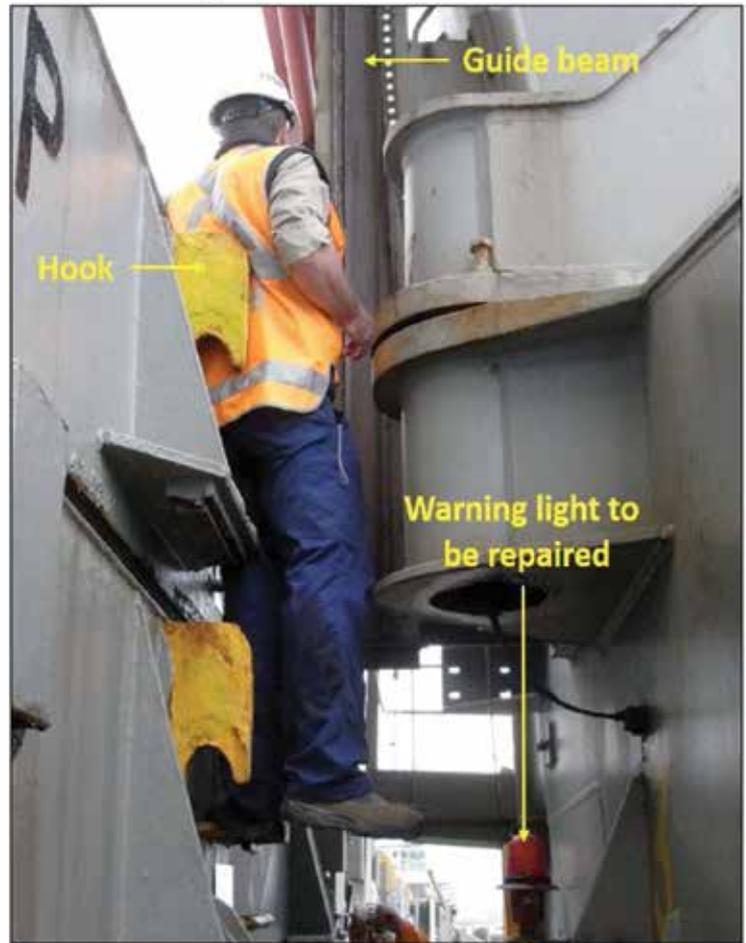
The vessel was in port and routine 'travelling manoeuvres' of the vessel's gantry crane by a ship's officer were being undertaken. The assistant electrician, probably standing near the top of the hatch access ladder, was caught and fatally crushed between the hatch lifting hook and the guide beam of the moving gantry crane.

Likely position of the assistant electrician.

The gantry crane 'in motion' warning light nearest to the assistant electrician's location was not operating and the warning sirens were not audible from his location. As a result, he was not provided with either a visual or audible warning of the crane's movement.
