Seaways

Mariners' Alerting and Reporting Scheme

MARS Report No. 279 January 2016

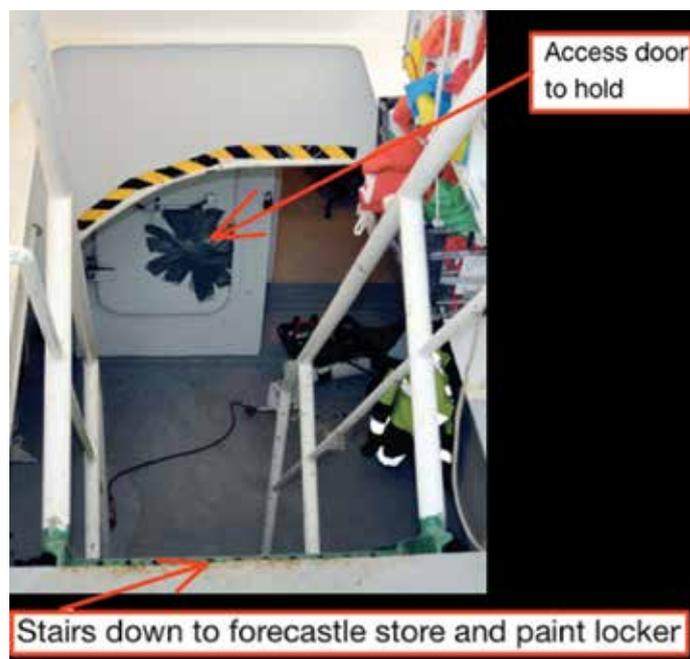
During the meeting, particular attention was paid to the use of personal protective equipment (full-vision goggles and respiratory particle filters) to protect against exposure to dust during loading. Although oxidation of the zinc concentrate, and thus its ability to reduce the oxygen content of a confined space, was indicated as a risk on the MSDS documentation, this risk was apparently not discussed during the safety meeting.

Suspecting a confined space incident, he rushed to get assistance. Two crew members equipped with breathing apparatus went into the hold while others outside assisted with a rope. With some difficulty they managed to evacuate the first mate, but he could not be resuscitated. It was later established that he had died of asphyxiation. Measurements performed the day after the accident showed that the level of oxygen in the air at the stairwell was 2.6%.

- Section 3 of the IMSBC Code states that when transporting solid bulk cargoes, crew must always be aware that such cargoes can be susceptible to oxidation.
- Always read and plan for all risks that are highlighted in the MSDS documentation.
- Before entering a confined space, in this case the hold, always ventilate first and then test for hazardous gases and oxygen content. Follow your company's confined space procedure.
- Never enter an enclosed space on your own. At the very least, a supervisor must be present at the entrance to the enclosed space and must be in communication with the individuals who are entering the space.

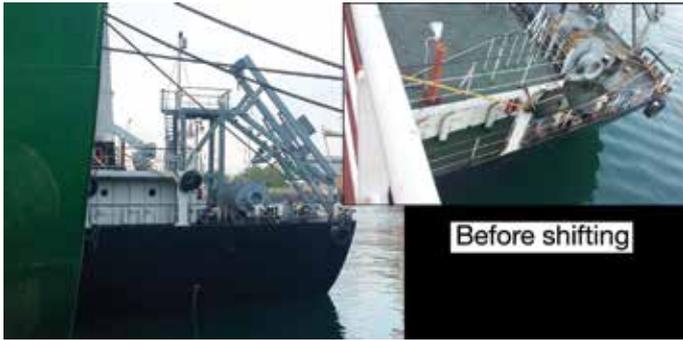
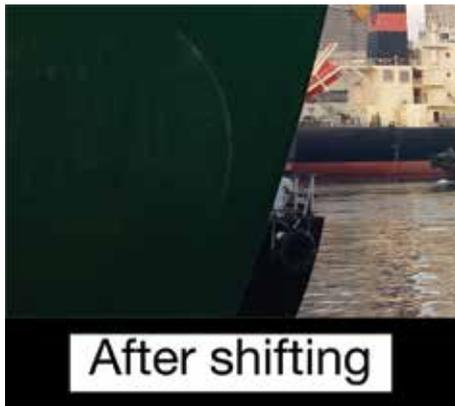
→ The vessel was port side at berth taking bunkers via a barge on the starboard side. The bunker barge was secured alongside the vessel and was initially overhanging the vessel's stern by 10 to 12 metres. Although the berth immediately astern was vacant at the time, potentially it could have received another vessel. The bunker barge overhang would then become a potential hazard.

After assessing the situation, the bunker barge was subsequently moved forward to reduce the overhang considerably.

- Masters and mates should always assess the berthing arrangement and think about possible consequences.
- If potentially dangerous situations arise, such as an overhanging bunker barge that cannot be repositioned, the port should be advised.
- Bunker barges should be equipped with flexible hoses to enable a variable range for connections, removing the need for the bunker barge to overhang.

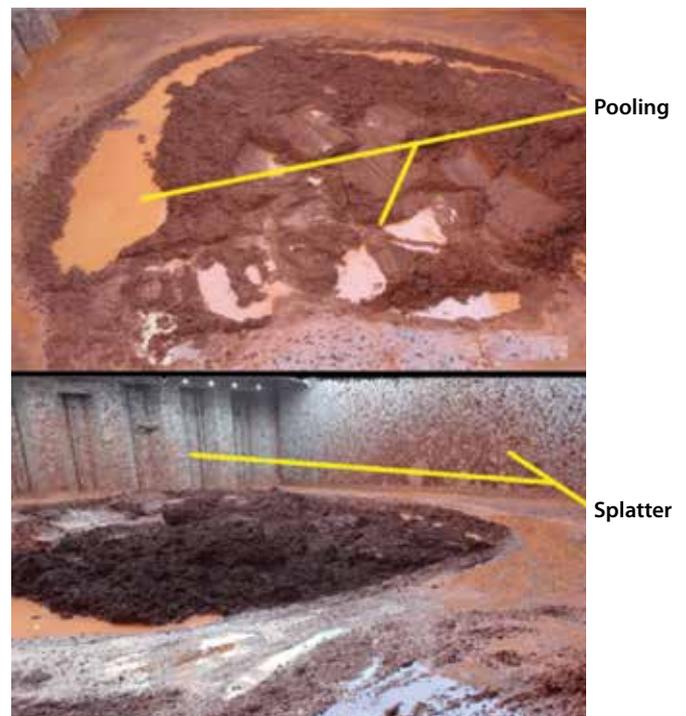
View of bauxite cargo loaded on another vessel at the same port at about the same period as the casualty vessel

Irrespective of the cargo, if you see splatter on the sides of the hold or pooling water on the cargo (see photo) – beware! Have the cargo tested for moisture content and do not transport it if moisture is above the transportable moisture limit (TML).

Notwithstanding Appendix 1 of the IMSBC Code, for the time being one should assume that any wet or moist cargo of bauxite containing an appreciable amount of fines is Group A unless testing has shown otherwise – even if the shippers have issued a cargo declaration stating the material to be Group C.

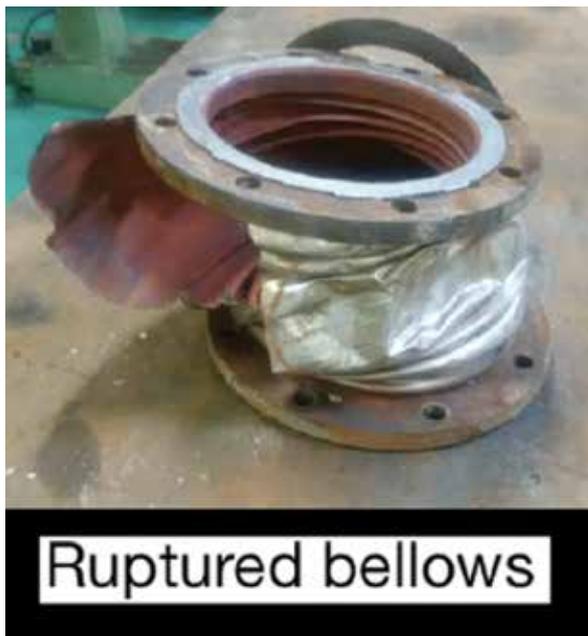
The suction pressure of the pump is normally at around 3 bar and the discharge pressure near 80 bar. The water temperature in the circuit is about 130°C.

The company investigation found that the rupture of the expansion bellows was caused by an overpressure in the pump system between the suction valve and the delivery valve. This overpressure was caused by a leak in the delivery valve; once the suction valve and recirculation valve were both closed the pressure quickly increased above the design pressure of the bellows, which is the weakest part of the system.
