The Nautical Institute Marine Accident Reporting Scheme

MARS Report No 184 February 2008

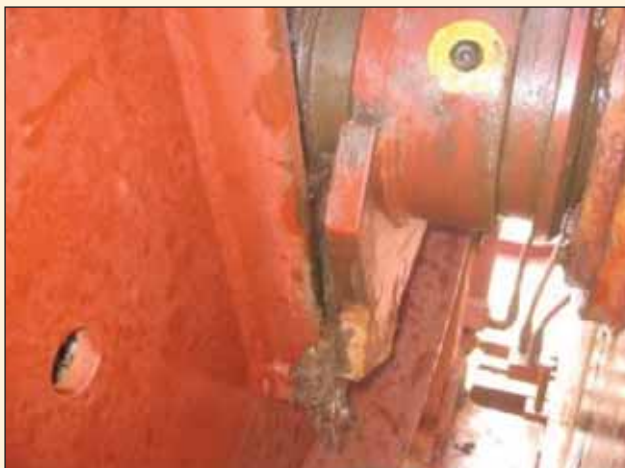
During one such pause, the shaft suddenly began to rotate unexpectedly, and the sleeve of the seaman's parka got caught in the clutch assembly, quickly drawing his hand into the rotating part.

1. The winch power supply had not been isolated before commencement of work;
2. Loose fitting parka and inadequately fastened sleeve cuff.

▲ View of dog clutch into which the parka sleeve and hand were drawn

1. Machinery or moving gear should be de-activated before any maintenance is carried out on or near them.

2. If work on a moving system cannot be avoided, the job must be carried out by two persons at least, one of them being in position to activate the emergency stop at any moment.
3. Clothing and personal protective equipment (PPE) must not be loose when working on or near moving systems.
4. Risk assessment should take into account every realistic hazard. Past risk assessments should be reviewed during onboard daily meetings so that previously identified hazards are not missed.
