### MARS 200815

#### Careless hull painting

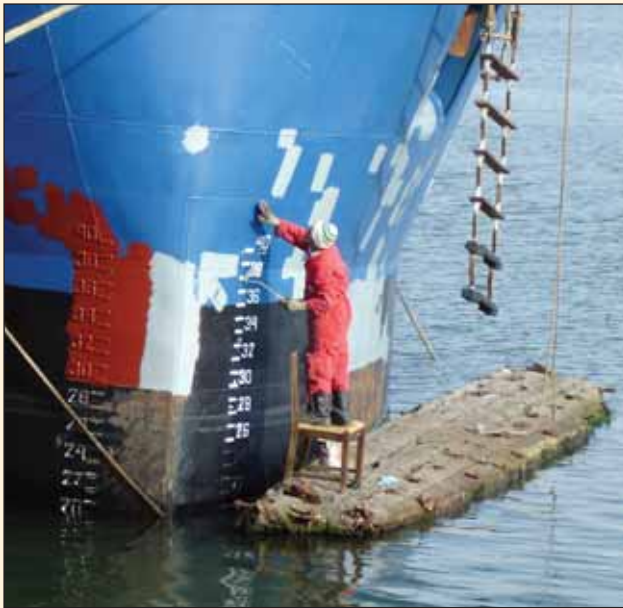
Glaring violations of safe working practices (not in any order):

1. Apparently unsupervised lone crew member at work.
2. No flotation aid, lifeline or eye protection in use.
3. Two separate ladder sections, and pilot ladder (the lower section) being used in an unauthorized manner and also inclined dangerously.
4. Discarded wharf fender with suspect stability and no safety railings or manropes being used as a punt.
5. Highly inappropriate and unsafe use of messroom chair.
6. Unsecured paint container can topple and cause pollution.

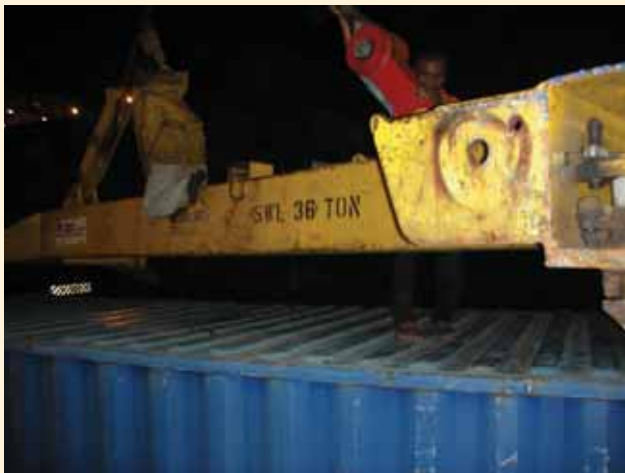
I witnessed very unsafe working practices at a container terminal where my vessel called recently. For every lift, the stevedores clambered on to the roof of the container without a proper ladder, although occasionally they would be hoisted aloft while standing on the forks of a fork lift truck. The dangerously exposed men struggled to position the spreader on the containers and were working without any safety shoes,

▲ 1: Manhandling the spreader: one worker has no shoes and the other is wearing 'flip-flops'

helmet or working gloves. At least one of them was barefoot. On board another vessel that was finishing loading at the terminal, we witnessed a stevedore climbing down from a height of five containers.

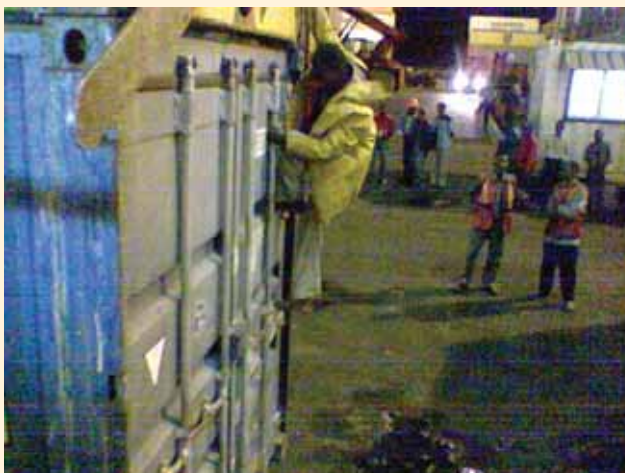
▲ 2: Stevedore climbing down a container. Note the relatively well-kitted out 'supervisory' staff

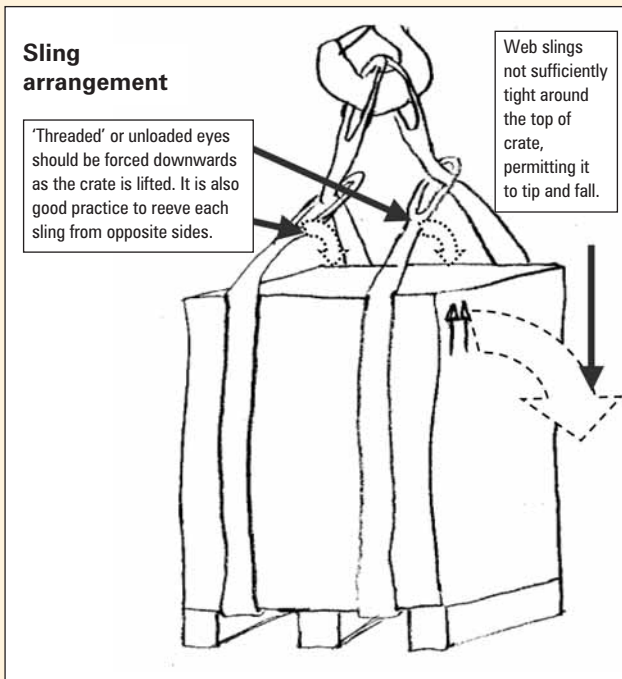
On a ship at anchor, a crate containing machinery spares, reeved with two webbing slings, was being lowered into the engine room through the engine room hatch using the ship's stores crane. During the lowering process, a corner of the base of the crate caught on a section of ducting immediately below the hatch coaming, became unbalanced and tipped through the slings, falling to the deck below. The impact destroyed the crate; however, there were no injuries or damage other than that the spares were rendered unuseable.

1. Failure to sling the crate properly; webbing slings not tight around the top of the crate;
2. Ship rolling slightly at anchorage, causing the crate to swing during passage through hatch;

3. Failure to conduct / review formal risk assessment prior to the lifting operation;
4. It is thought that the spare part was inadequately secured inside the crate and as the crate tilted, the internal shift of weight assisted the 'tipping' motion;
5. The crate's height was greater than the other two dimensions, which made it more prone to tipping;

6. The crate had no fitting to prevent the slings from slipping off in case the load became unbalanced;
7. 'Routine task' complacency and inadequate understanding of risk assessment among the ratings.

1. The company issued notices to masters and safety bulletins on risk assessment, work planning and safe lifting techniques.
2. Crane operator familiarisation training was conducted on board and will be supplemented by further computer based or practical training in crane operations and rigging / slinging.
3. Permit to work system presently applying only to lifts within hazardous areas to be extended to include all lifting tasks.
4. Investigate and solicit vessel proposals for a steel cage / box to be used for lifting operations into engine room.
