MARS 200841 Fatality in fuel tank

A crew member lost his life while working in a fuel oil tank at a time when the ship was undergoing repairs in dry dock.

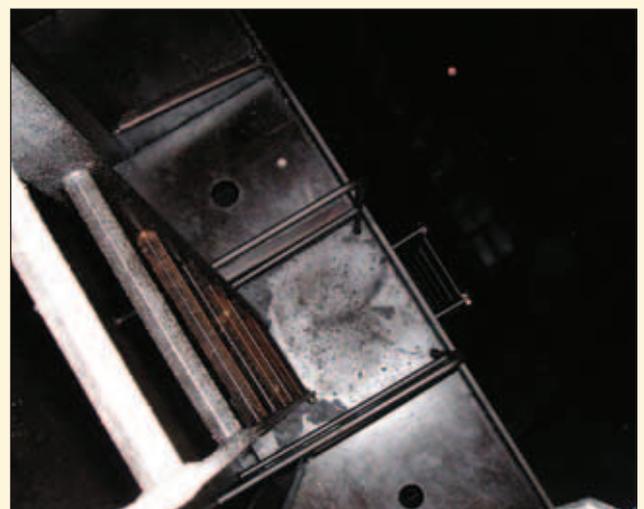
While an able seaman (AB) was sent to fetch the cleaning gear, the bosun observed that the OS inside the tank appeared to be kneeling, but assumed that this pose was to facilitate better cleaning of the platform. A few minutes later, the bosun called out to the OS and lowered the cleaning gear on a rope. The OS rose from the kneeling position, with his hands extended above his head in order to collect the equipment being lowered. At this point he either suffered a black out or just lost balance and fell backwards 12 m down to the tank bottom from the platform. The platform was only provided with guard rails on two of its sides, and the unprotected side happened to be the one behind the OS.

1. The upper platform on the access ladder had safety railings only on two sides, with no guard rails or chains on the tank side. This design flaw seems to have existed from the time of construction of the ship and apparently had not been rectified;

▲ View of the platform from the main deck before accident. Two tiers of chain fencing were fitted on the unprotected side before leaving drydock.

1. Suitable securing arrangements should be put in place around the platform before the vessel departs dry dock. Such arrangements to be also put in place in similar locations on the vessel.
2. Tanks/spaces on other company vessels to be checked at a suitable opportunity to ensure proper safeguards are provided.
3. Format/contents of the company's enclosed space permit to be reviewed and amended to expand the scope of risks associated with the entry/work to be performed. Until the issue of the amended enclosed space permits, all enclosed space entries should be accompanied by a risk assessment.
4. This report to be circulated/shared not just within the company's vessels but with the shipping industry in general, to avoid any recurrence of such a tragic accident.

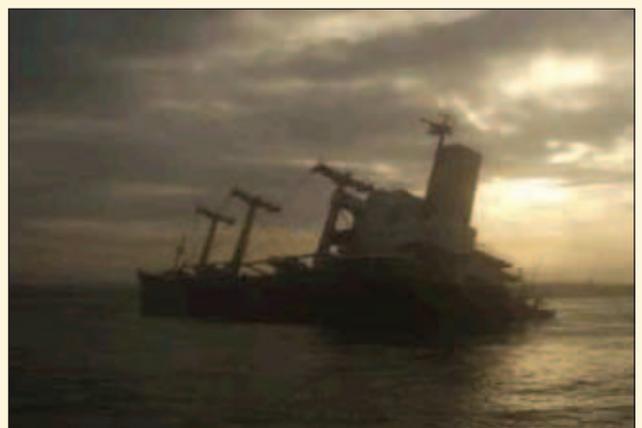
A dry cargo ship loaded 20,000 MT iron ore fines. After sailing and when only a few nautical miles outside the port, the vessel started to develop a list. The list continued to increase and the captain intentionally ran the ship aground (beached it) to avoid capsizing.

1. The ore at the port concerned is generally saturated with water when extracted from the mine;
2. The ore was stored in the open for a prolonged period during the rainy season;
3. The shipper failed to provide certificates showing moisture content (MC) and transportable moisture limit (TML); meanwhile the ship's staff did not seem to have been aware of the unusual wetness of the cargo and the requirements under the BC Code;
4. The high moisture content, combined with the main engine's vibrations, caused the cargo to liquefy. This resulted in the ship nearly capsizing before being successfully beached by the master.

▲ Vessel beached outside harbour entrance after iron ore fines cargo liquefied.

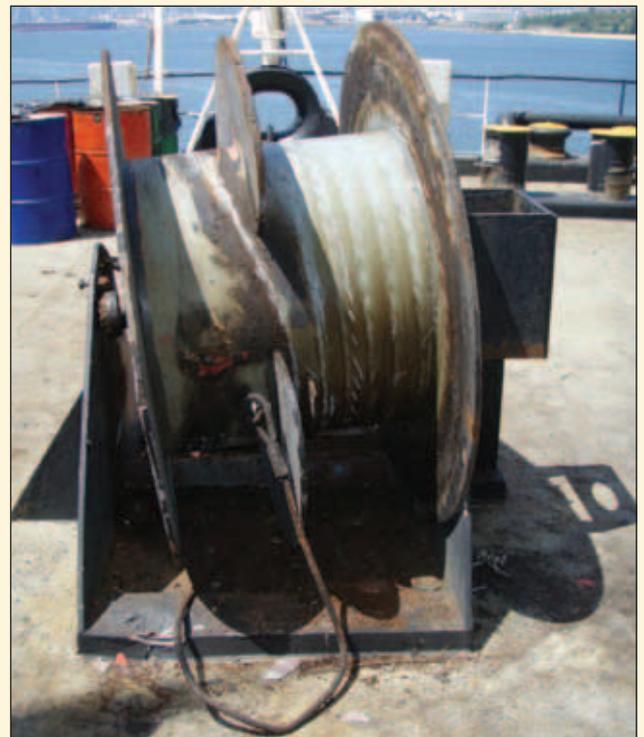
At a particular tension, the brake failed and the entire wire unreeved and broke away from the reel. Fortunately, the strong point held and this alone stopped the heavy end of the towing from falling astern into the dock, where a cherry picker was holding aloft several workers working on the rudder. Luckily no one was injured in the incident. Damage was restricted to the wire reel and to the deck plating.

The root cause was attributed to material failure in the brake's components.

▲ 1: View of damaged towing wire drum showing broken end fittings. The centrifugal brake system is housed within the reel.

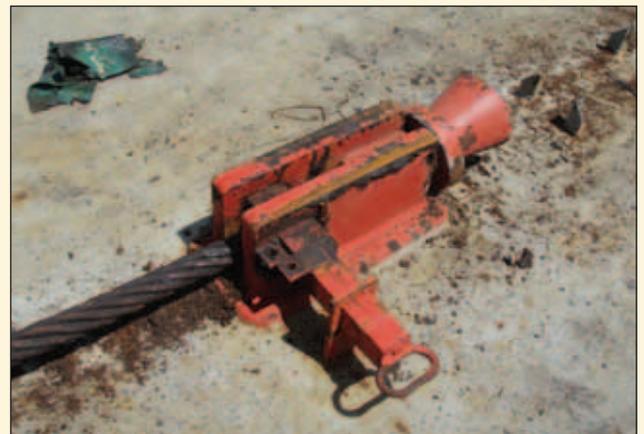
▲ 2: Heavy end of towing wire successfully held by strong point.
