# LP Bulletin

## Bulletin 697 - 05/10 - Carriage of Cement Cargo - USA

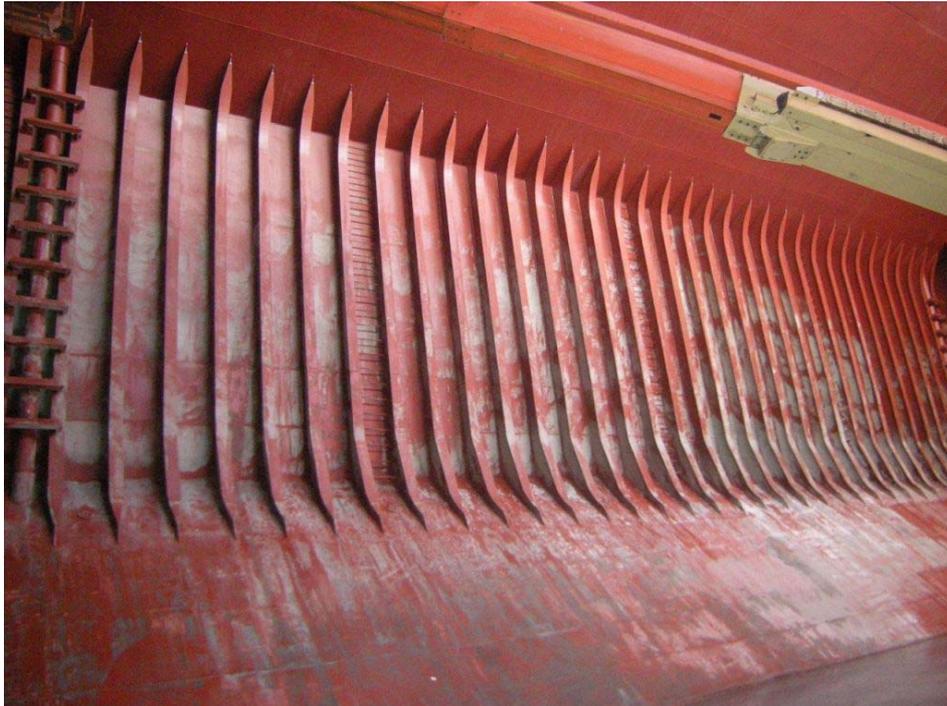
In this particular case it was found that local weather at time of loading, and especially during the 7 day discharge, played a significant role in the adverse condition of the cargo holds subsequent to cargo discharge; cement residue ROB (remaining on board) was partially hardened at completion of cargo discharge. Additionally, the actions of the shore based cleaning crew exacerbated the condition and further delayed cleaning efforts and departure of the vessel by attempting to clean the partially hardened cement residue by inadequate means and by not immediately reporting the adverse hold conditions found to charterers.

The below photo was taken after the initial cleaning operation was completed (sweep, blow and pressure wash). Note remaining residues of semi-hardened cement on all surfaces. Under normal conditions all cement residue would have been removed.

Due to the semi-hardened nature of the cement residue subsequent to discharge, a more aggressive approach should have been followed from the outset of cleaning. Namely, stiff bristle brushes and hand scrapers should have been used to remove as much cement residue prior to pressure washing. The 2,500 psi pressure washers did not have enough force to remove the semi-hardened cement residue. Applying the water to the residue aided in the curing process of the cement. Unfortunately, the cleaning company continued to pressure wash each of the cargo holds top to bottom before much larger 20,000 psi pressure washers could be loaded on board.

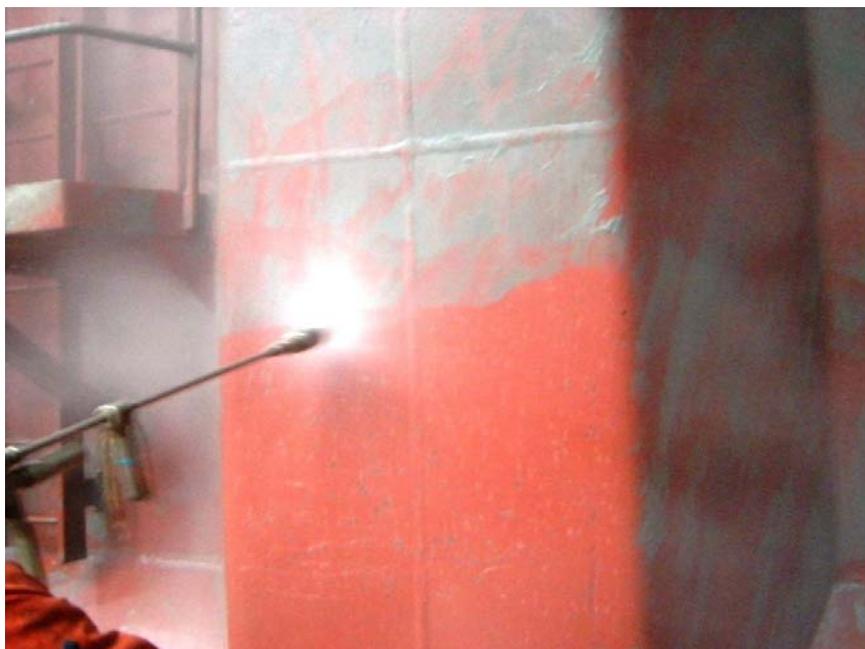
In the below photo the cement residue is being removed by a 20,000 psi machine; however, at a much higher cost and delay. A second barge was required to transport the additional equipment out to the ship lying at anchor, as well as a fresh water barge to supply the larger power washers with clean feed water.
